Whakatane Commercial Wharf

Condition Assessment and Repair Options Report

**Prepared for:
Whakatane District Council**

February 2015
Job No: 851847

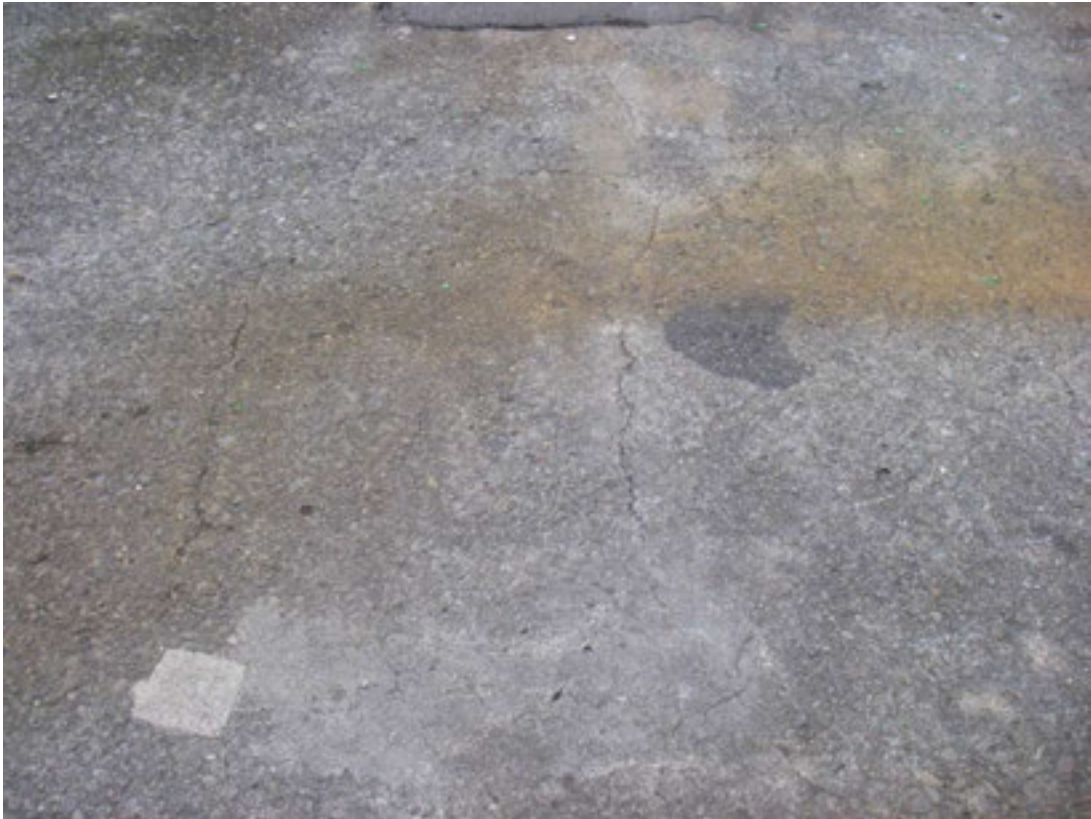
Photo T03 - cracking in slab (1936 section)

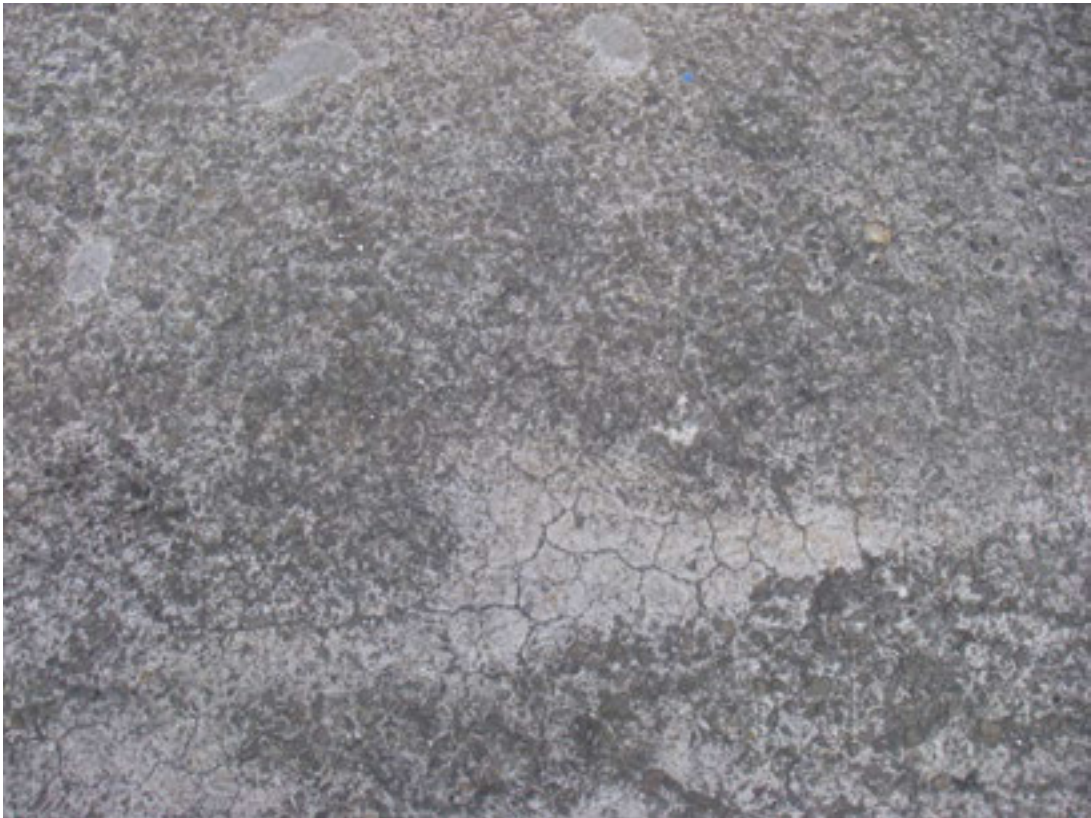
Photo T04 - cracking in slab (1936 section)

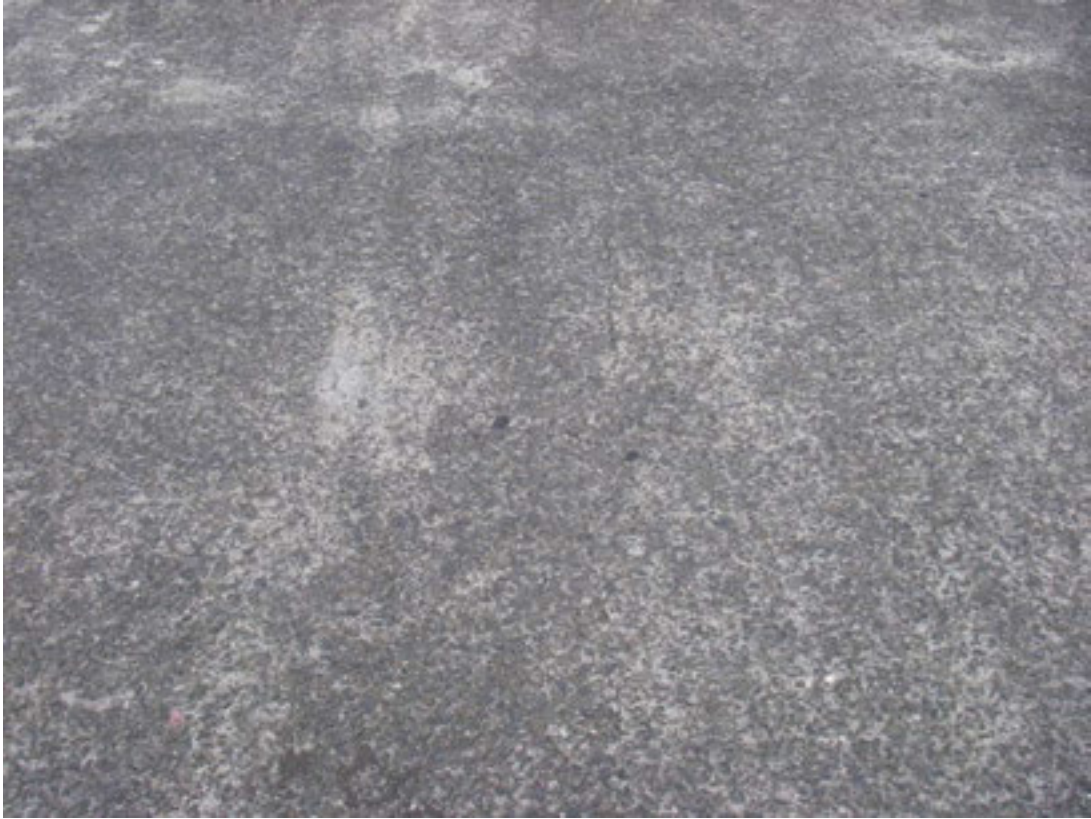
Photo T05 - cracking in slab (1940 section)

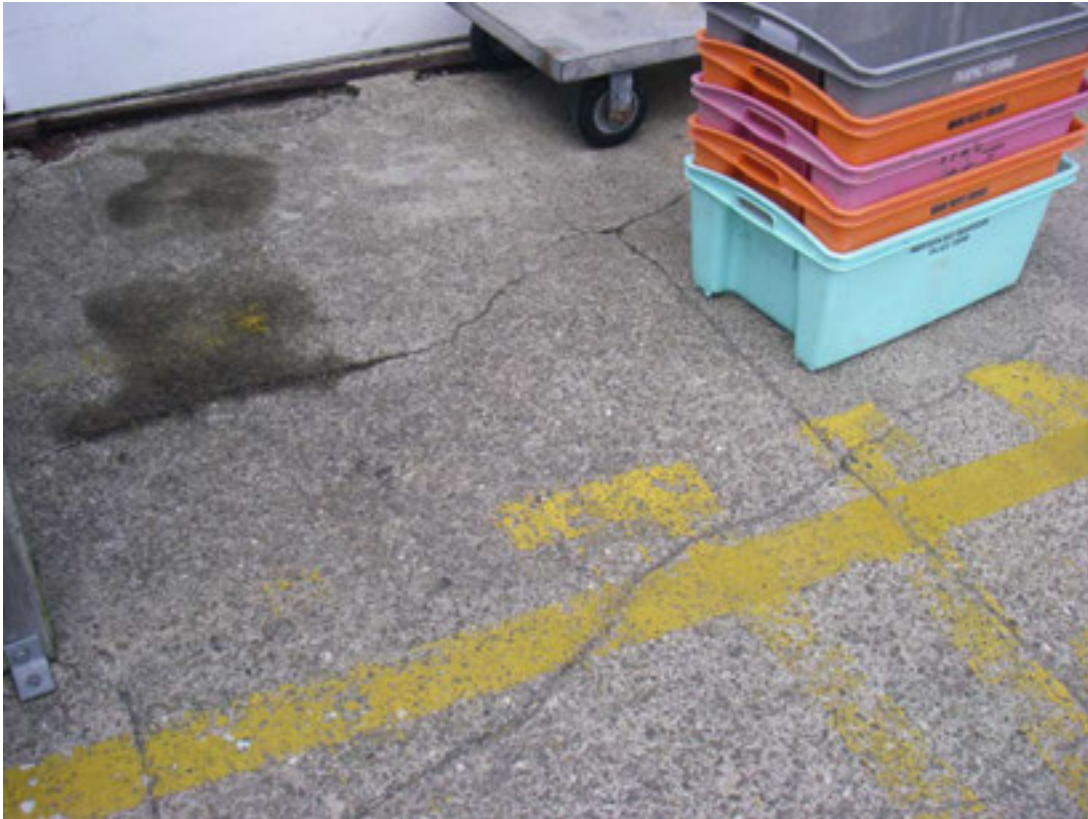
Photo T11 - cracking in slab (1919 section)

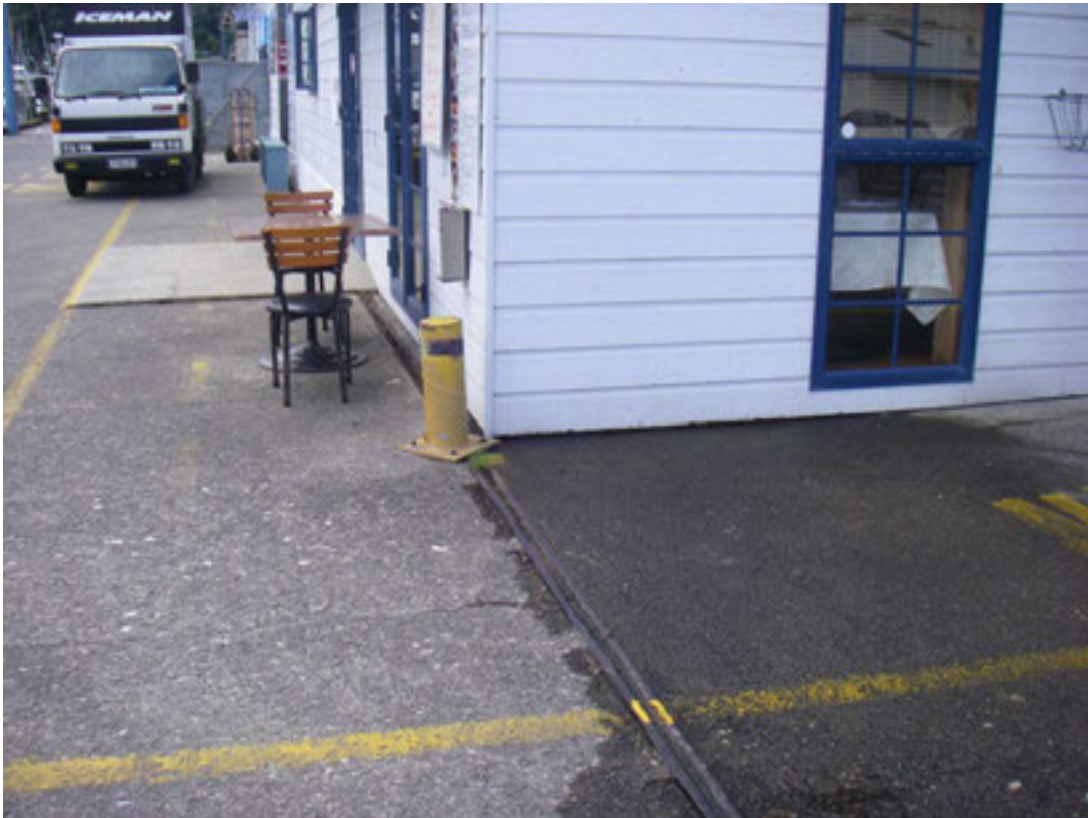
Photo T12 - cracking in slab (1919 section)

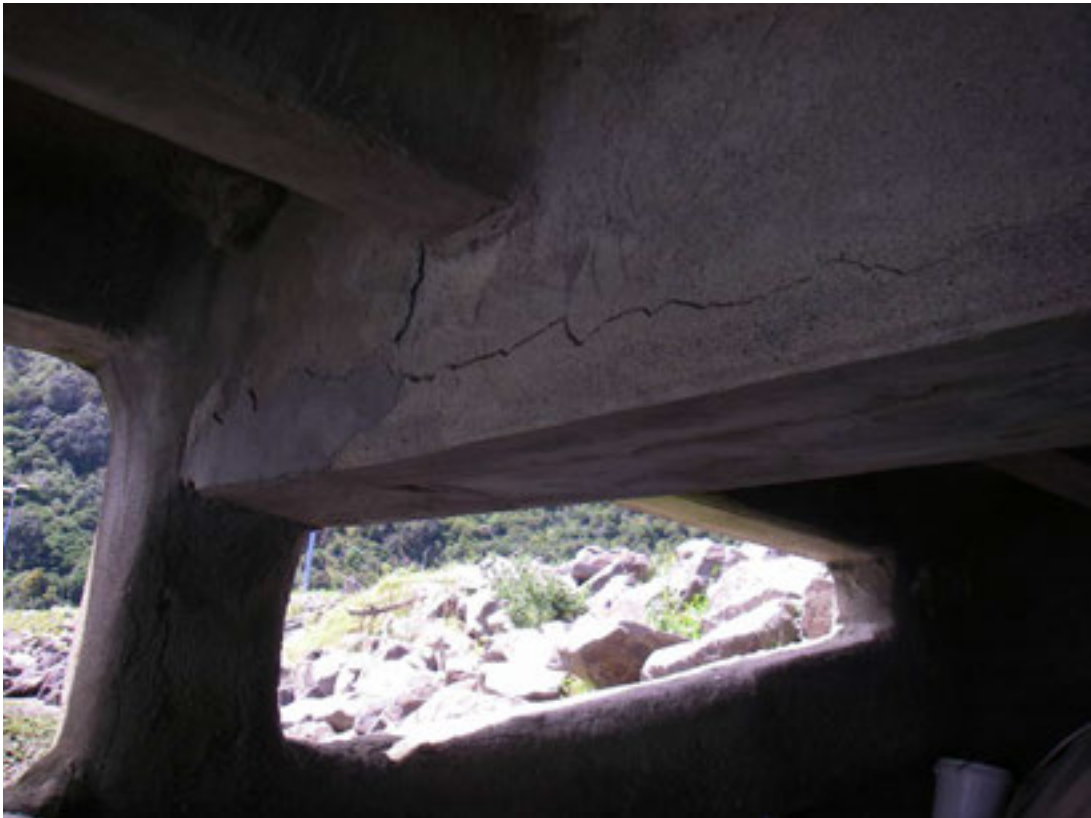
Immediate Priority: This relates to the section of slab at the rear of the wharf between gridlines A1 and A2. **This section of slab is considered dangerous and we recommend that this section of wharf deck is fenced off immediately to prevent vehicle loading until repairs are completed.**

Photo A03 - beam cracking between A1 and A2

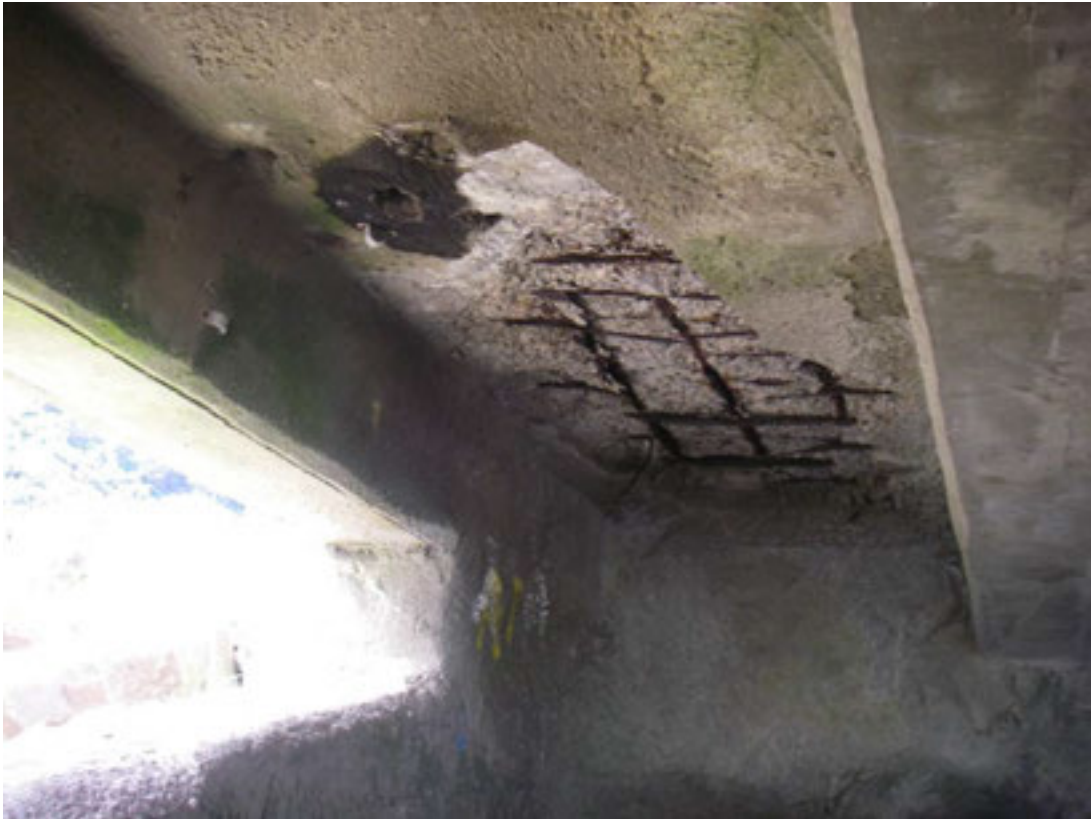
Additional areas of spalling from the slab soffit were noted. Significant corrosion of the exposed reinforcement was observed in the spalled areas, with total loss of reinforcing bar cross section in some areas. In some areas the depth of spalling was severe, with daylight visible through the slab between gridlines A1 and A2. **This section of slab (between A1 and A2) is considered dangerous and we recommend that this section of slab is fenced off immediately to prevent vehicle loading.**

Photo A04 - slab spalling between A1 and A2

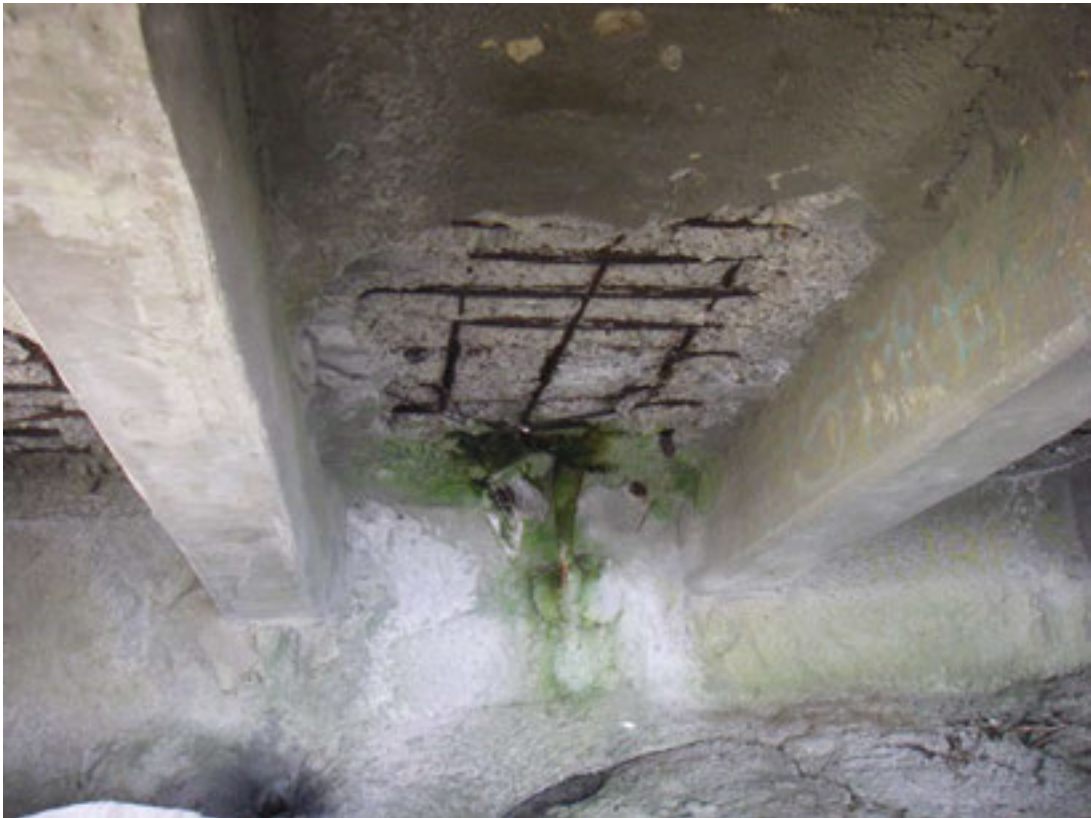
Photo A05 - slab spalling between A1 and A2

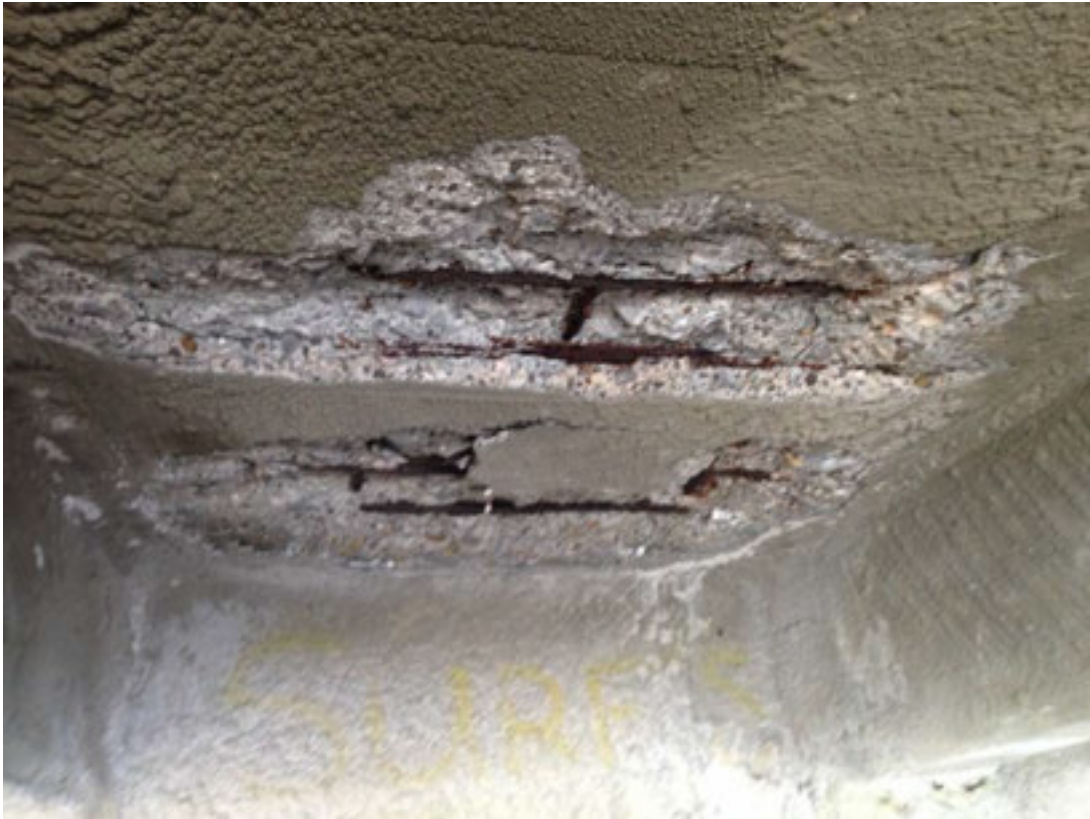
Photo A06 - slab spalling between A1 and A2

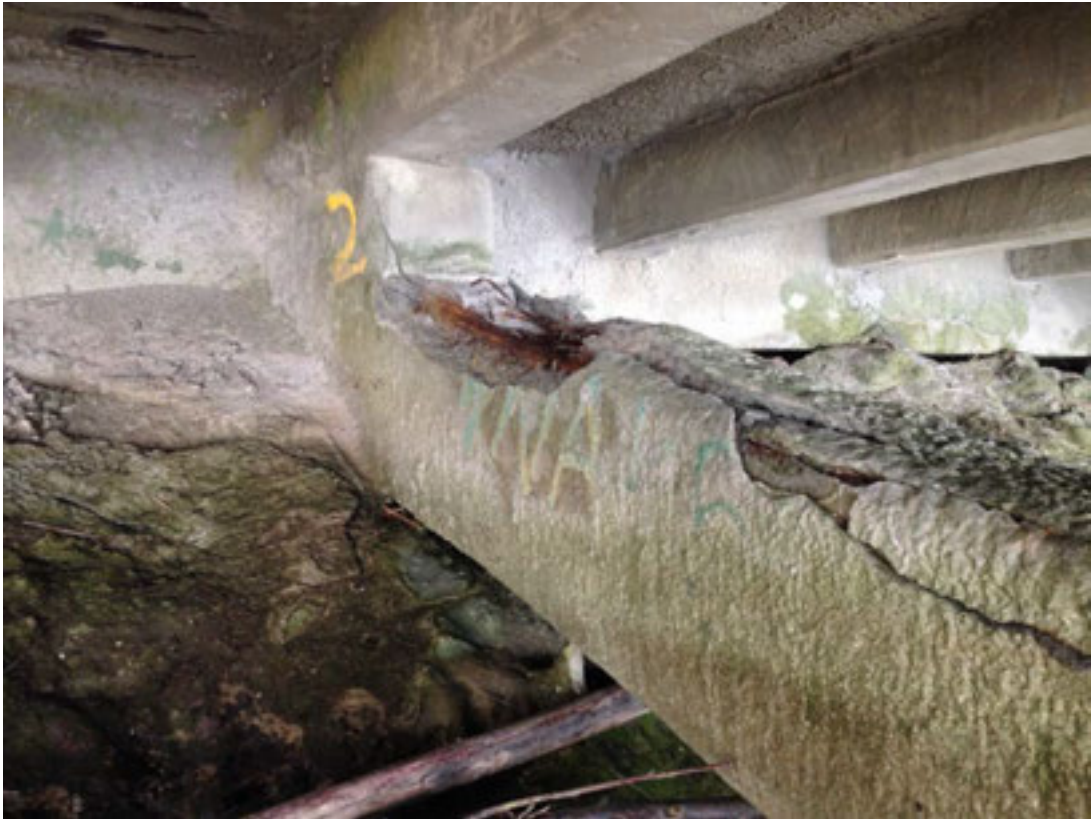
Photo A10 - spalling of raker beam at A2

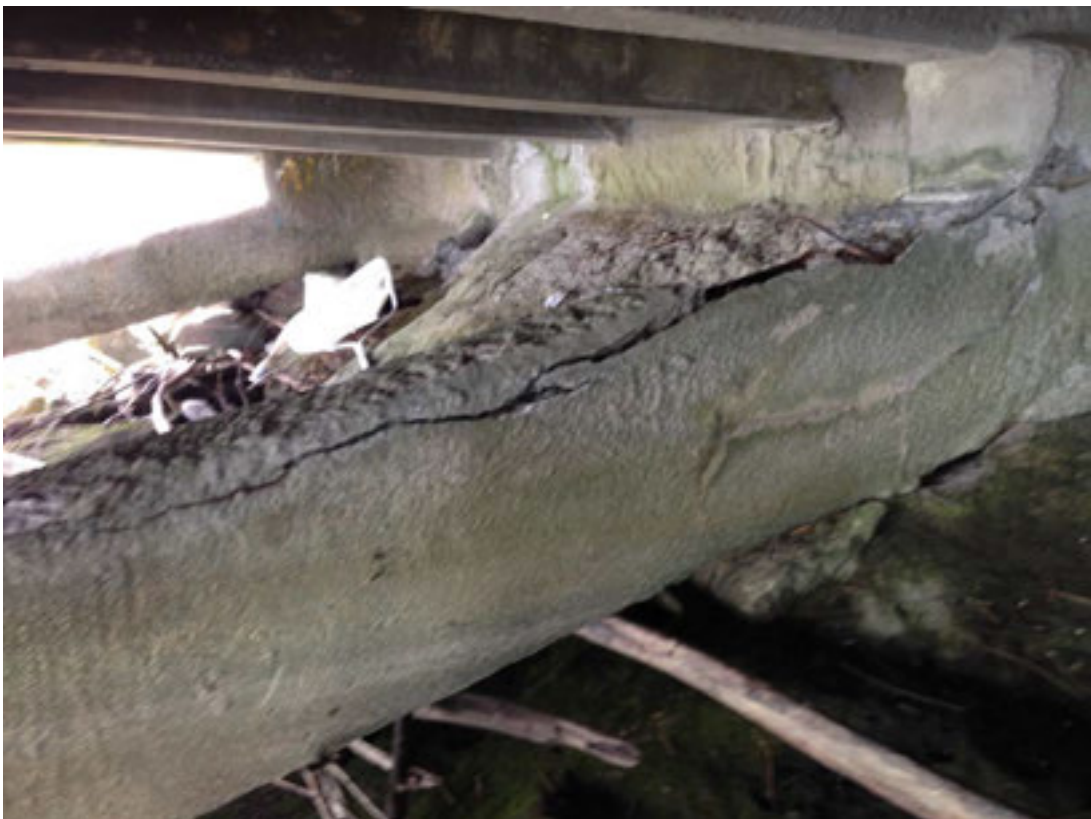
Photo A11 - spalling of raker beam at A2

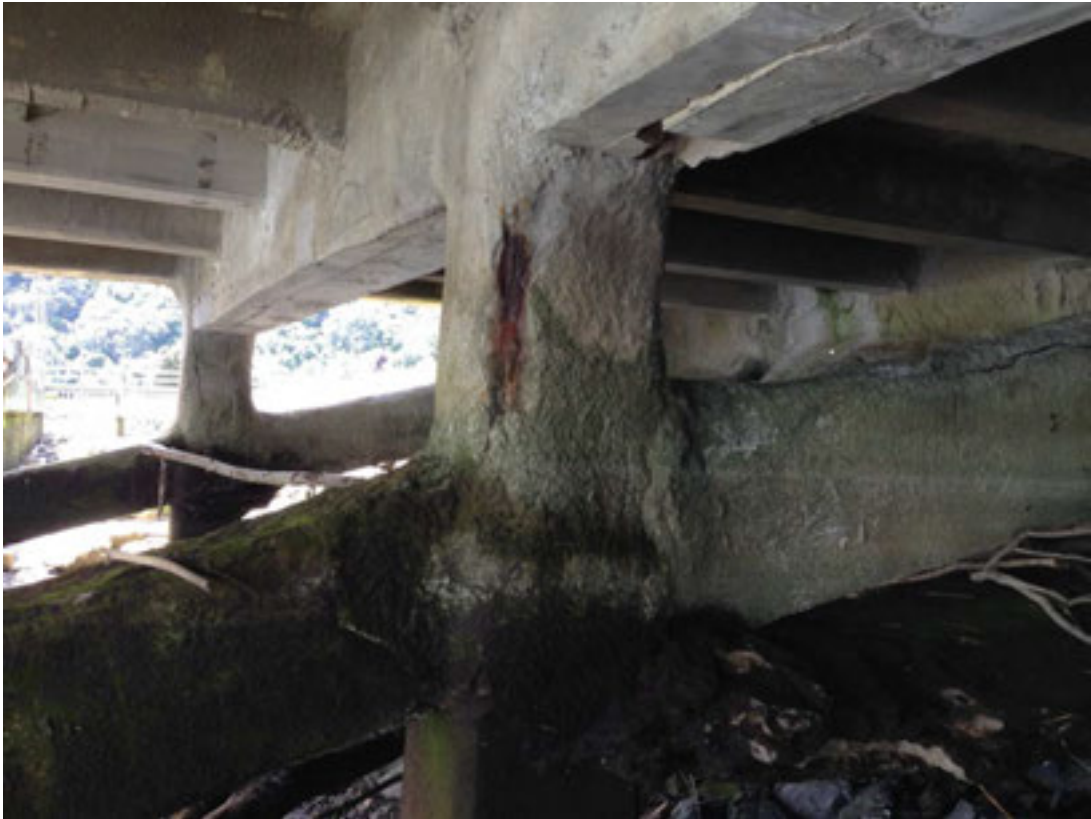
Photo A12 - spalling / corrosion at A2

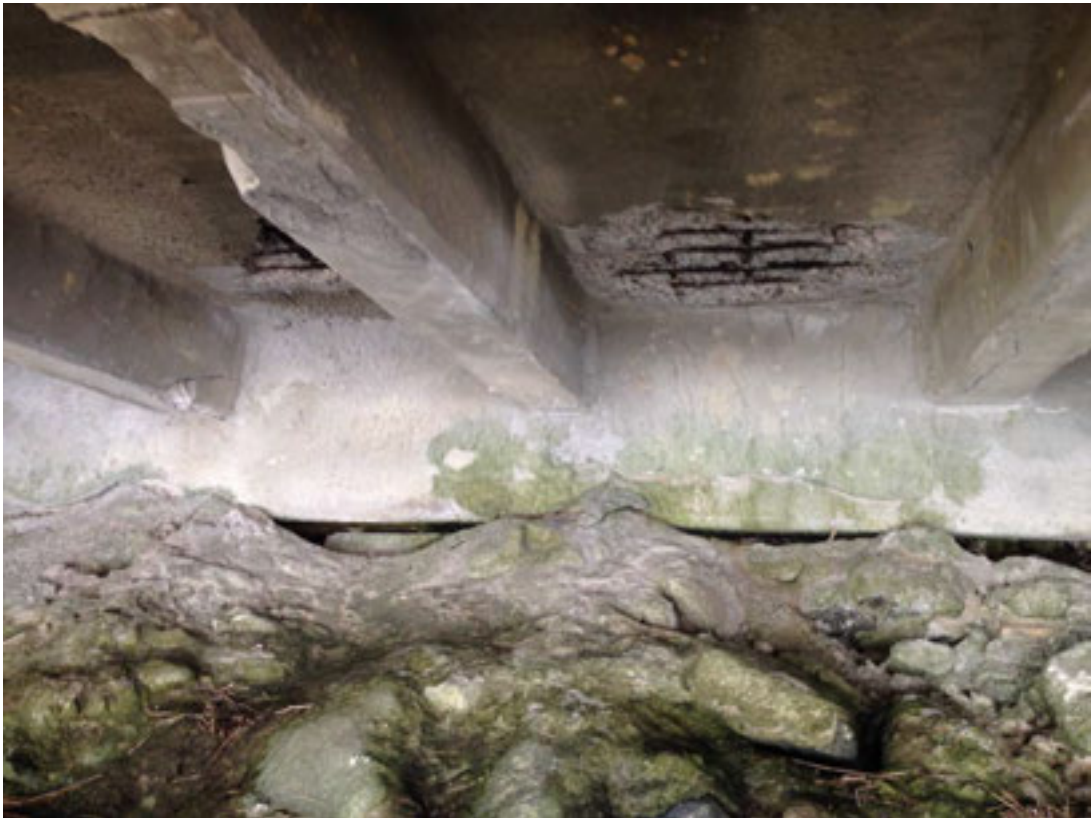
Photo A13 - spalling of slab between A2 and A3

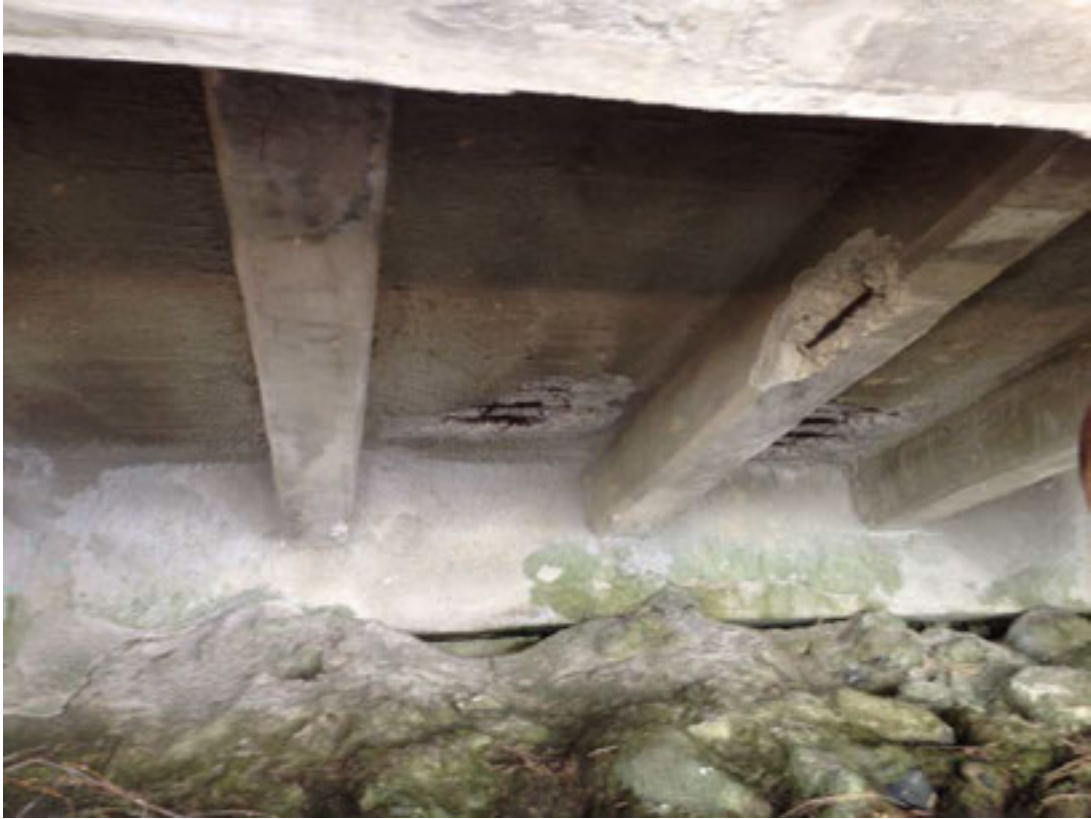
Photo A14 - spalling of slab between A2 and A3

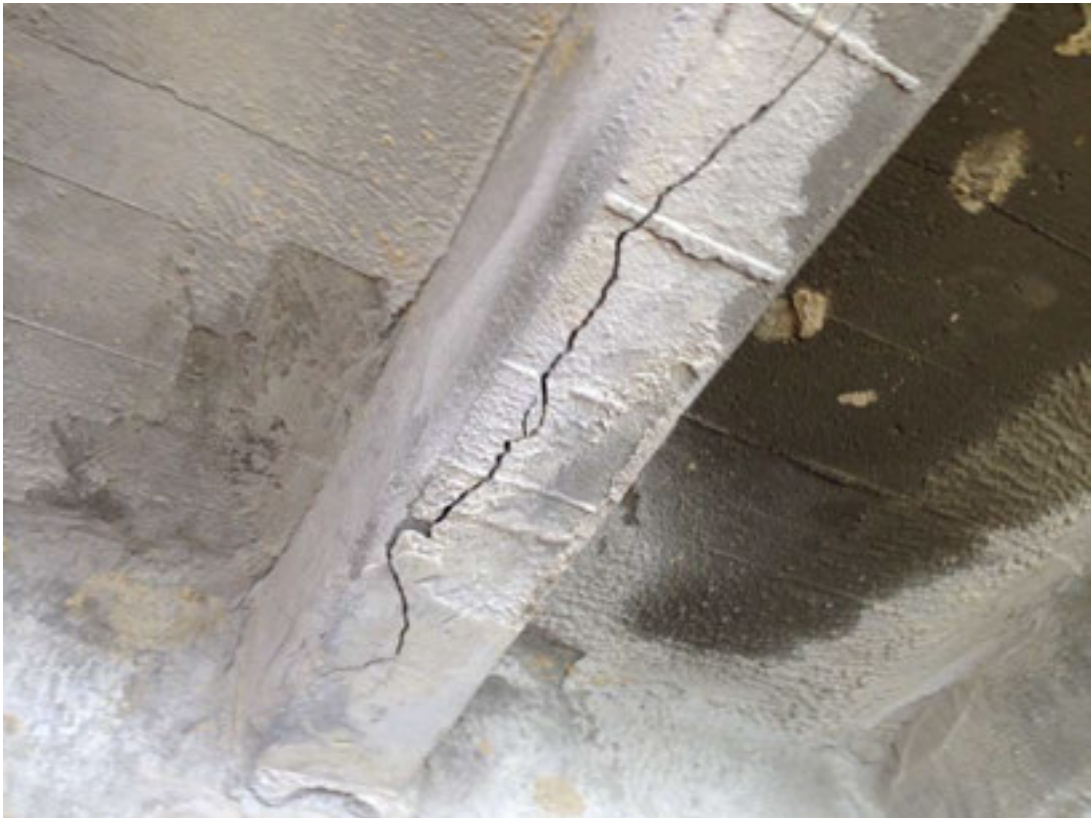
Photo A15 - cracking of beam between A2 and A3

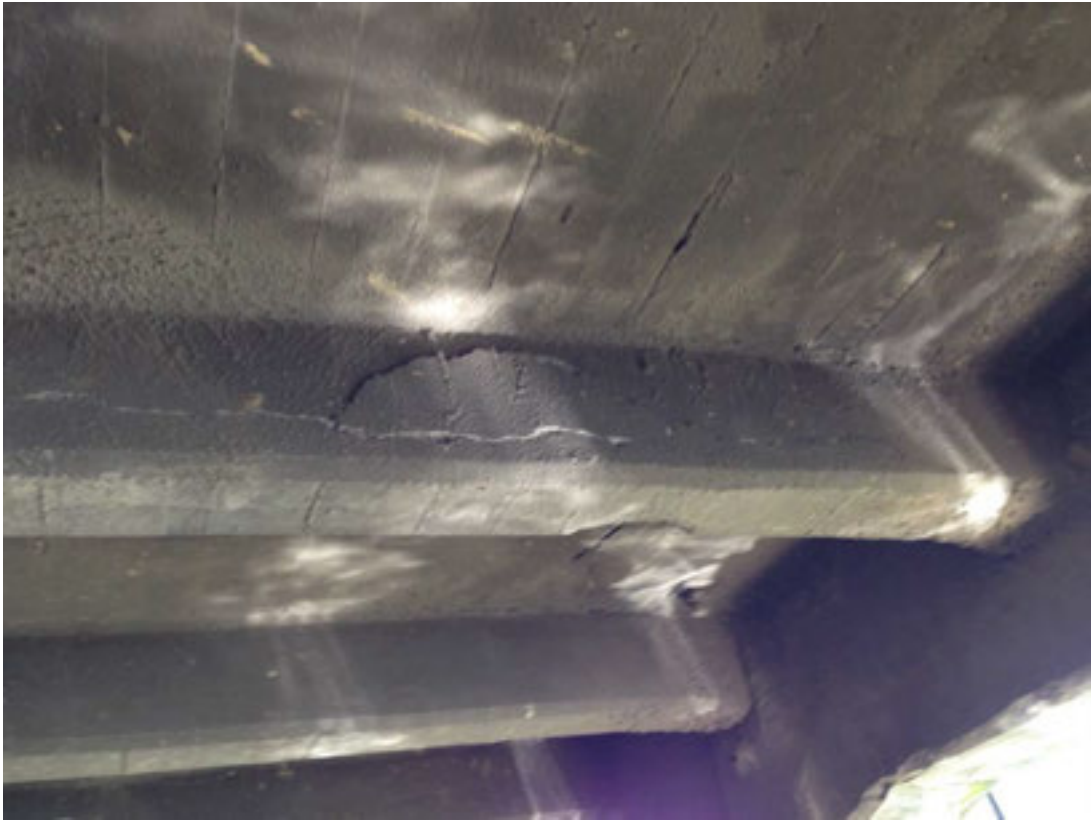
Photo A16 - cracking of beam between A2 and A3

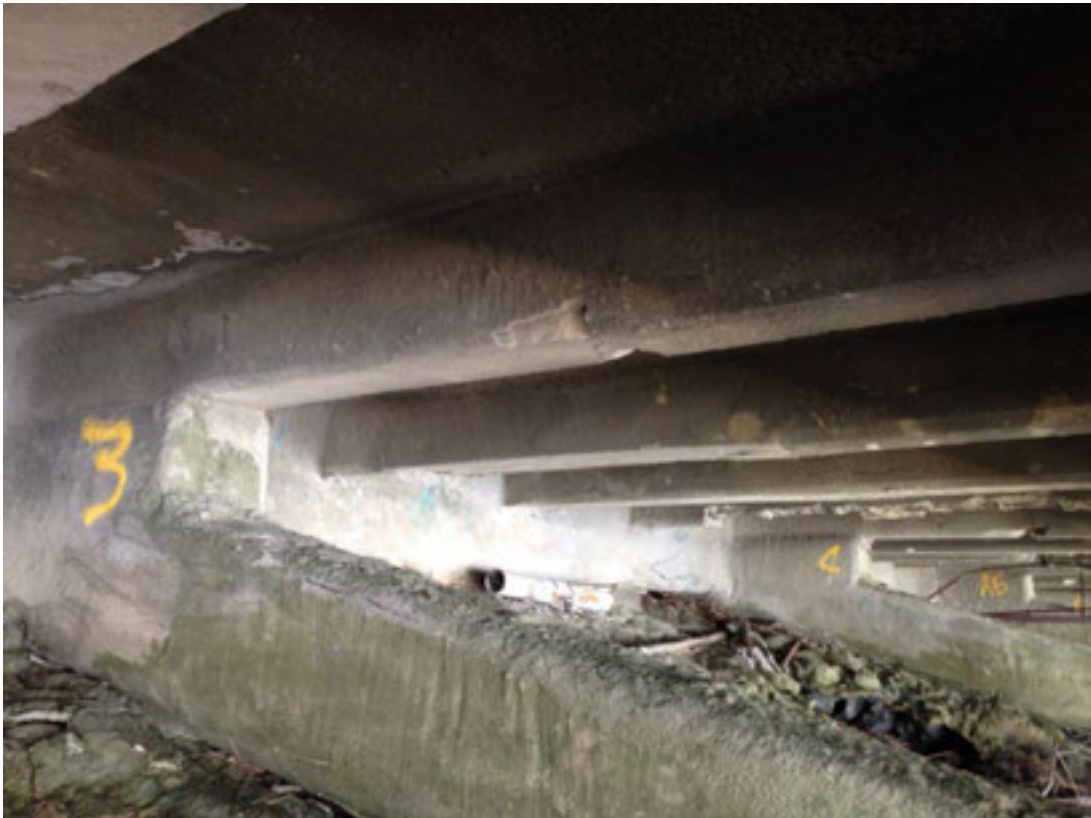
Photo A17 - spalling of beam at A3

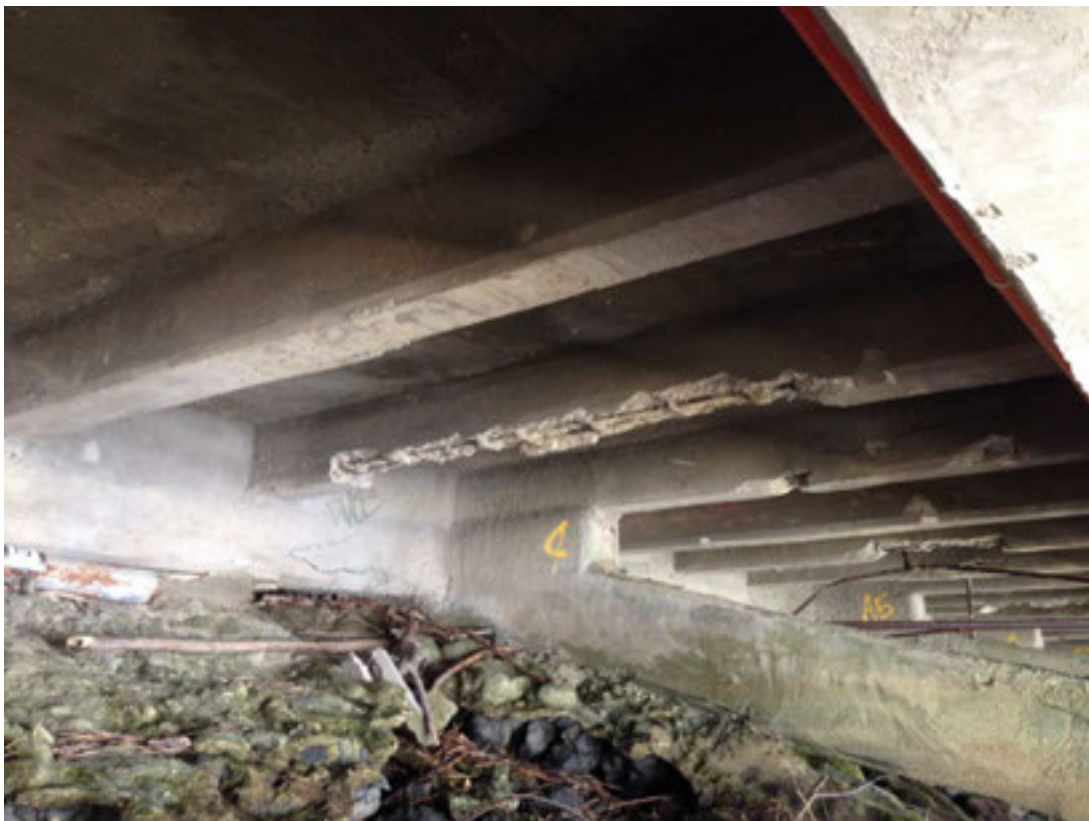
Photo A21 - spalling of beam between A3 and A4

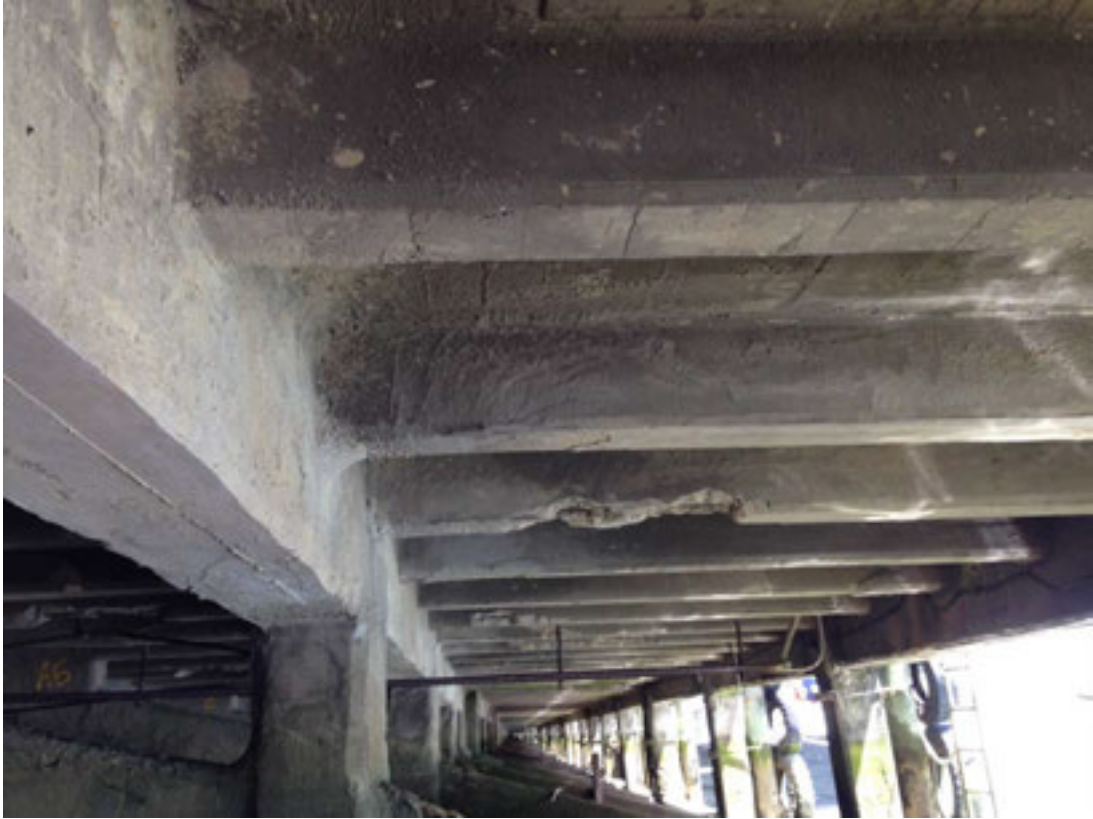
Photo A22 - spalling of beam at A4

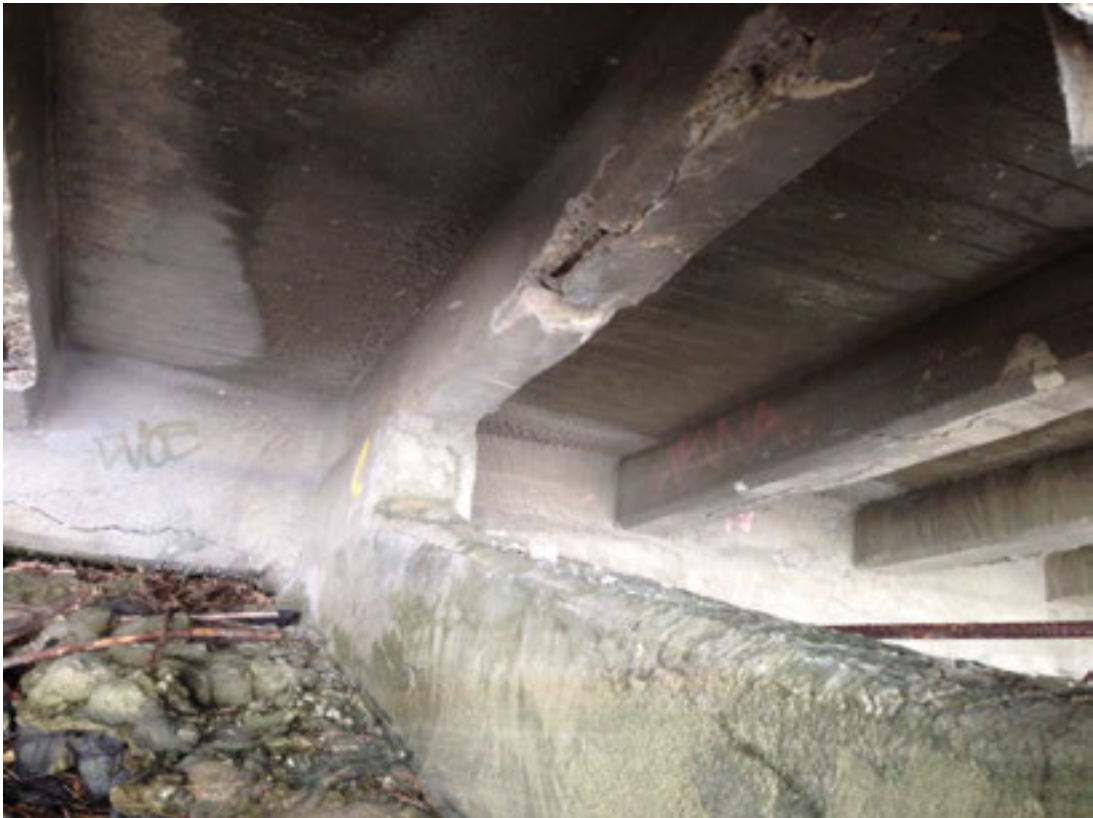
Photo A23 - spalling of beam at A4

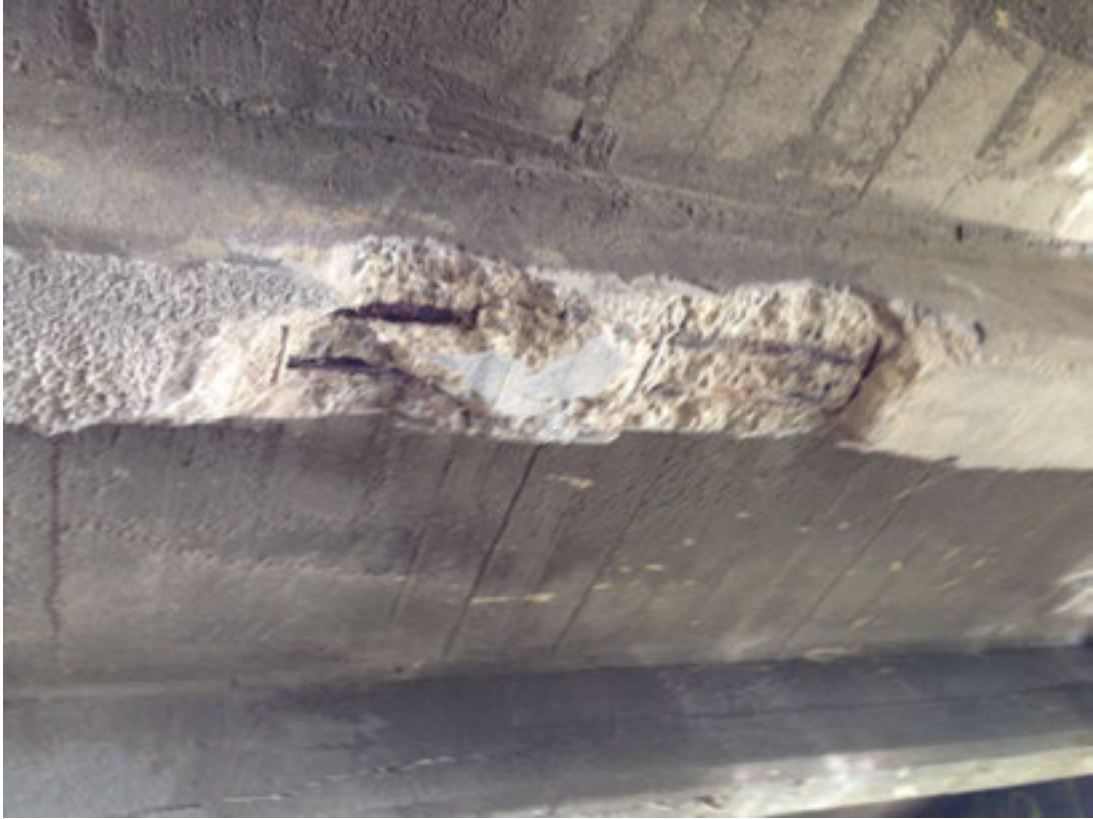
Photo A24 - spalling of beam at A4

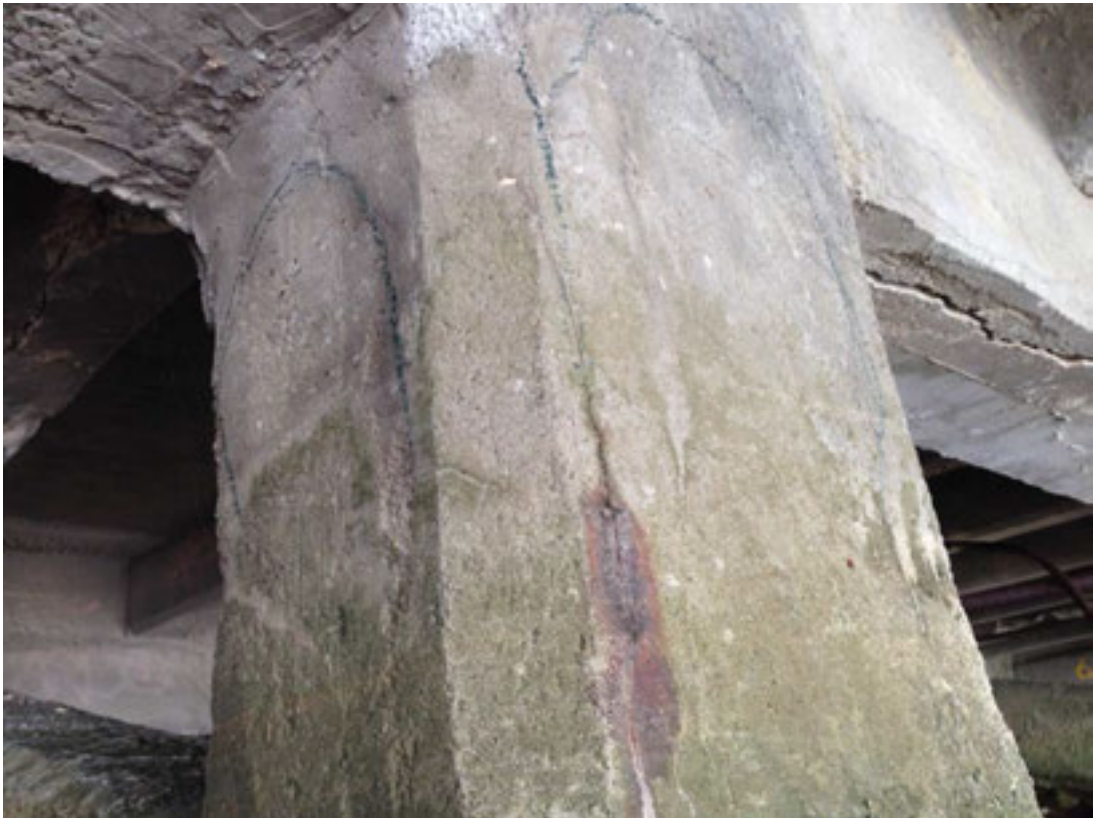
Photo A25 - Pile cracking at A4

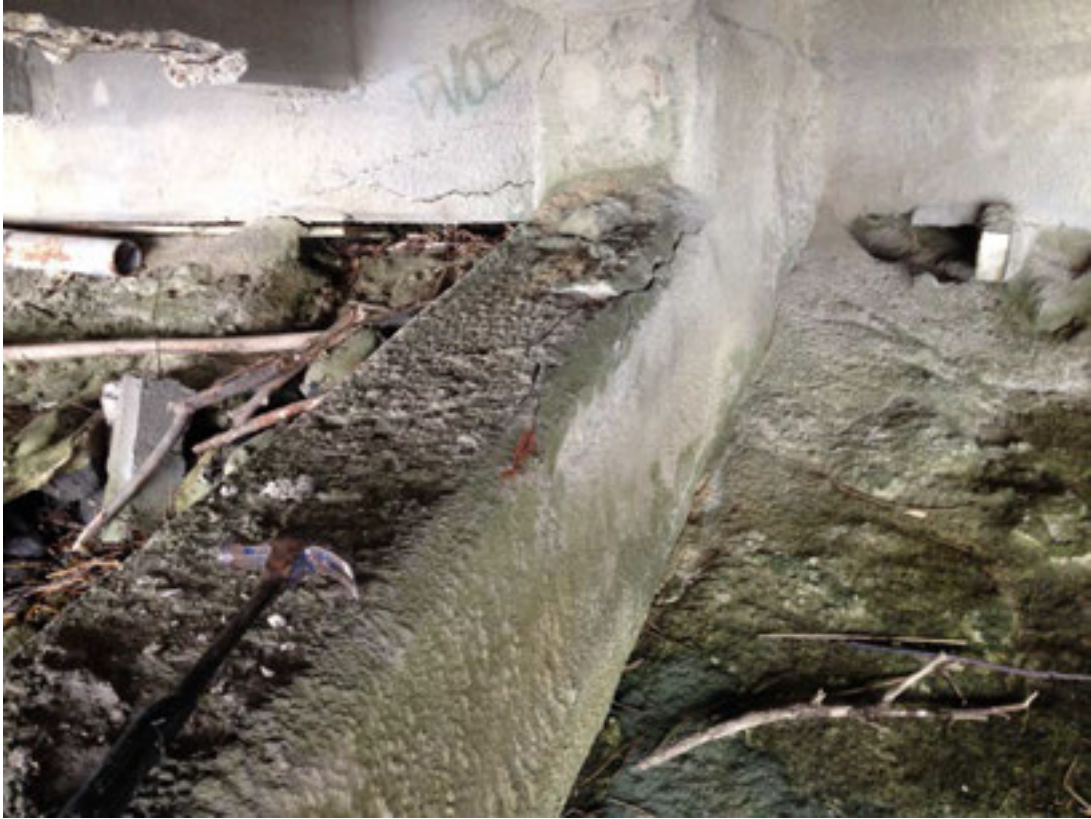
Photo A26 - cracking of raker beam at A4

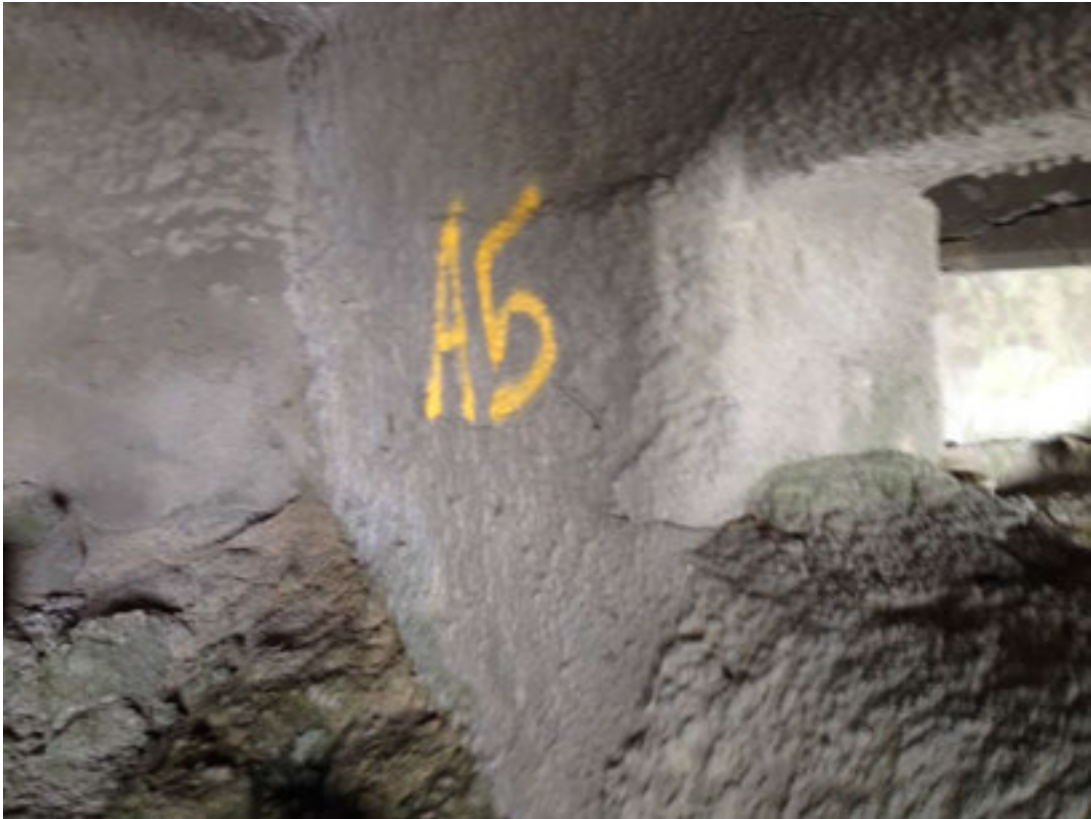
Photo A28 - Cracking at A5

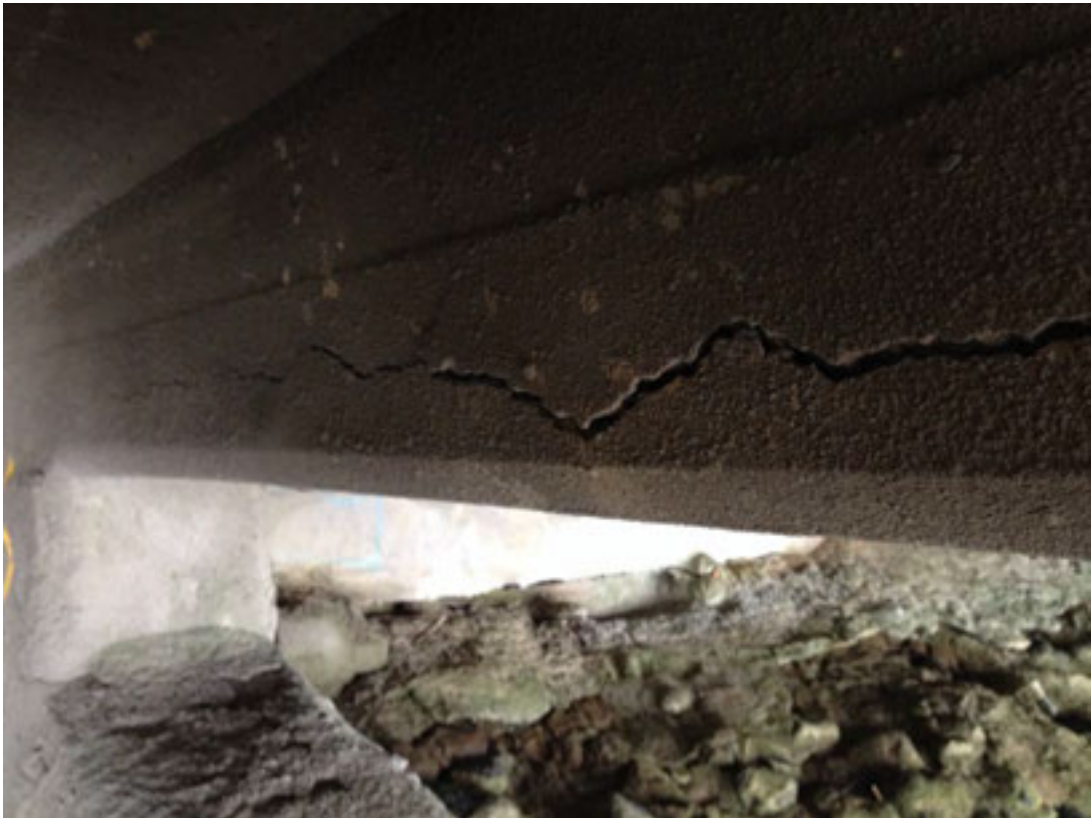
Photo A29 - Cracking of beam at A5
