Whakatane Commercial Wharf

Condition Assessment and Repair Options Report

**Prepared for:
Whakatane District Council**

February 2015
Job No: 851847

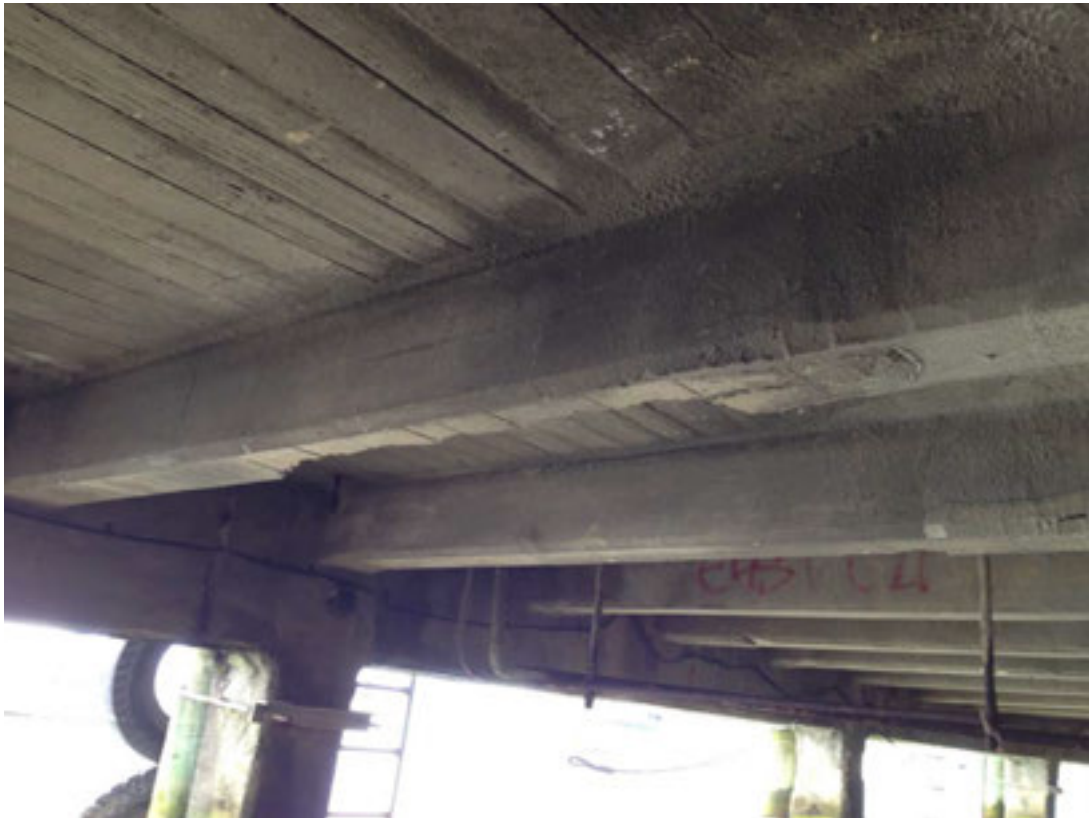
Photo A31 - spalling of beam between A5 and A6

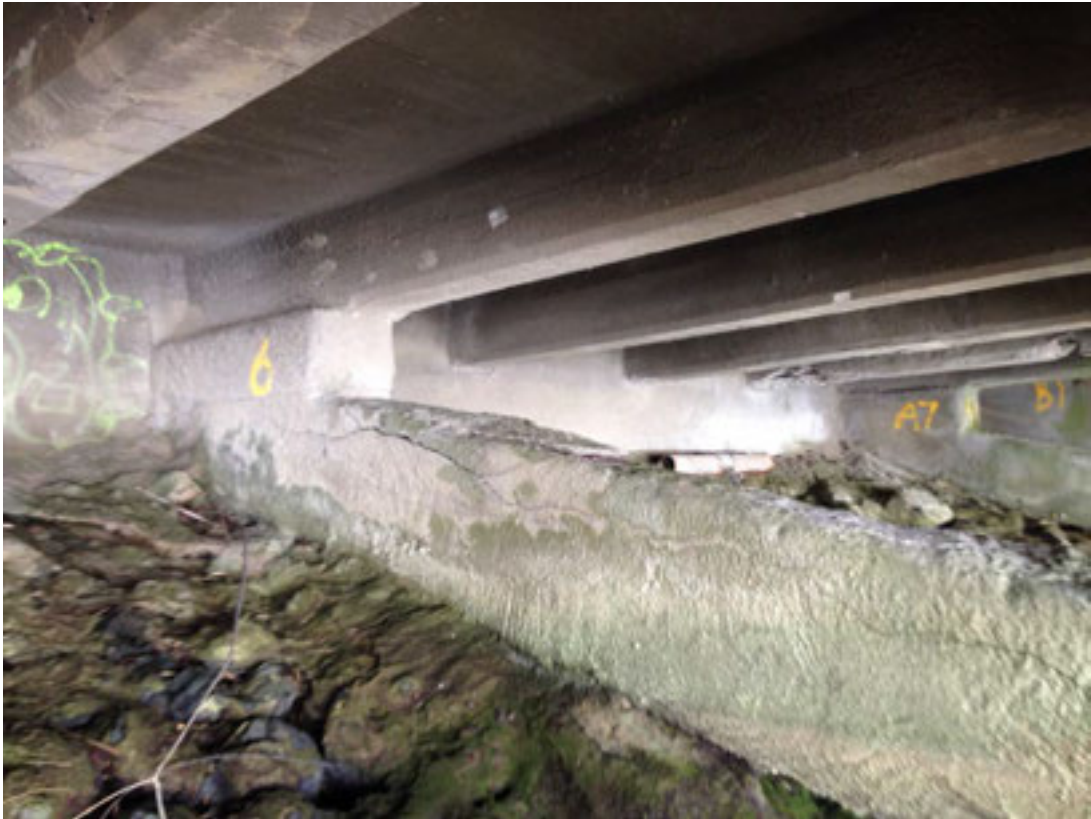
Photo A32 - cracking of raker beam at A6

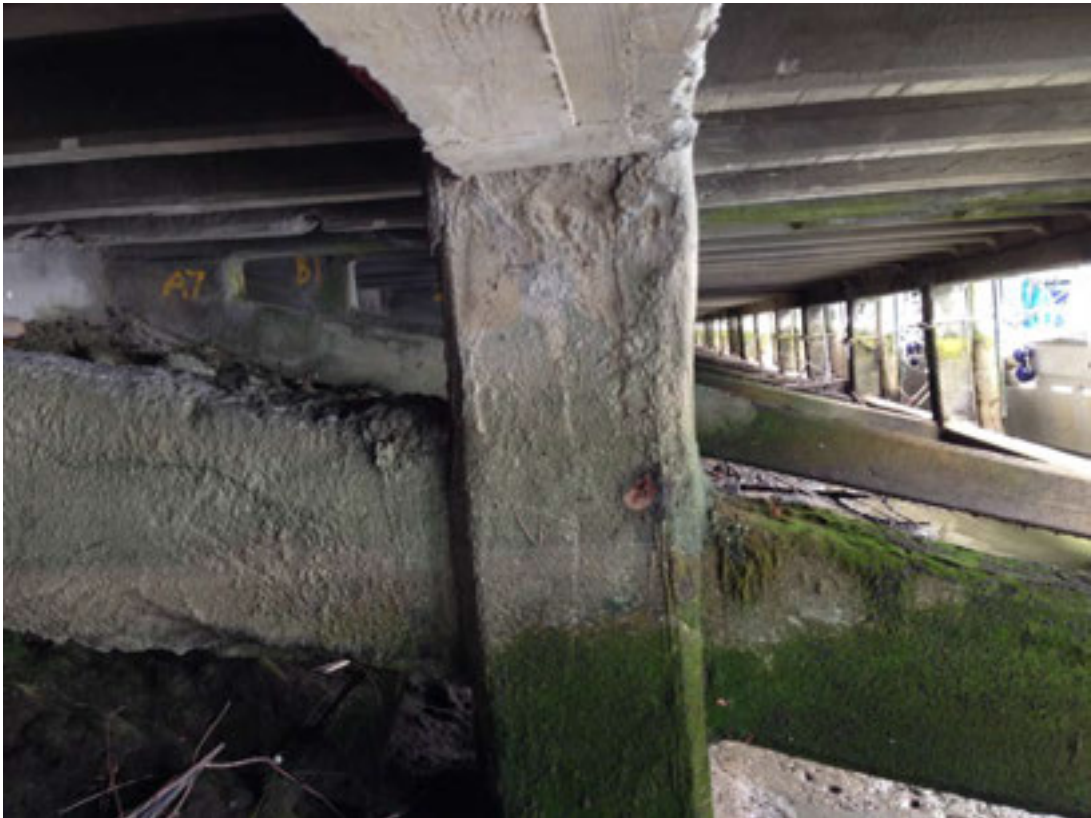
Photo A33 - cracking of raker beam at A6

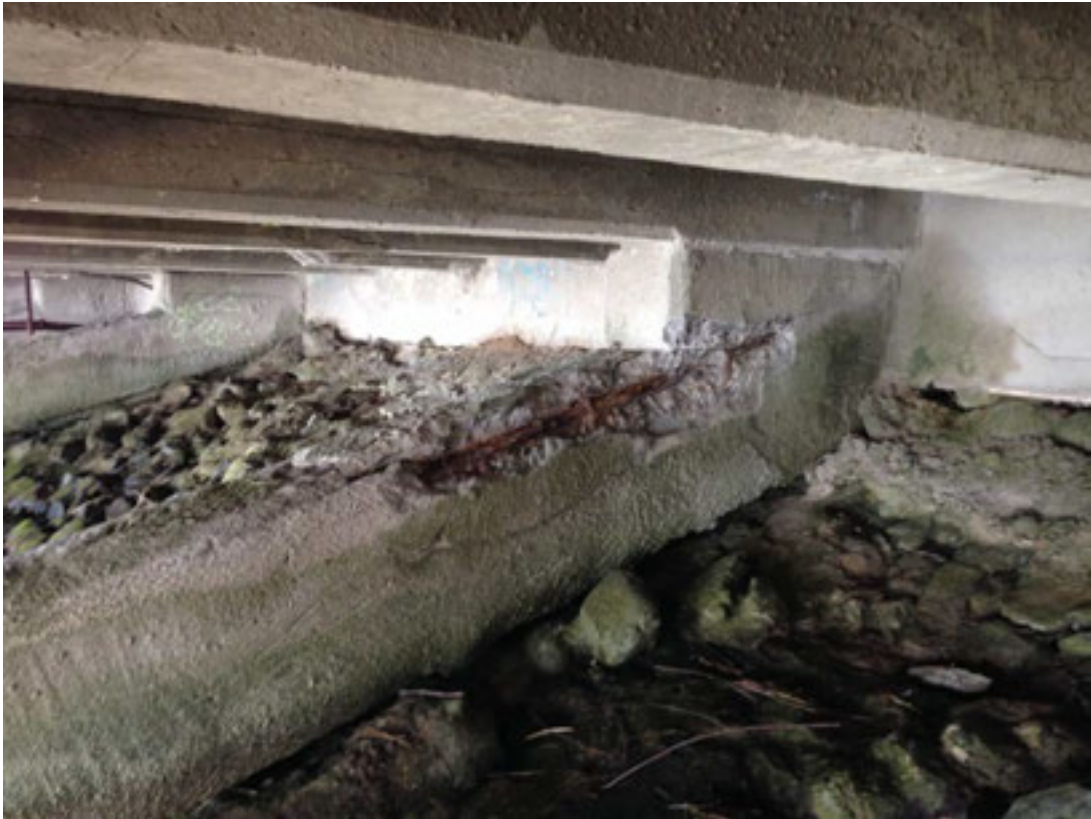
Photo A34 - spalling of raker beam at A6

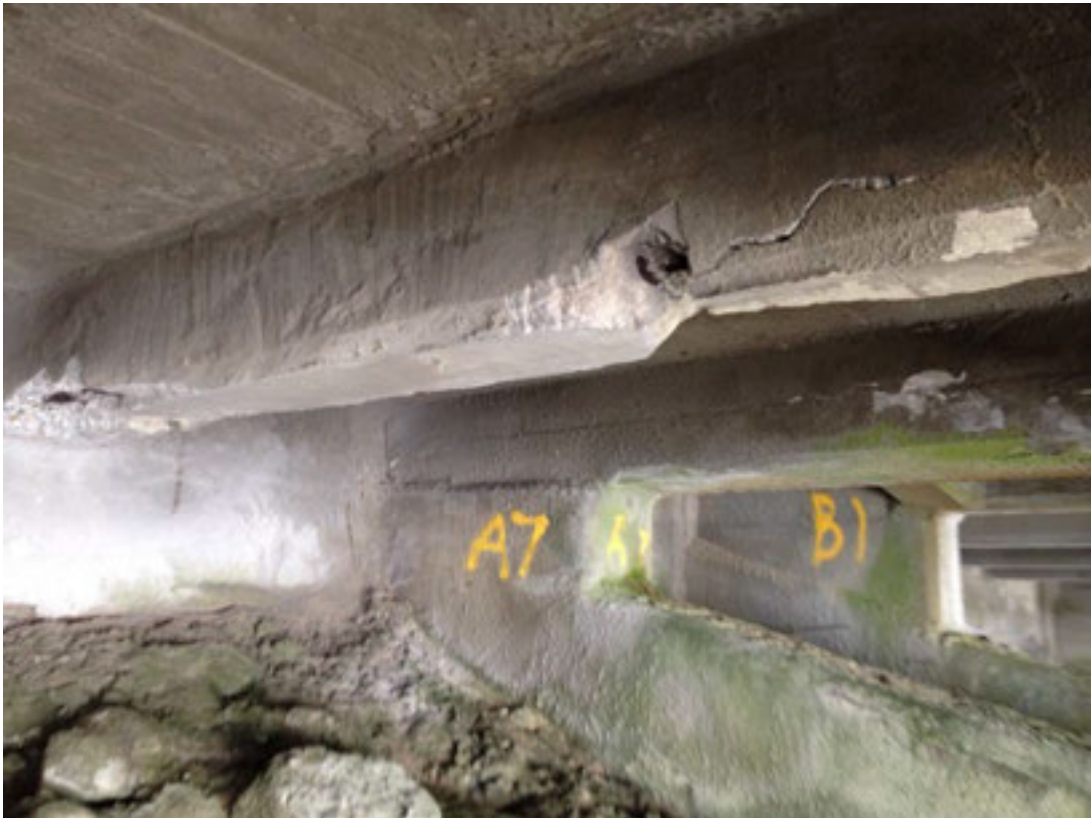
Photo A35 - Spalling of beam between A6 and A7

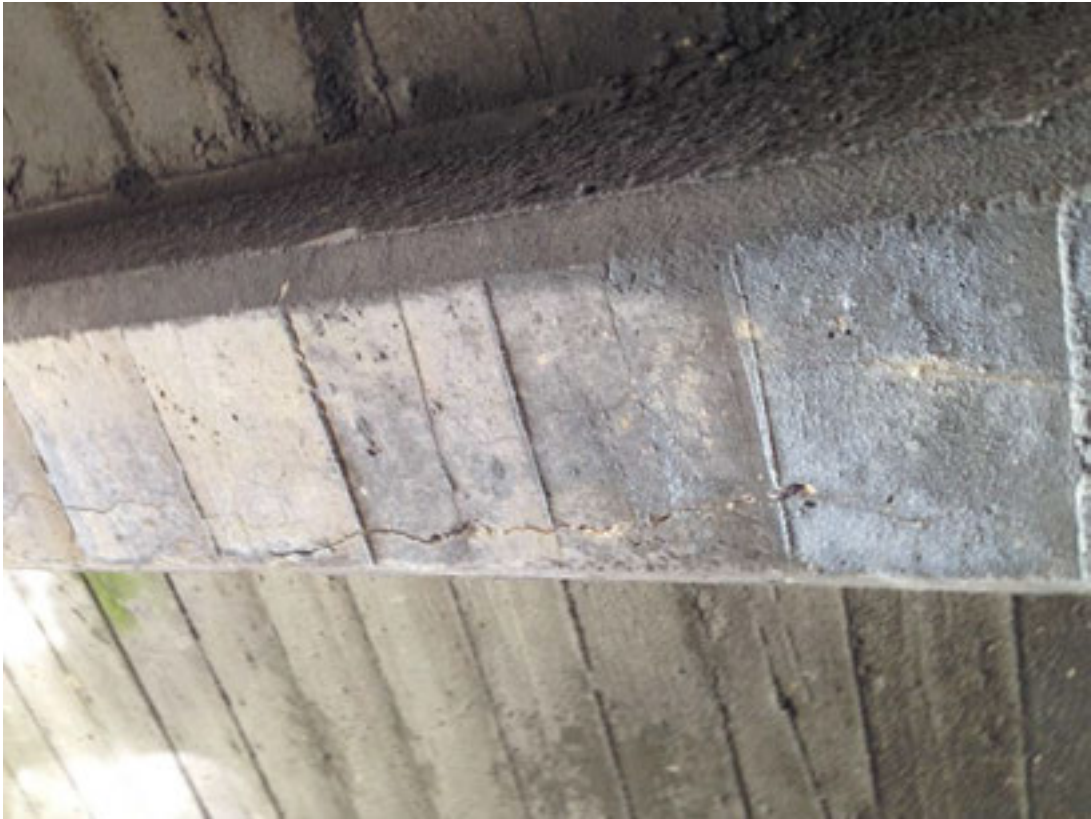
Photo A36 - cracking of beam between A6 and A7

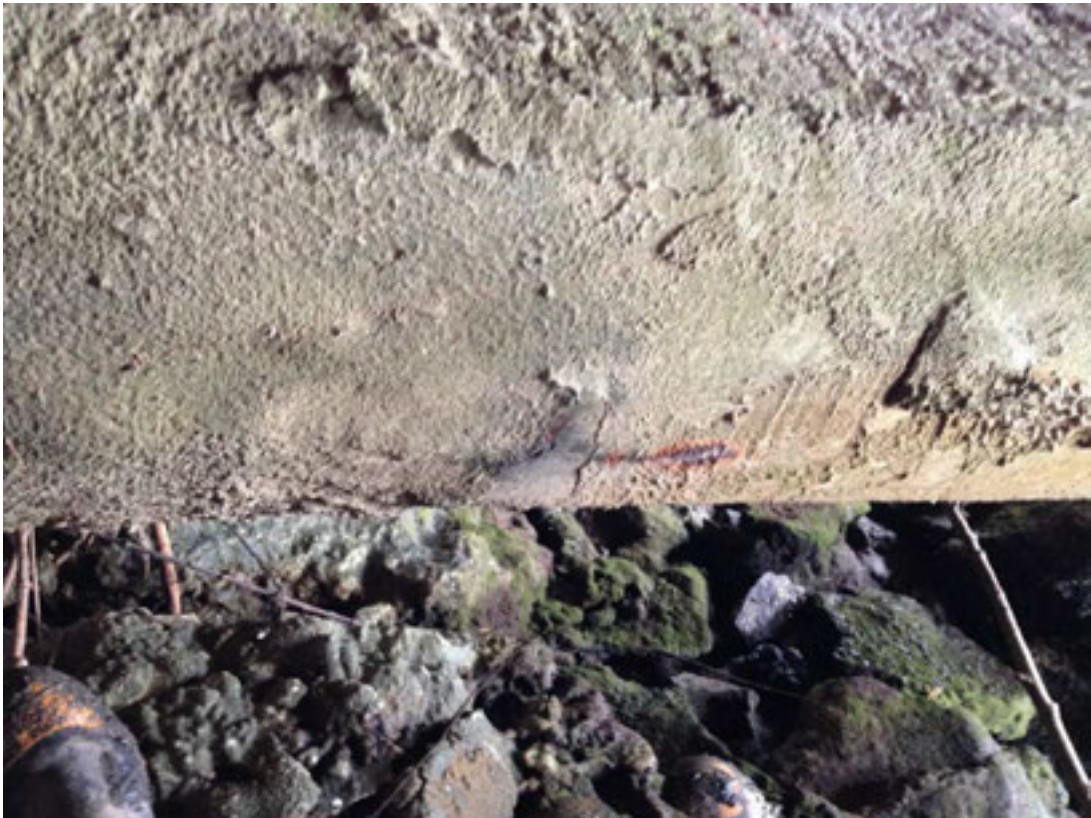
Photo B01- Staining at B1

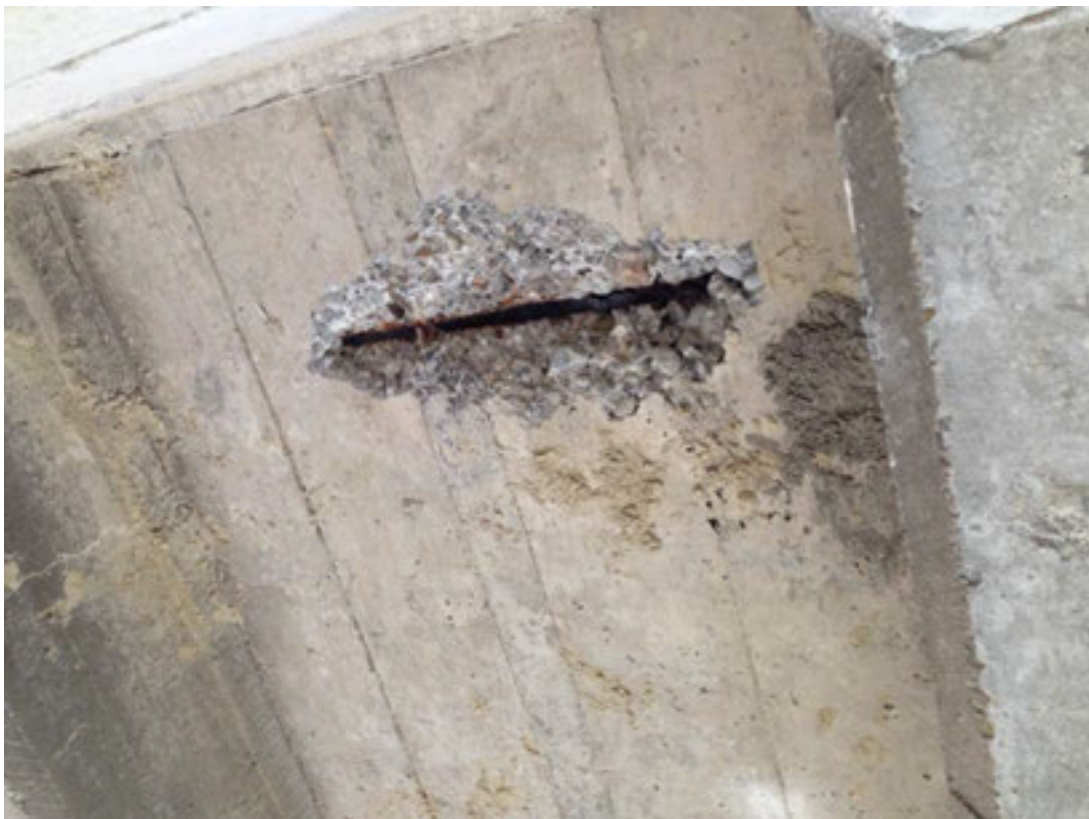
Photo B03 - slab spalling between B1 and B2

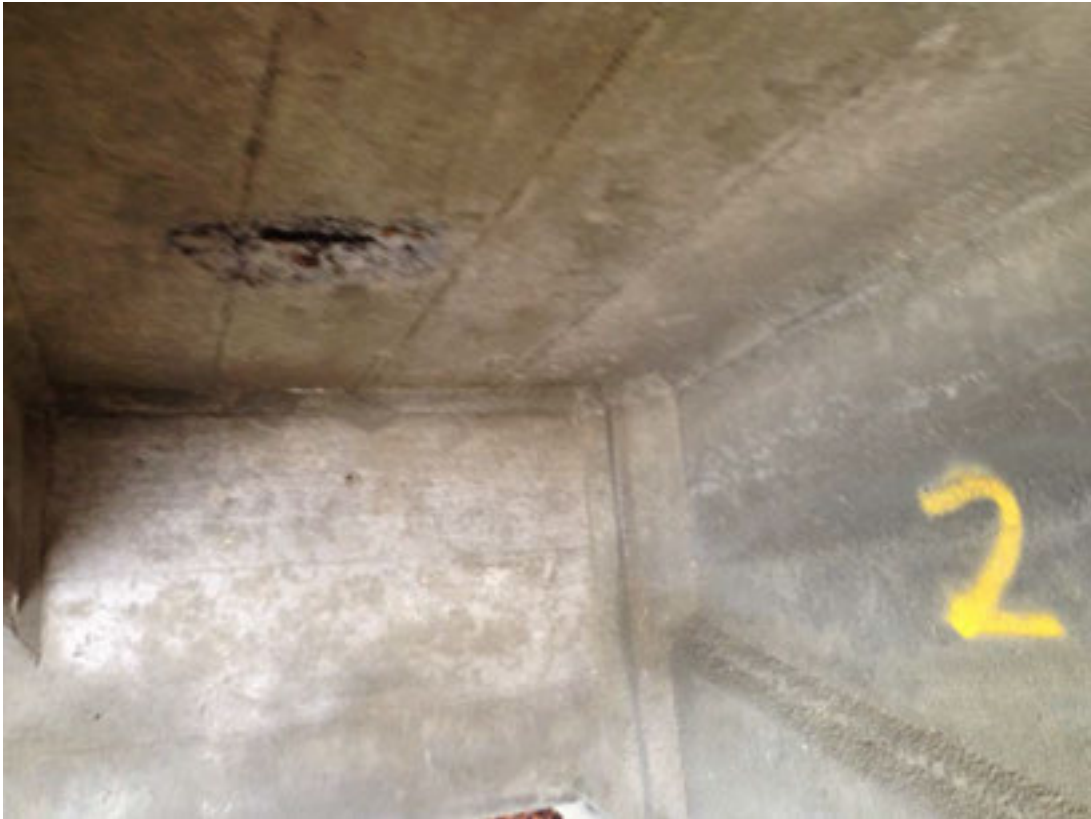
Photo B04 - slab spalling between B1 and B2

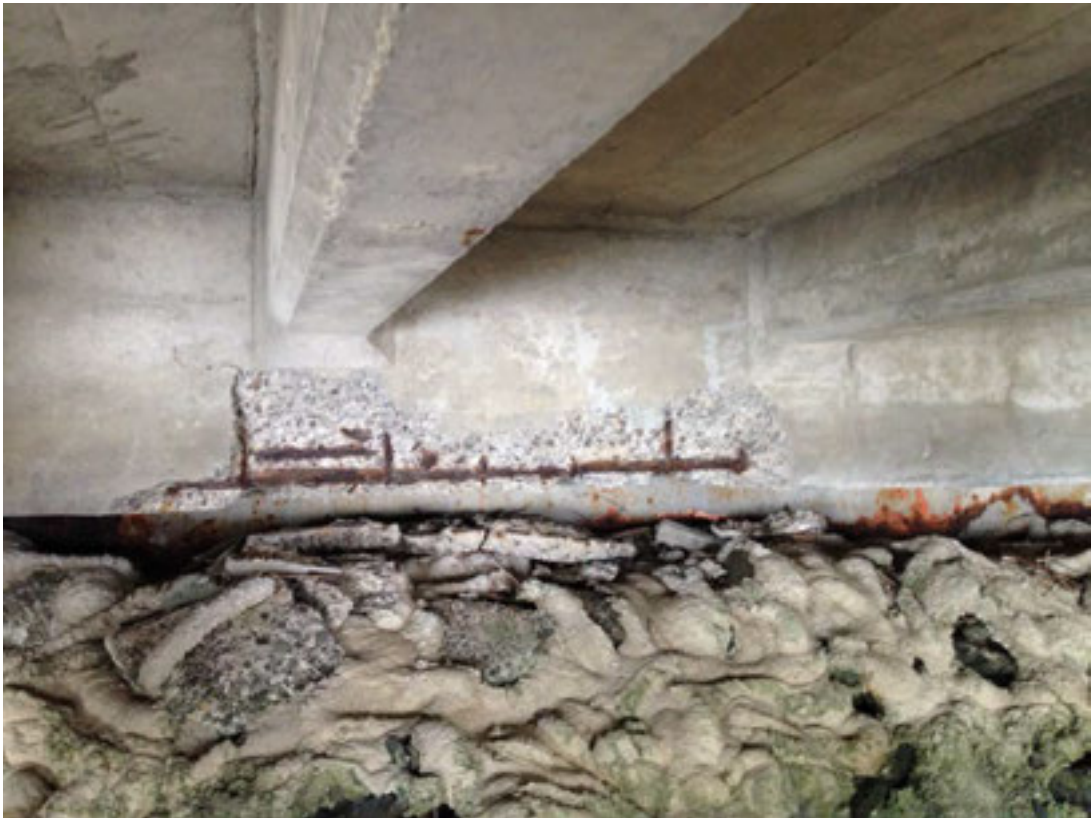
Photo B05 - rear beam spalling between B2 and B3

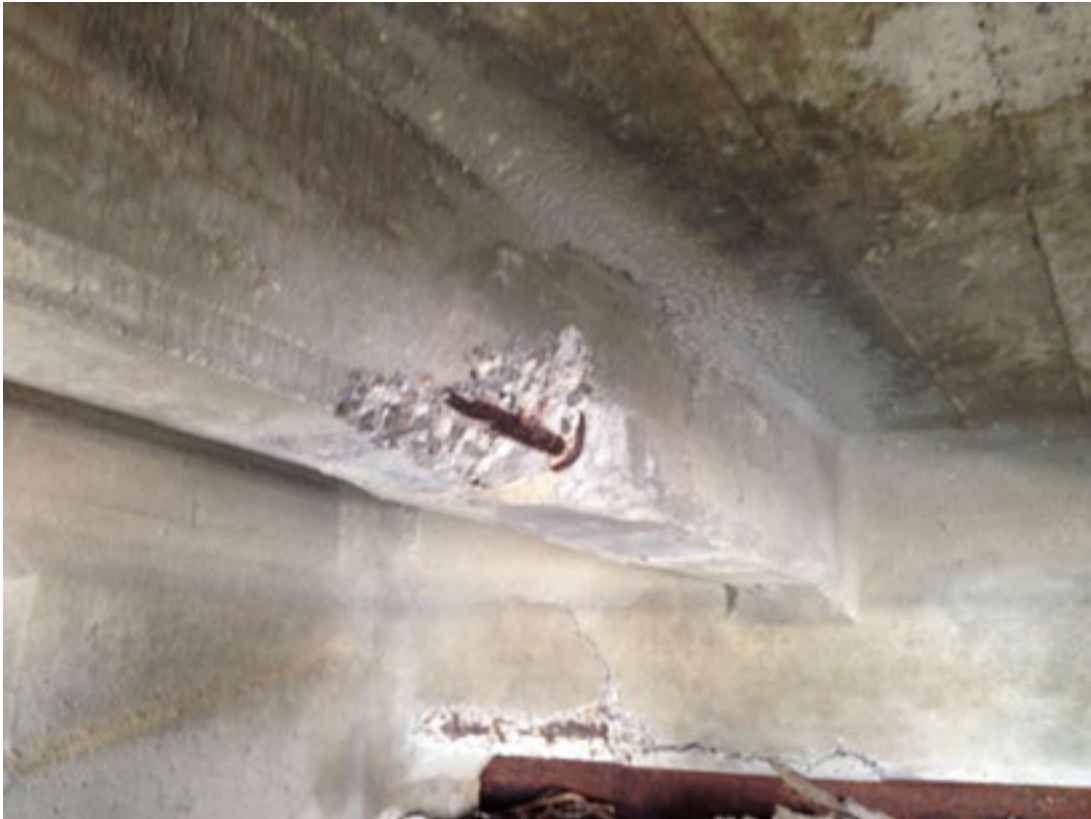
Photo B06 - beam spalling between B4 and B5

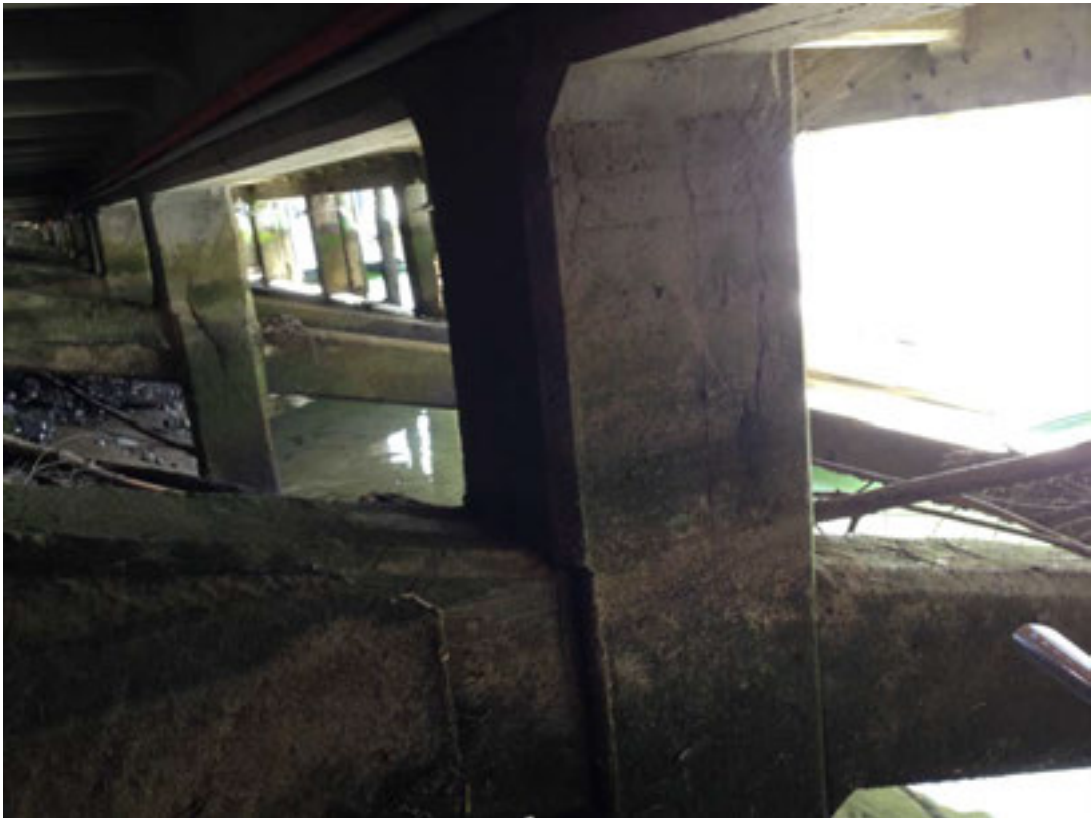
Photo B07 - Pile cracking at B5

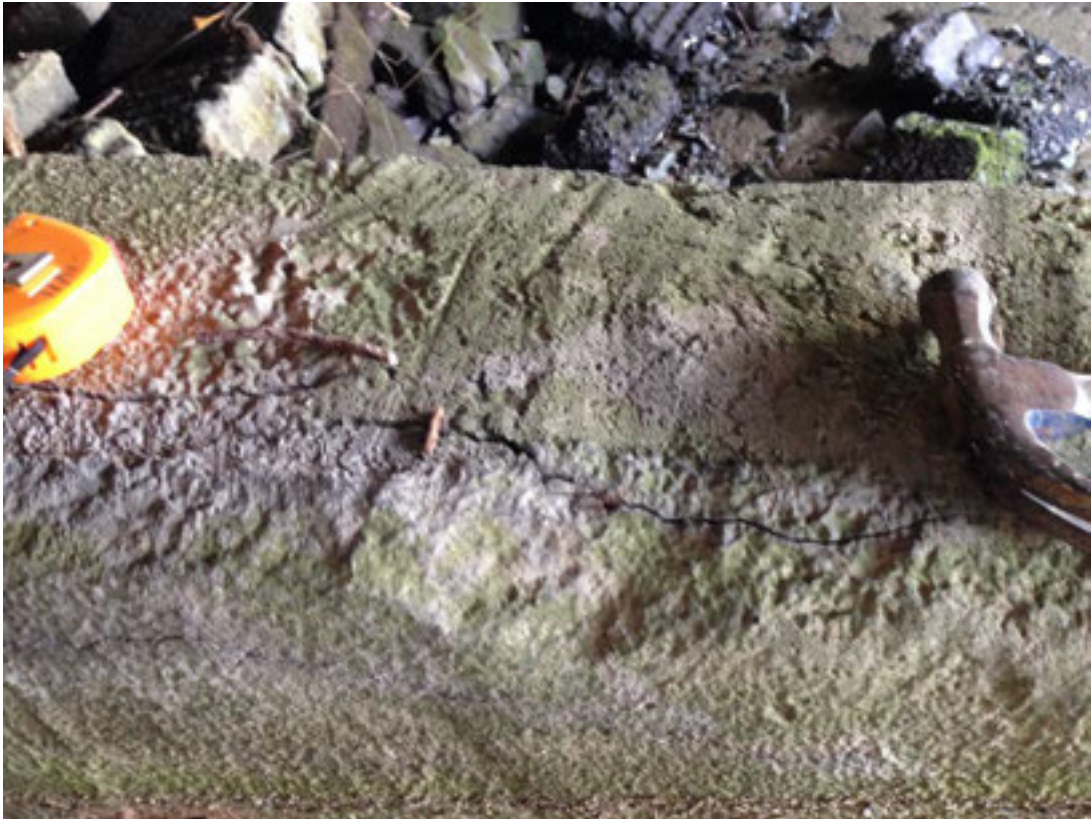
Photo B08 - Cracking of raker beam at B6

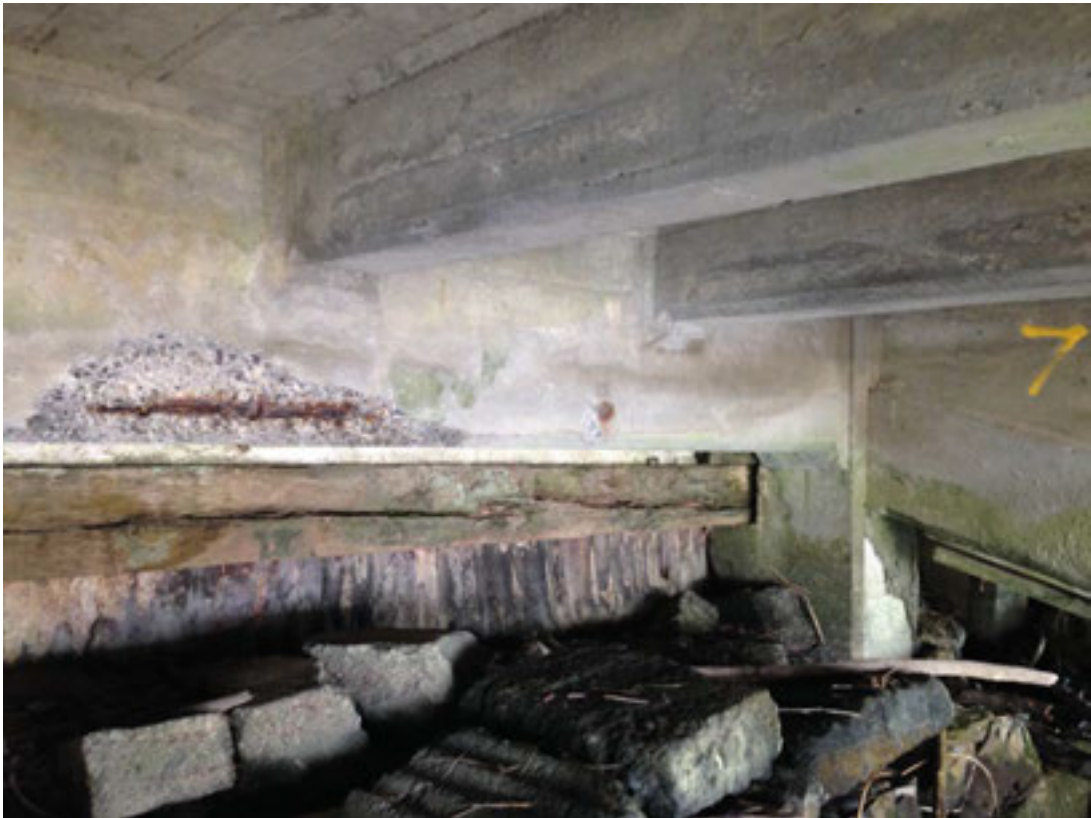
Photo B09 - spalling of rear beam between B6 and B7

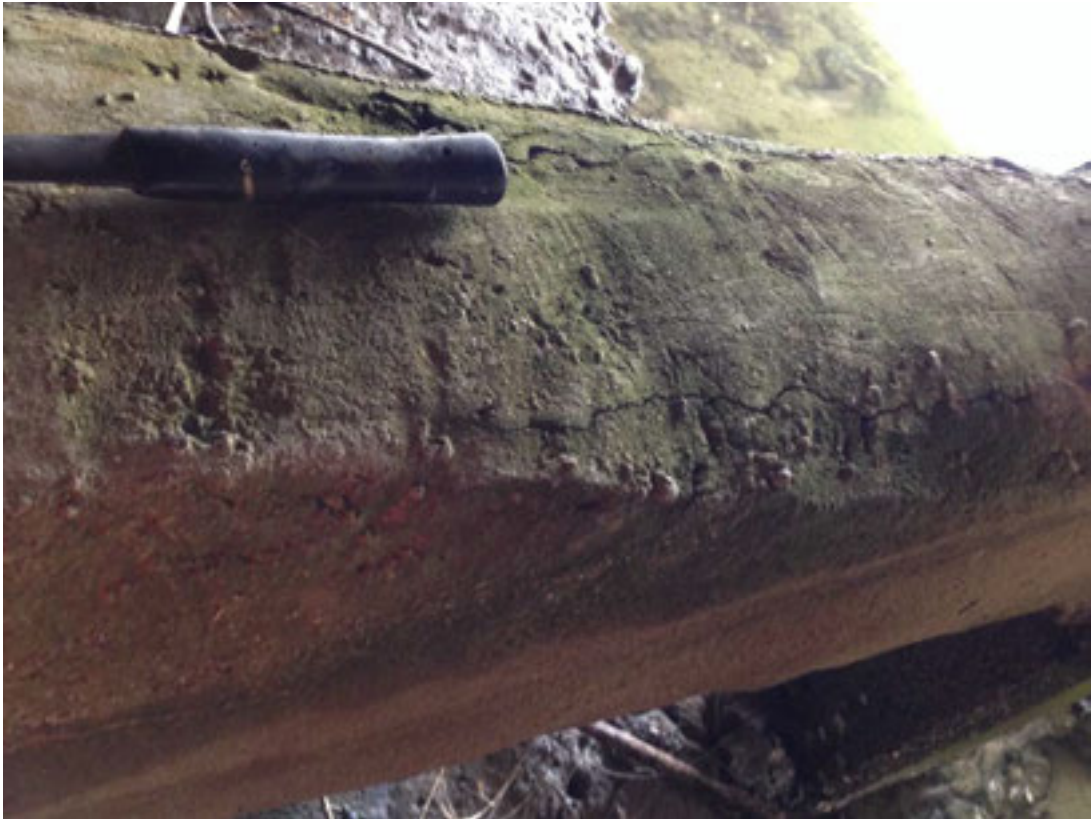
Photo B10 - cracking of raker beam at B9

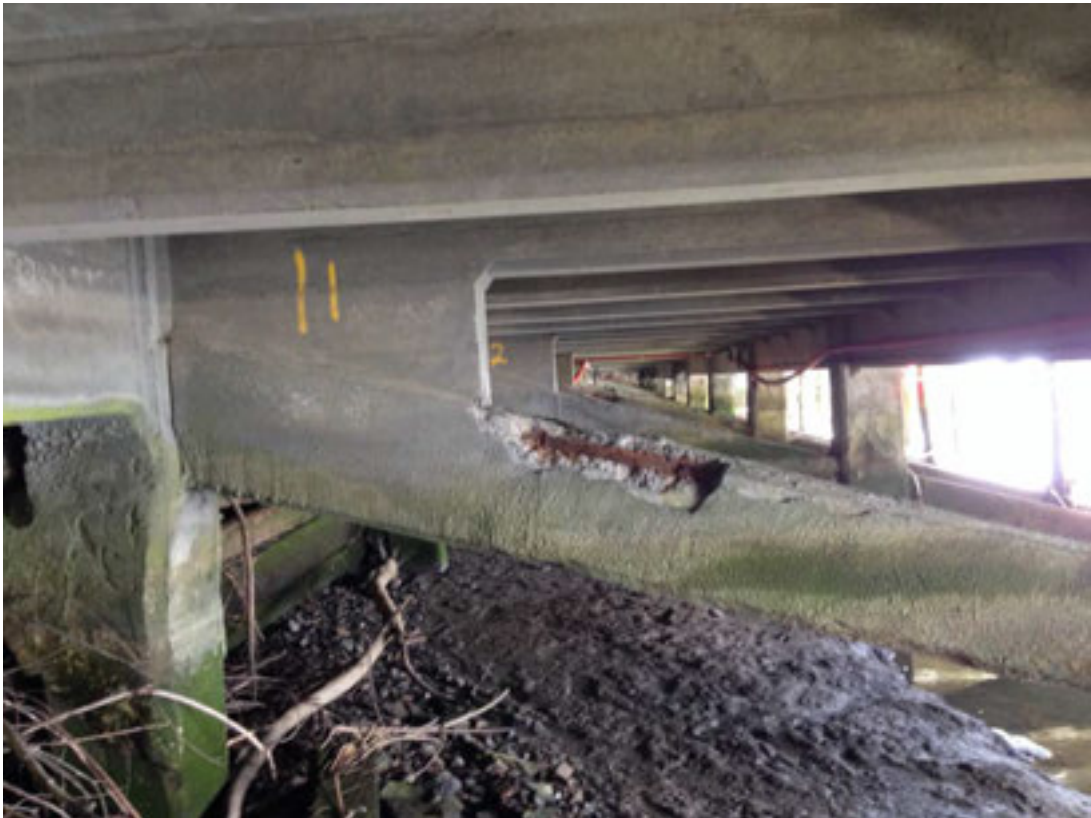
Photo B11 - spalling of raker beam at B11

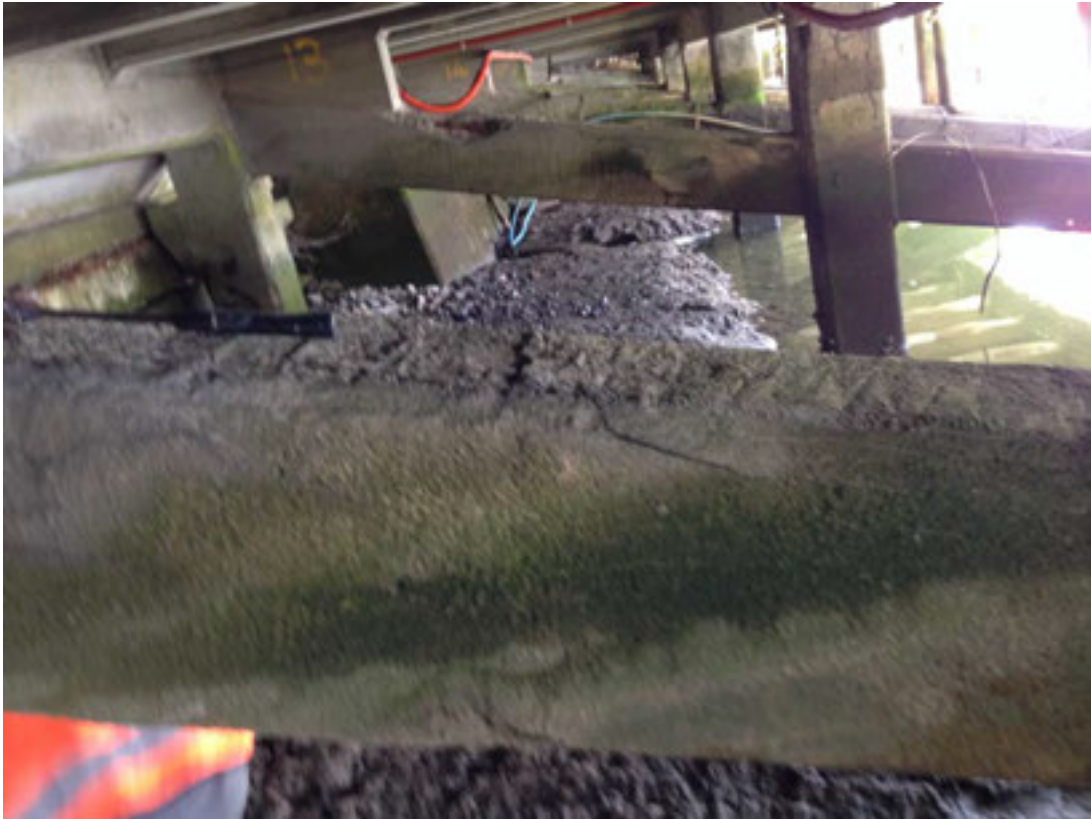
Photo B12 - spalling of raker beam at B12

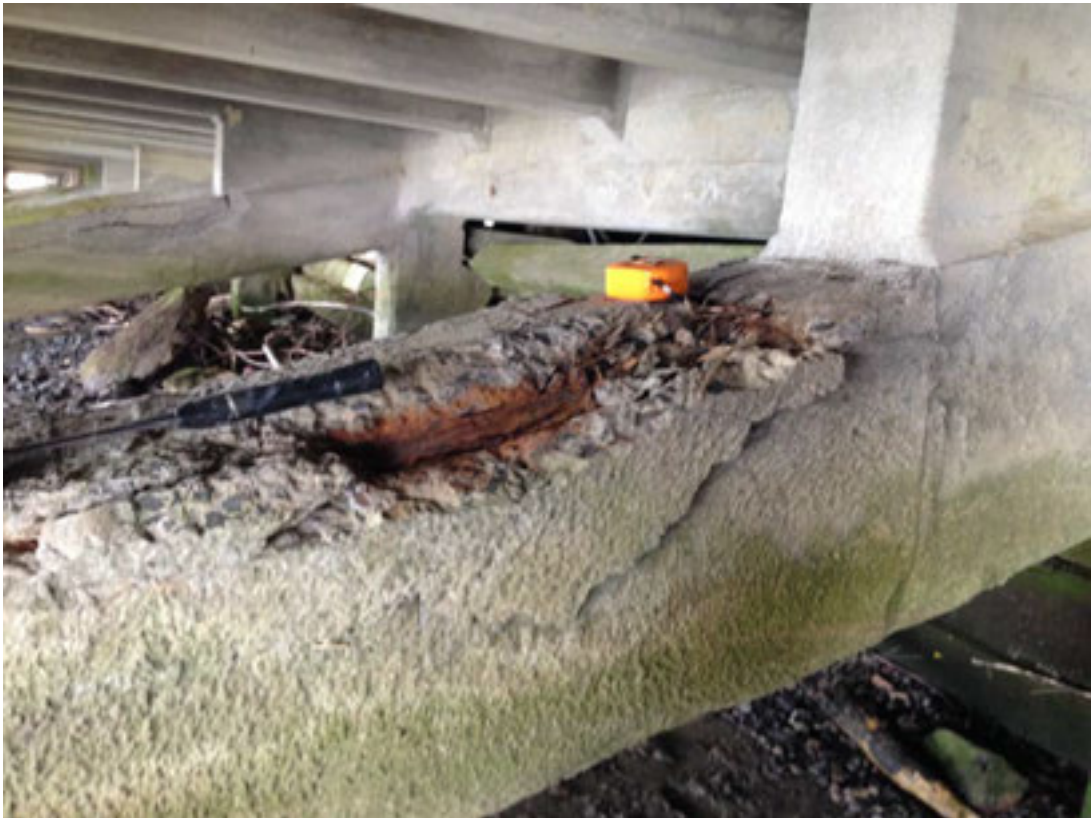
Photo B13 - spalling of raker beam at B12

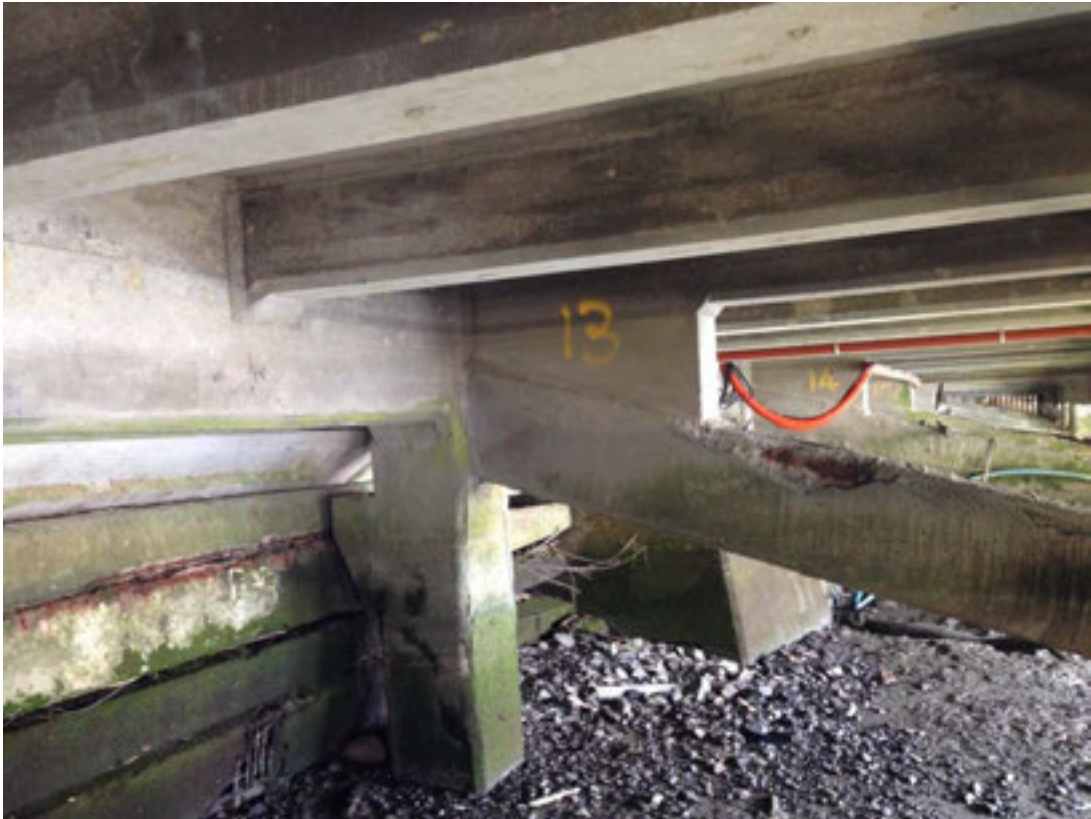
Photo B14 - spalling of raker beam at B13

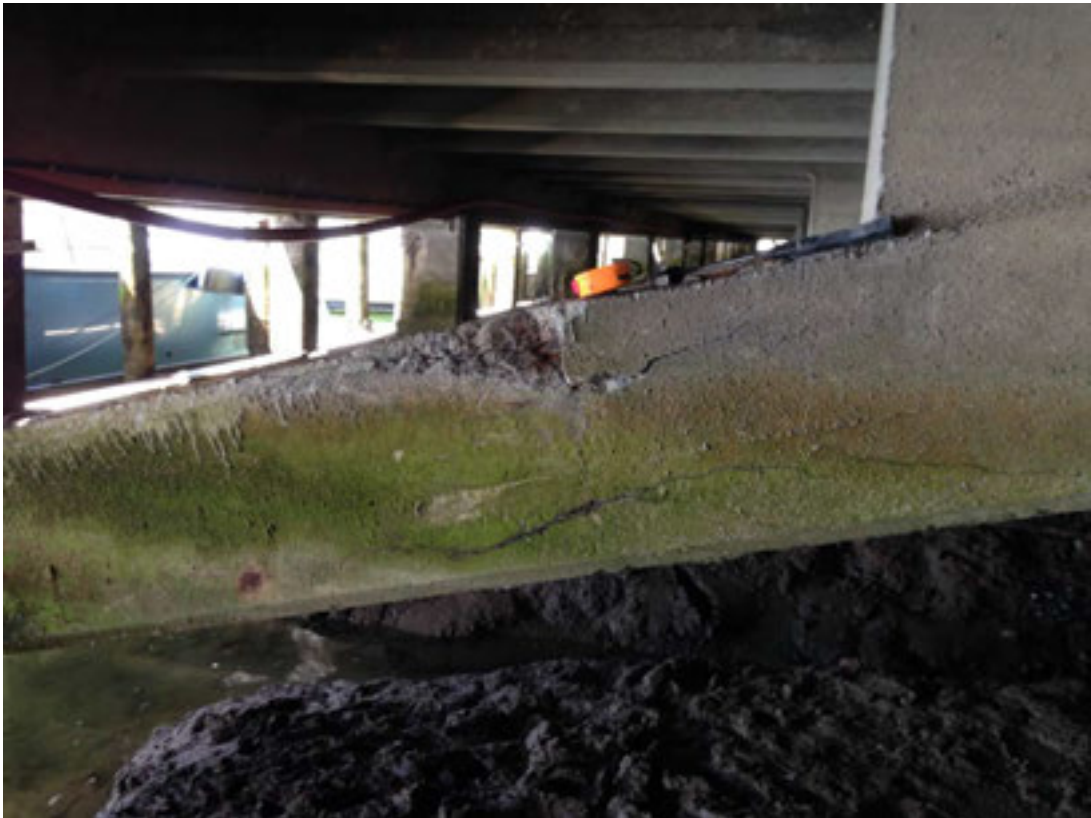
Photo B15 - spalling of raker beam at B13

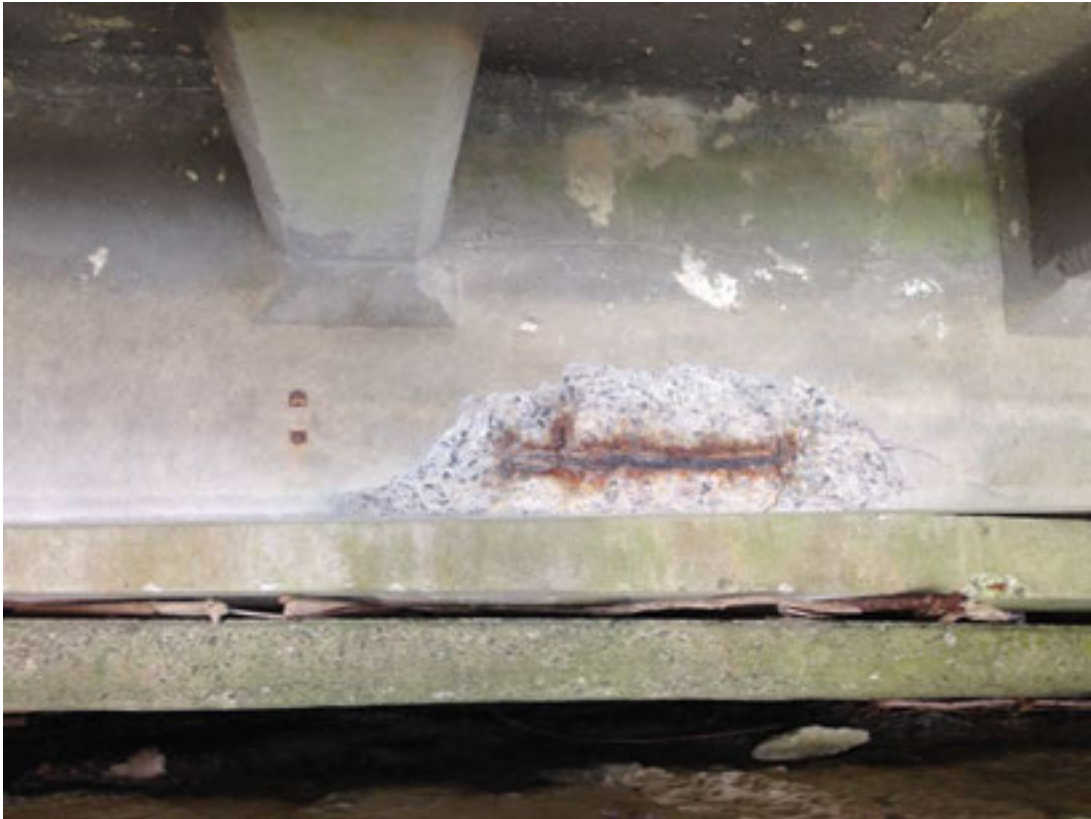
Photo B16 - spalling of rear beam between B15 and B16

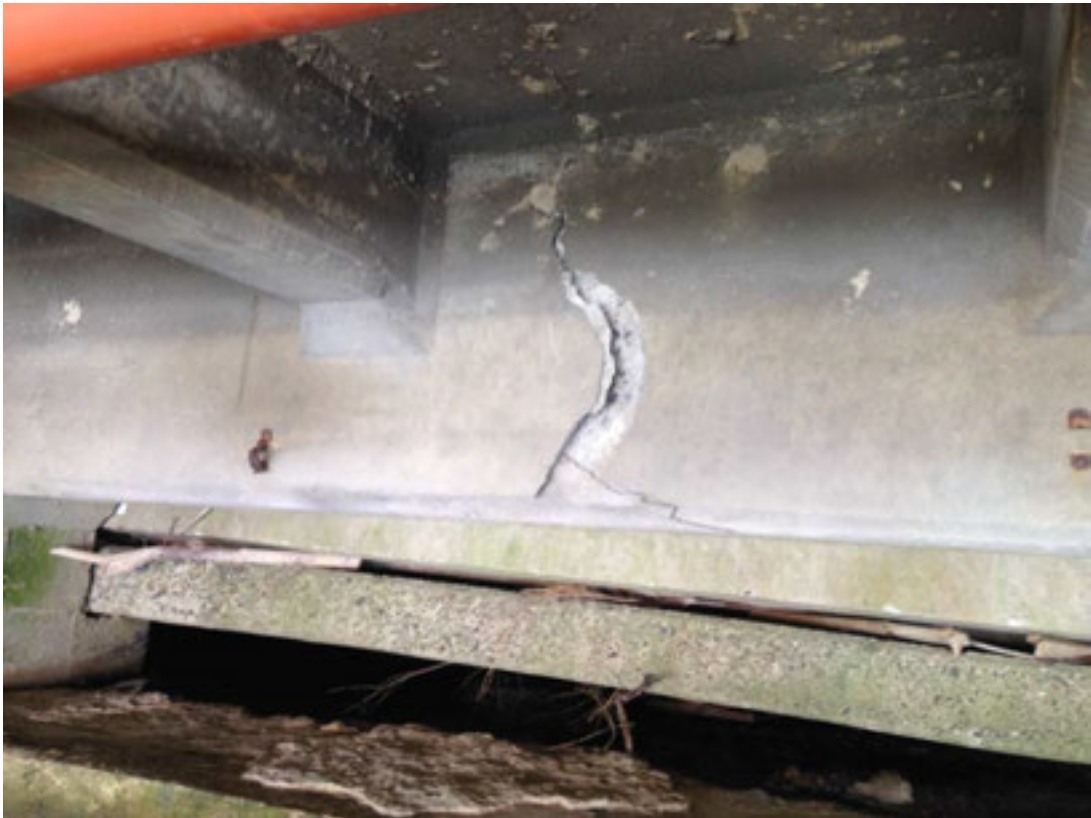
Photo B17 - cracking of rear beam between B15 and B16

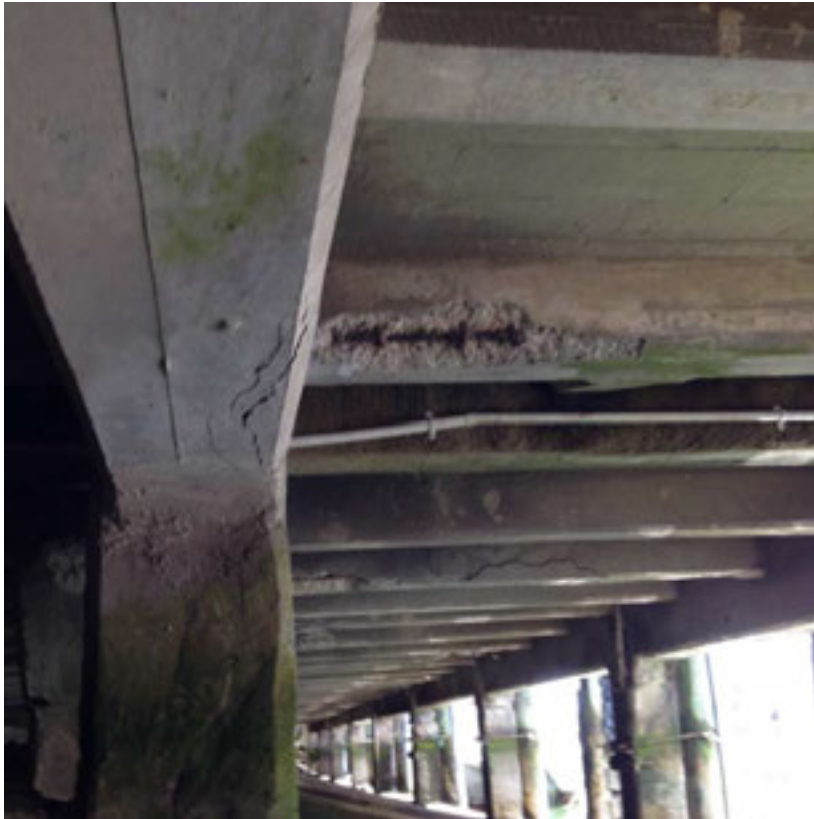
Photo B18 - cracks in beams at B15

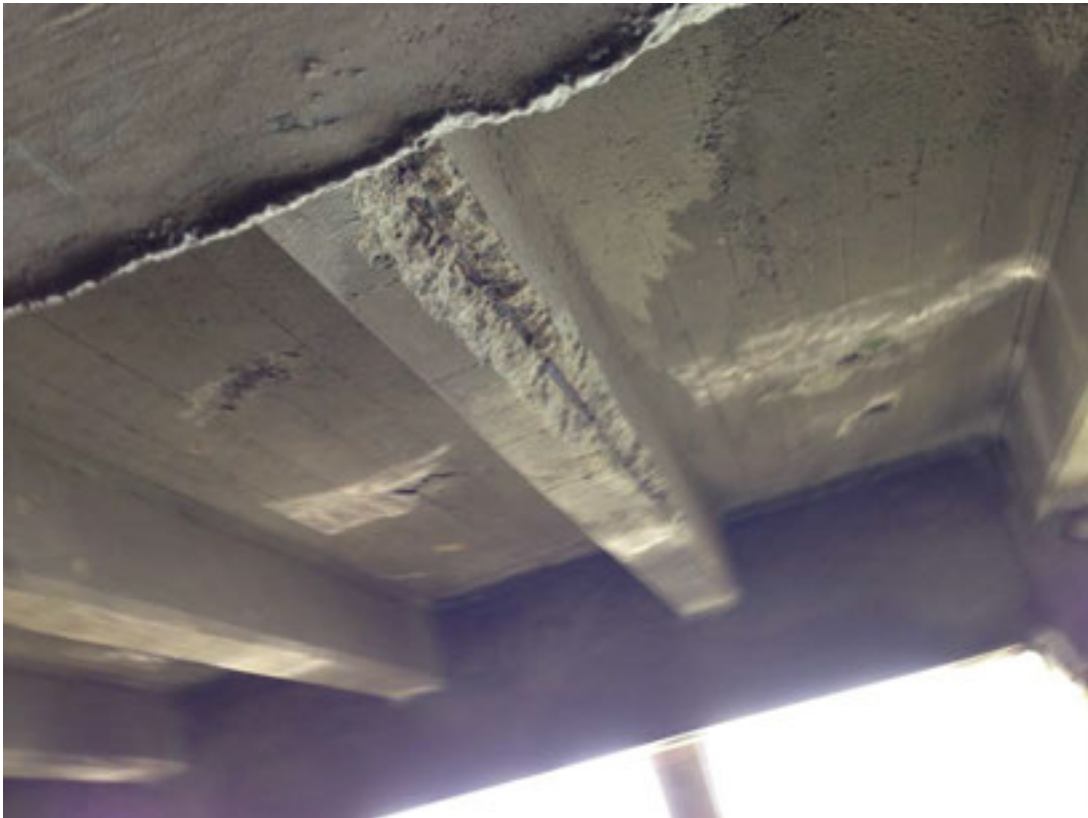
Photo C03 - beam spalling between C1 and C2

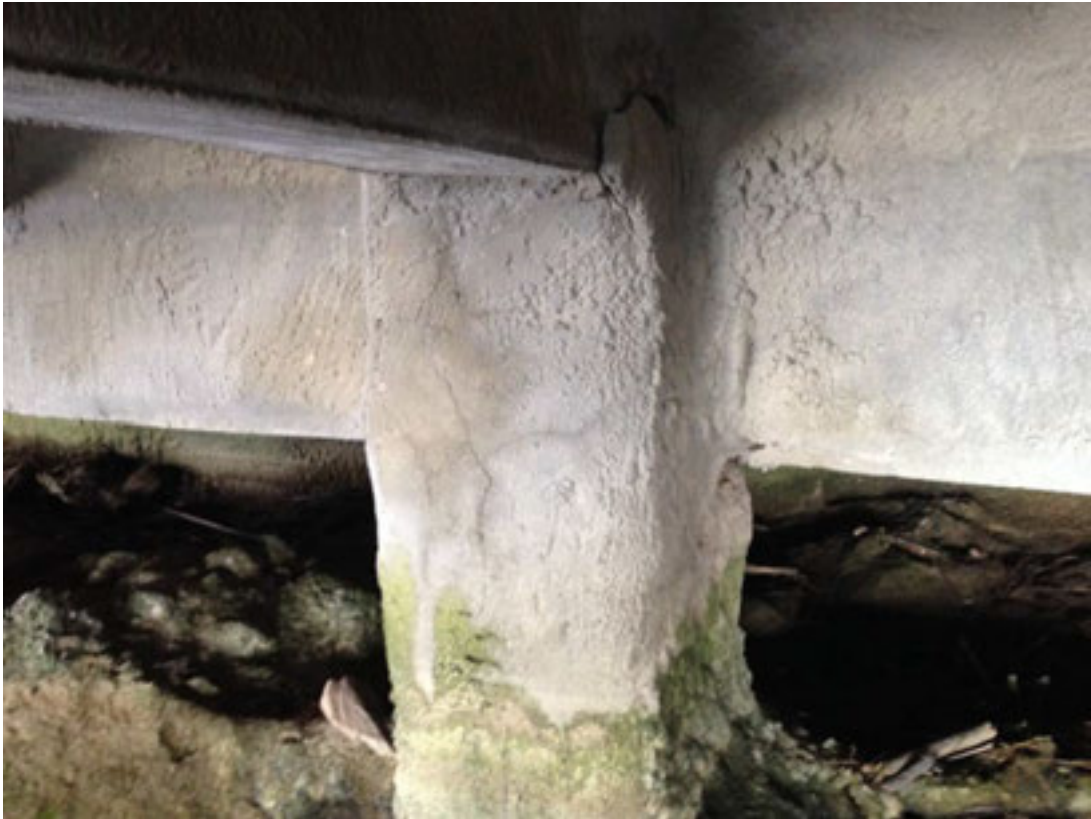
Photo C04 - cracking of pile repair

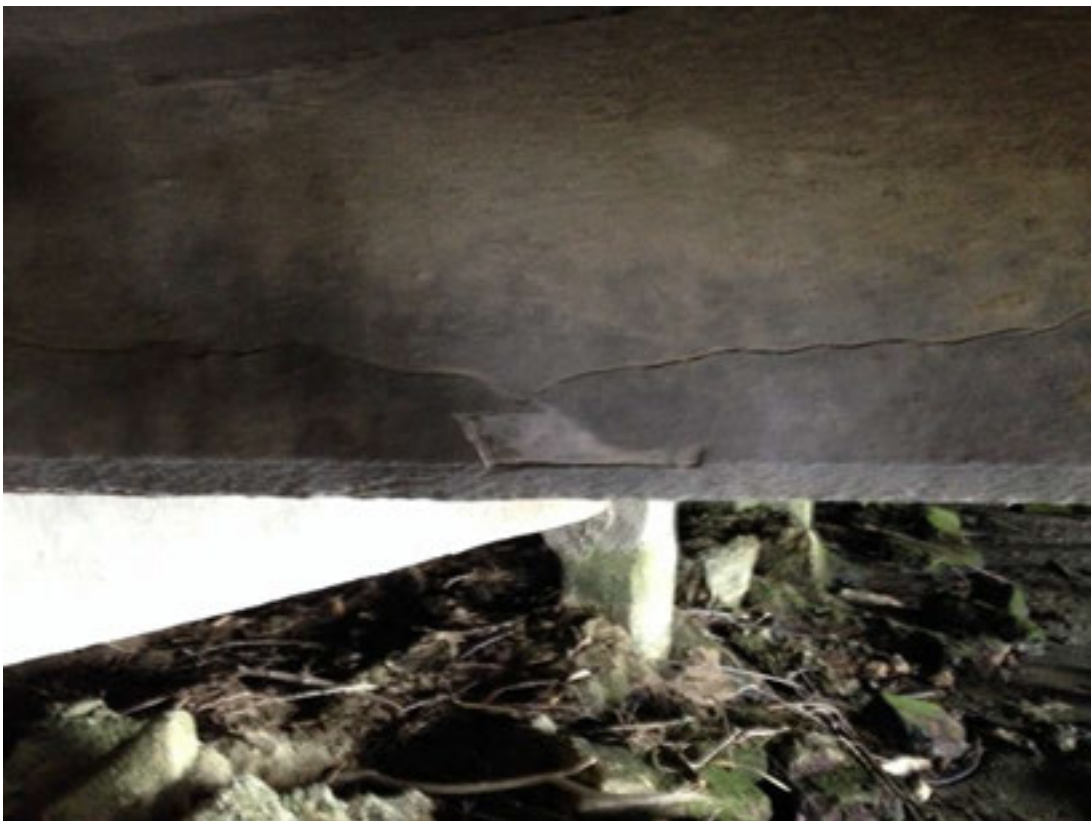
Photo C05 - cracking of beam
