Whakatane Commercial Wharf

Condition Assessment and Repair Options Report

**Prepared for:
Whakatane District Council**

February 2015
Job No: 851847

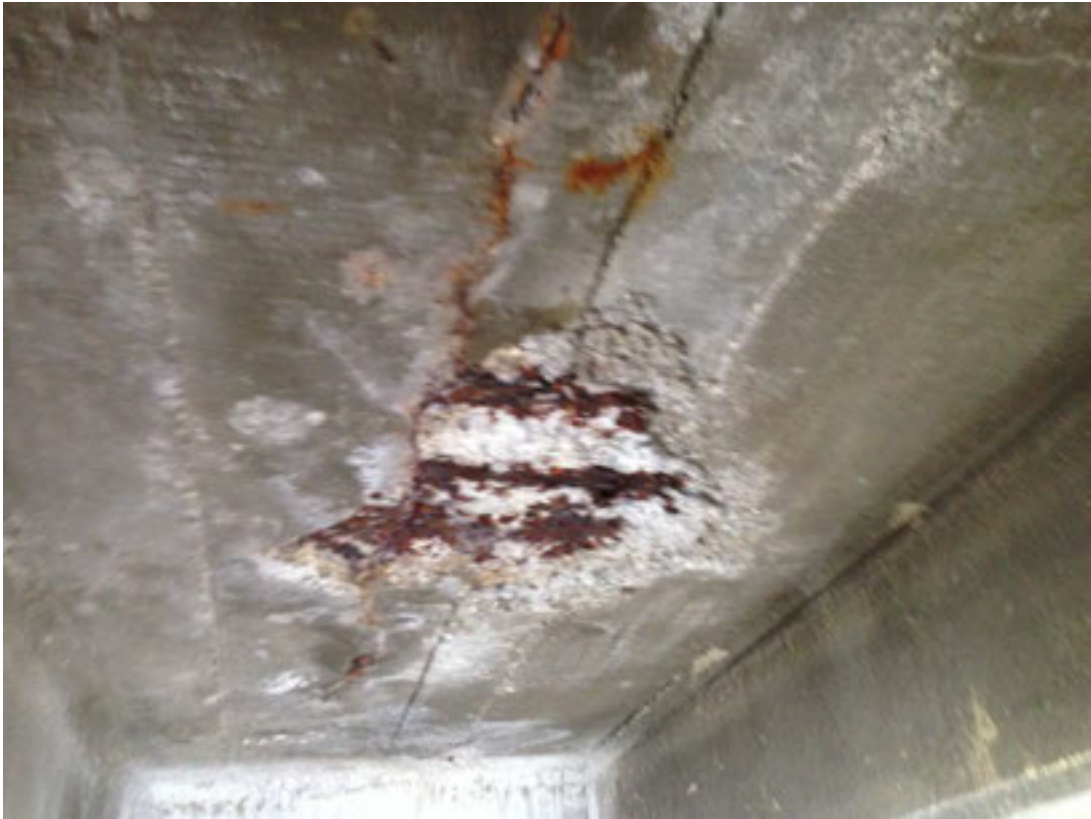
Photo C06 - spalling of slab

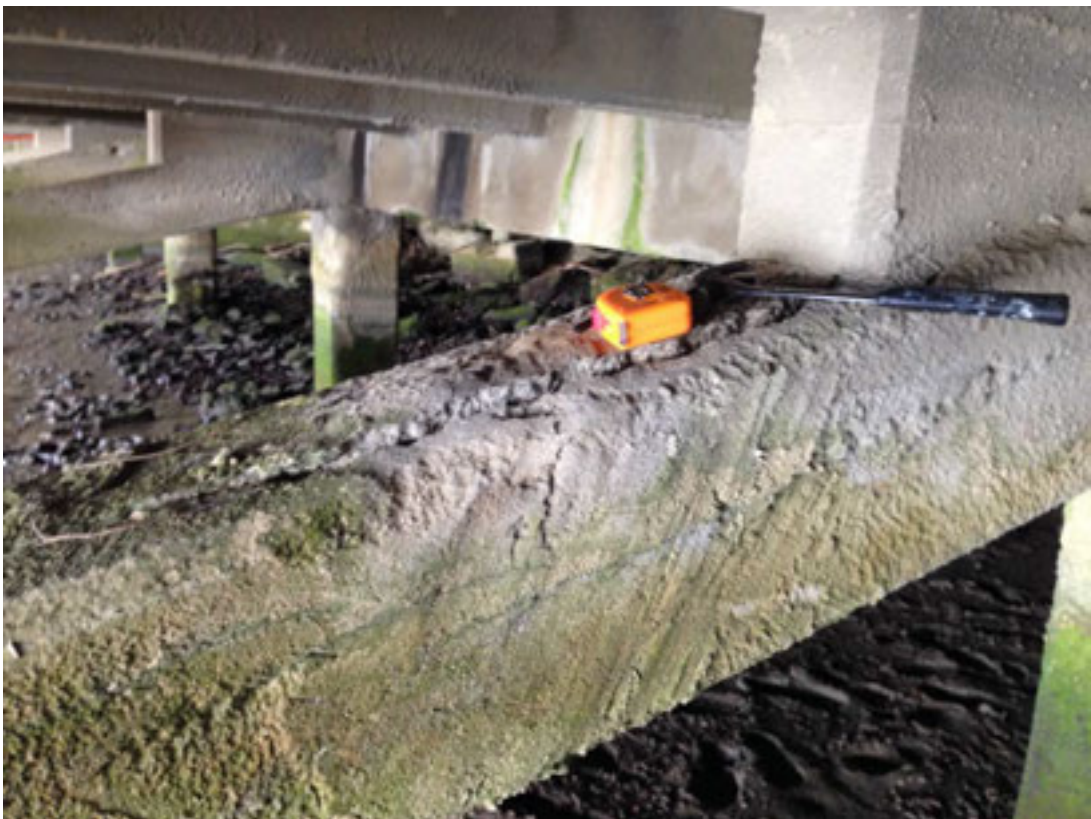
Photo C07 - cracking of raker at C7

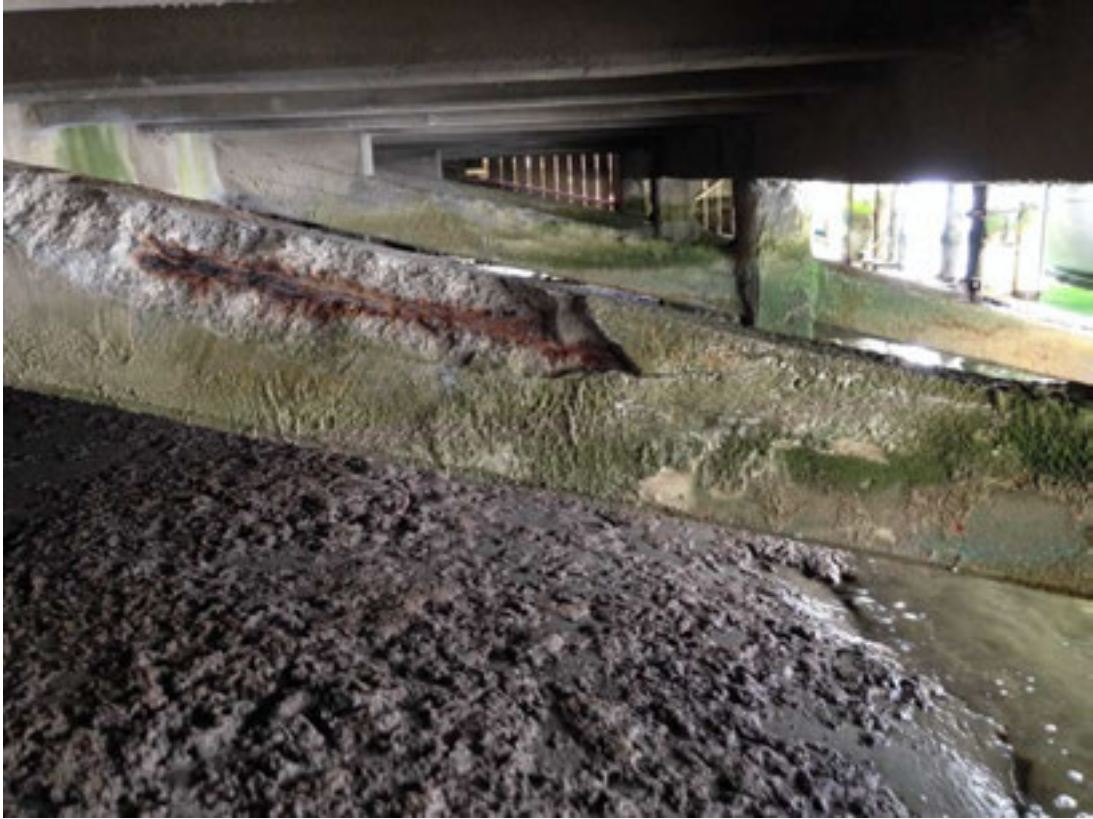
Photo C08 - cracking of raker at C6

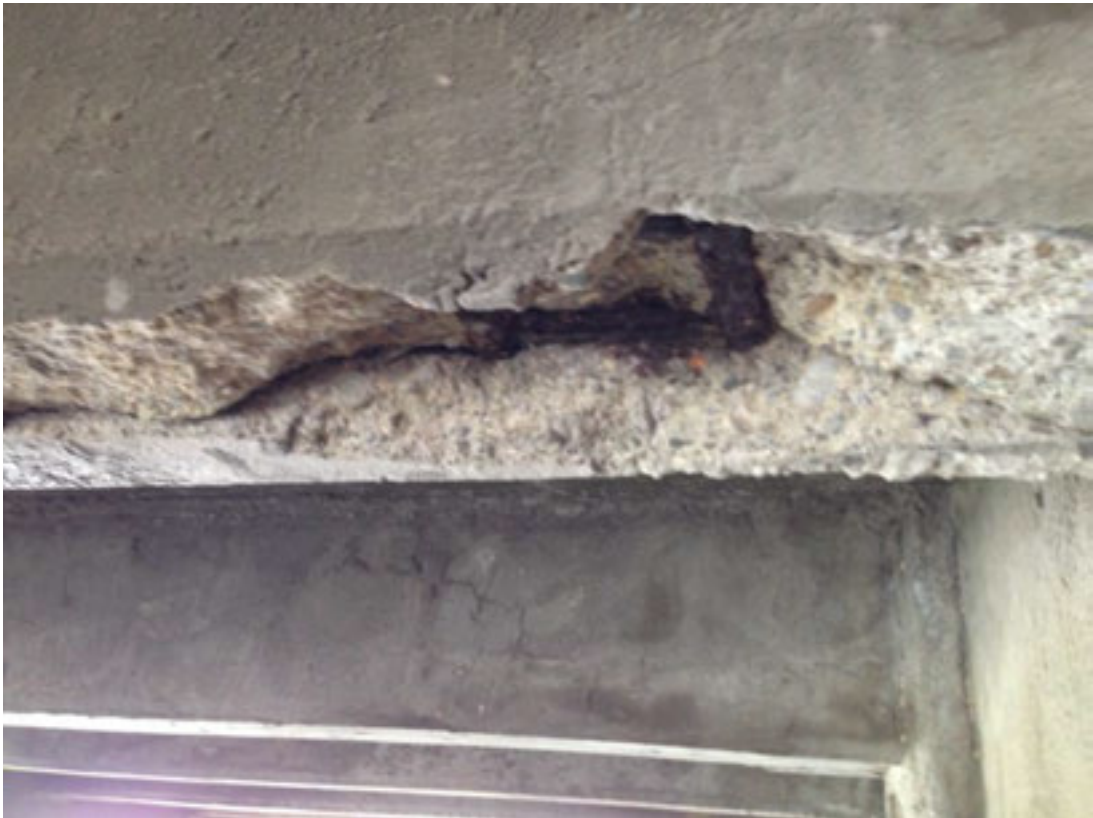
Photo C09 - spalling of beam
