Murupara Public Water Supply – Water Safety Plan

Whakatane District Council

- Final July 2018

- Version 2.00, May 2019

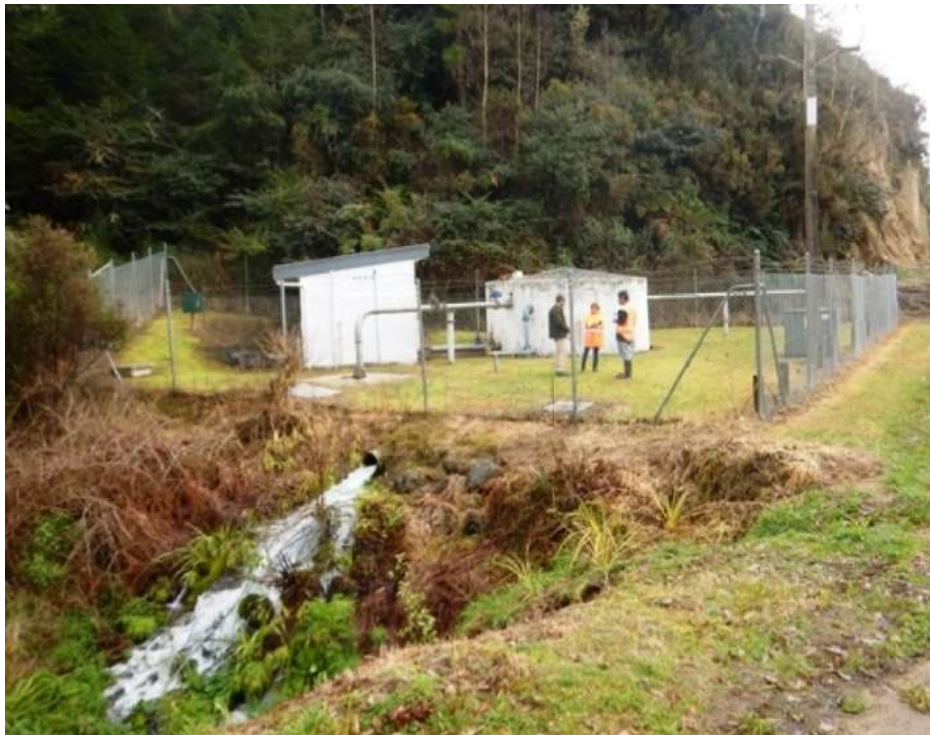
Figure 4: Pump Station Site with Bores and Suction Tank (Left) and North Bore Head (Right)

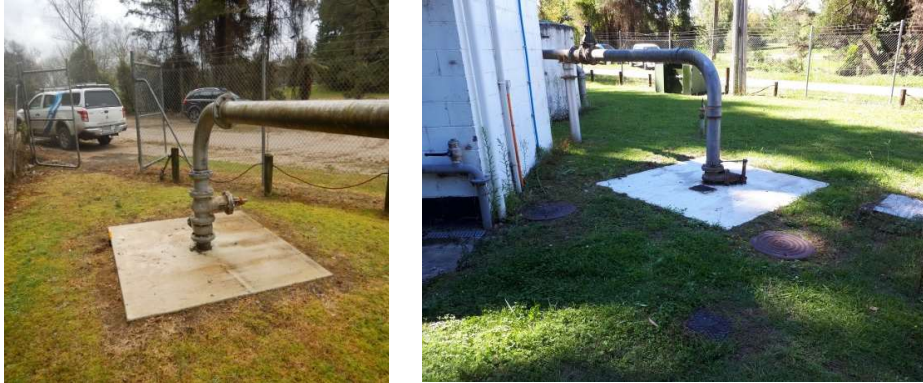
Figure 5: North Bore Head (Left) and South Bore Head (Right)

14	S2.2 (PM3)	Bore head Security	Carry out checks to determine adequacy of cable gland seals and bore head seals including replacing any deteriorating gaskets with water tight gaskets.	AE / PM	8 hours	December 2019

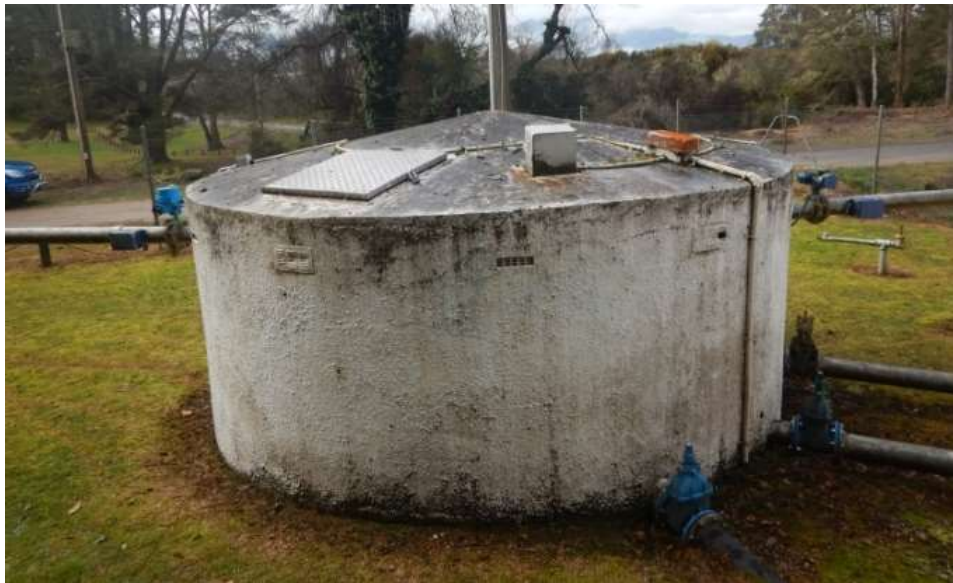
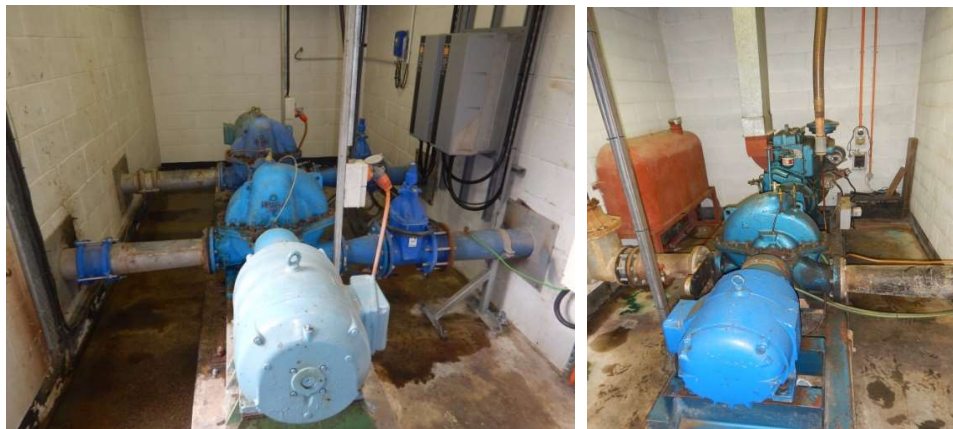
Figure 6: Suction Tank (Top), Two High-Lift pumps (Bottom Left) and Diesel pump with diesel storage (Bottom Right)

All air vents on the suction tank and the overflow pipe from the suction tank should be meshed to prevent entry of vermin, birds and feral animals.

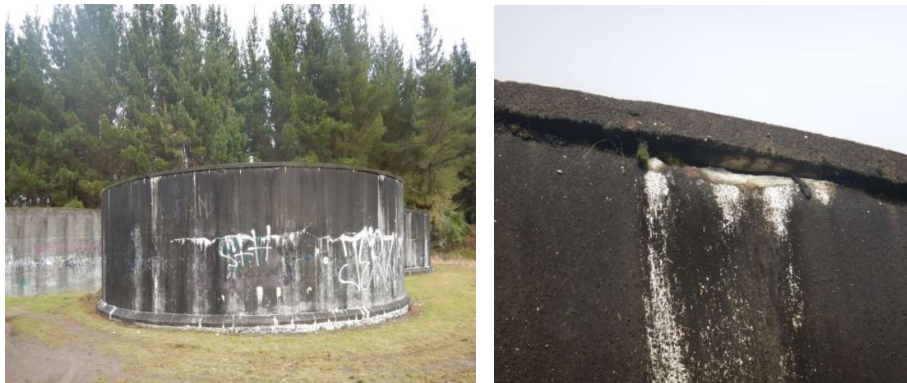
The total storage capacity of 1,135 m³ available is just sufficient to meet average daily demand and fire-fighting flows and provides 24-hour emergency storage. The concrete reservoirs are required to be assessed for structural integrity due to their age and are currently appear to be in average condition. The reservoir site is highly vulnerable to vandalism; the site inspection showed broken glass/bottles, tracks on the site indicating vehicle access and extensive graffiti on at least two reservoir walls. The reservoir vents have been repaired by WDC on a number of occasions due to vandalism. Security fence to be installed at the reservoir site; however, there are ongoing land matter issues dating back to 2010 which Council is

Figure 7: Concrete Reservoirs (Left) and Reservoir Roof (Right)

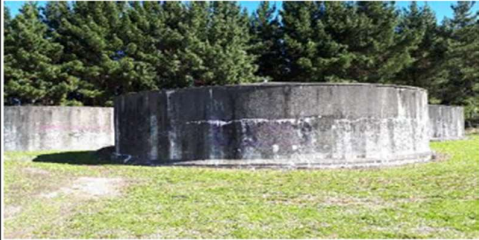
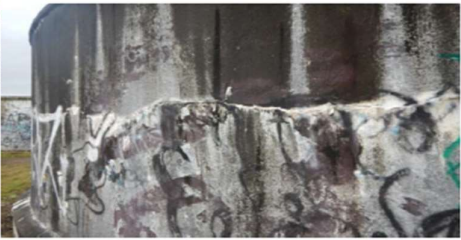
Reservoir Inspection				
General Information				
Project:	Murupara Water Safety Plan			
Survey Carried out by:	Sala Ranasinghe			
Date of Site Visit:	17th July 2017			
Location of Reservoirs:	Murupara			
Number of Reservoirs on site:	3 Reservoirs. 1 Reservoir out of commission			
Client Details:	Whakatane District Council			
Assessment				
Access to reservoir:	Dirt road			
Security to reservoir site:	Forestry gate to access road from main road, no gate at reservoir site.			
Security fence or stock fence?	No security/stock fence on site.			
Reservoir construction material (Concrete/Timber/Steel/Plastic/Other):	Material:	In service: Concrete (455 m3)	No:	1
	Material:	In service: Concrete (340 m3)	No:	2
	Material:	Not in service: Concrete (455 m3)	No:	1
	Material:		No:	
Condition of Reservoirs (Good/Average/Bad) please comment:	Reservoir 1: All reservoirs - Visual inspection showed average/poor condition. Few damp patches on the reservoirs although no ponding seen. Two reservoirs with extensive graffiti marked on structure.

Evidence of human or animal access on site?	Evidence of human access: vehicle tracks on site and broken bottles/glass.			
Evidence of vandalism?	Broken bottles/glass on site and reservoirs vandalised by graffiti.			
Any points of possible entry of animals into reservoir?	Visual inspection of reservoir showed possible points of entry of animals into reservoir between roof and tank body. To be further inspected by WTP operators. Overflow required to be meshed.			
Any signs of leaks?	Wet patches on reservoir structure, but no ponding.			
Check reservoir roof	As above.			
Any reservoirs not being used?	1 concrete reservoir not in use and disconnected from reticulation (455 m3)			
Is ladder access restricted?	No ladder on site.			
Are roof hatches designed to prevent rainwater ingress?	Wasn't able to confirm during site visit.			
Are roof hatches padlocked?	As above.			
Photos				
Reservoir Structure
