Whakatāne District Council

Quantitative Landslide and Debris
Flow Hazard Assessment
Matatā Escarpment

November 2013

T&T Ref: 29115

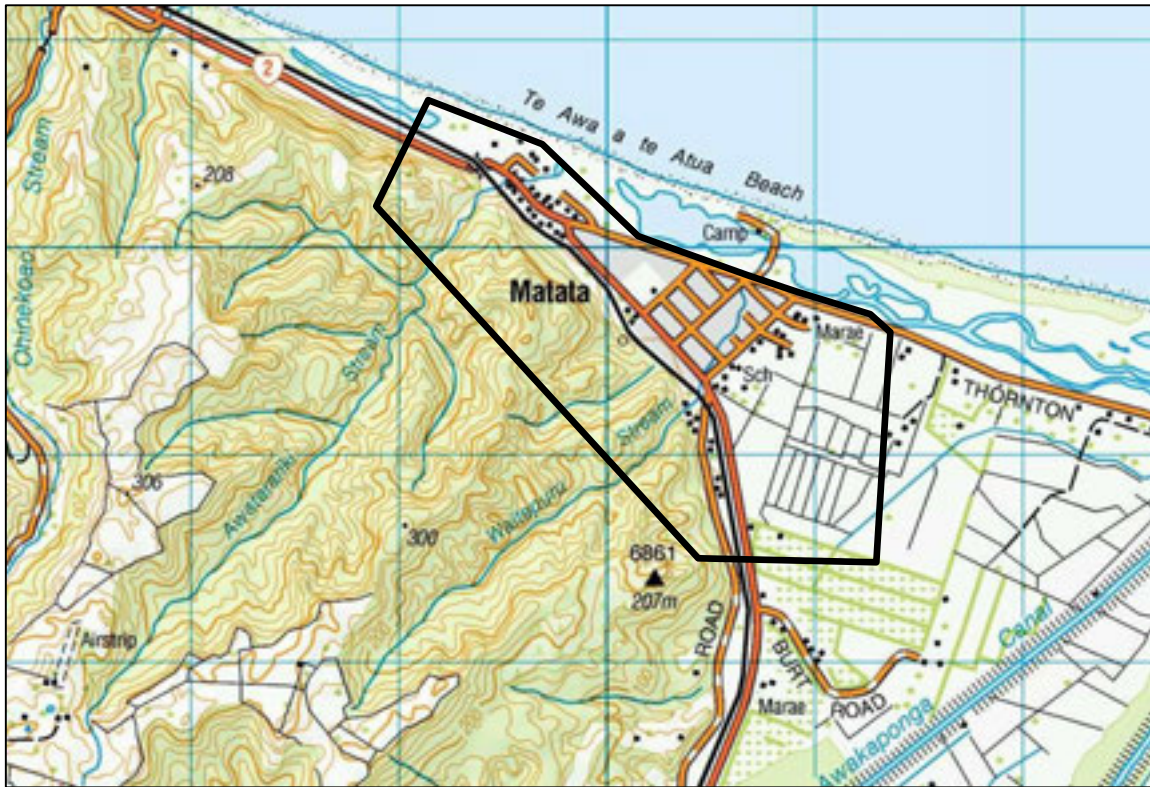
Figure 2.1: Location plan indicating the extent of the Matatā QLRA study

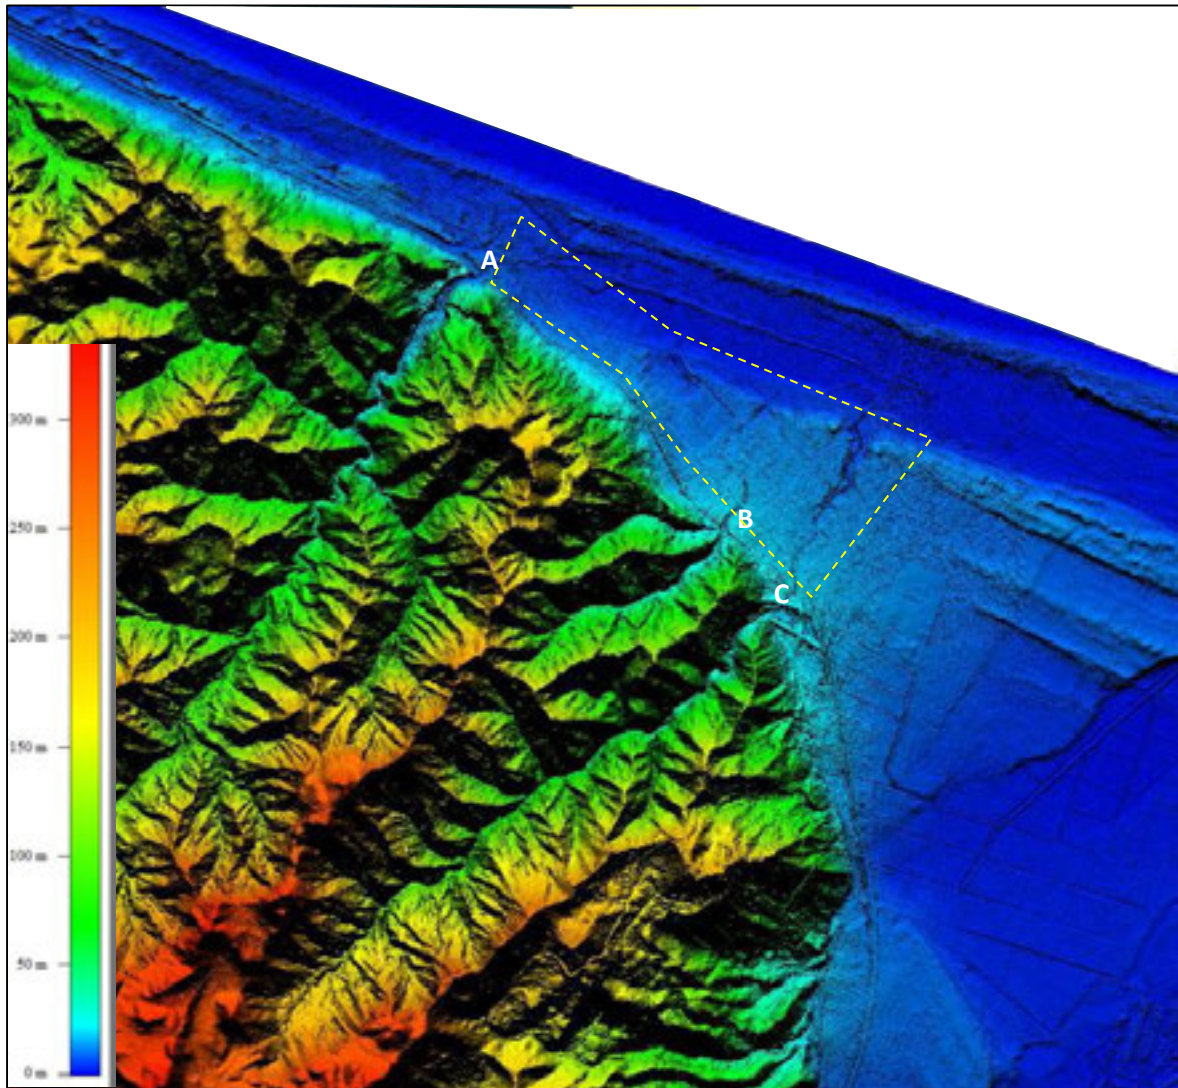
Figure 5.1: Terrain map developed from LiDAR data showing the elevated and dissected terrain located behind Matatā. The locations of the Awatarariki (A), Waimea(B) and Waitepuru (C) streams are indicated. The main residential area of Matatā is indicated by the yellow line.

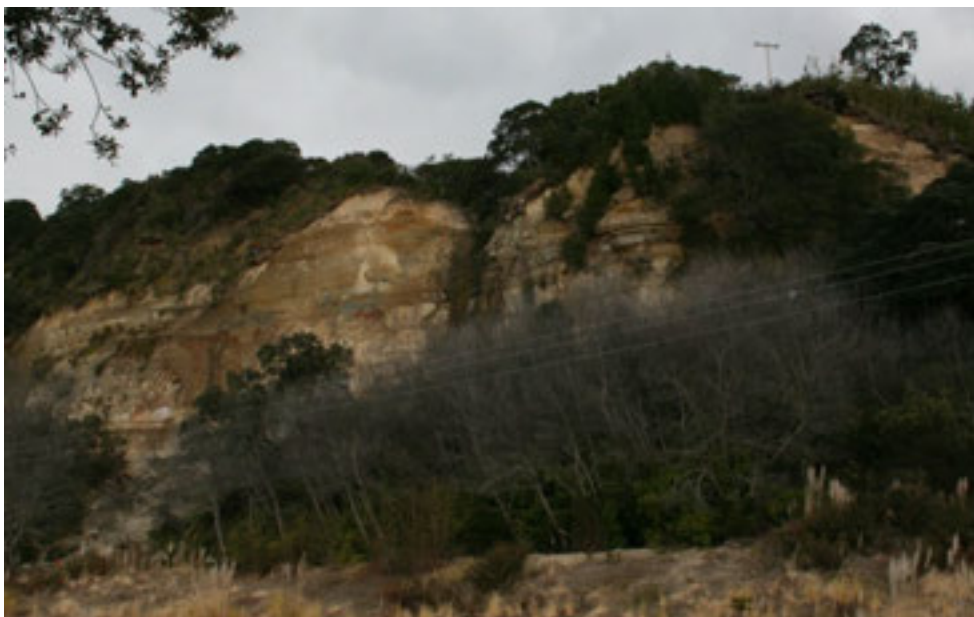
Figure 5.2: Abandoned sea cliffs forming the escarpment west of Matatā. View looking south from SH2.

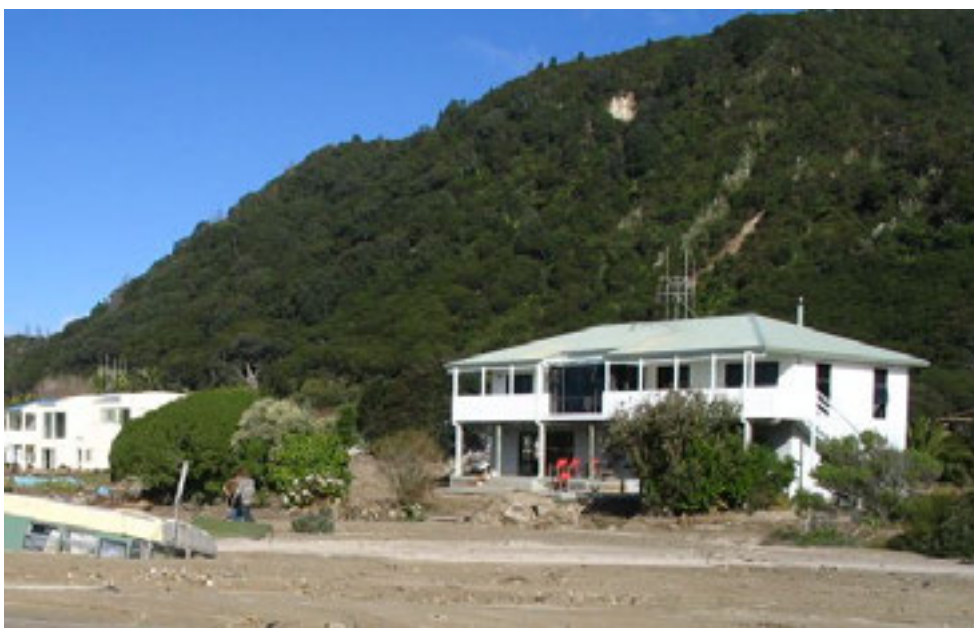
Figure 5.3: View of the escarpment slopes east of the Awatarariki Stream. Photo taken in the immediate aftermath of the 2005 debris flows.

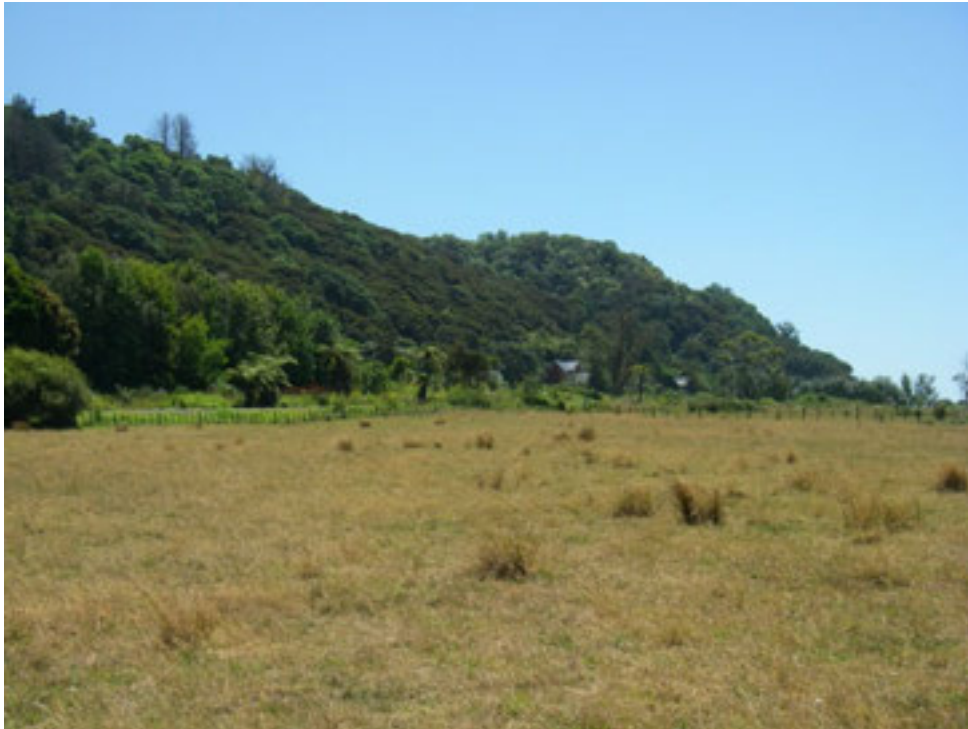
Figure 5.4: View of the Matatā Escarpment to the south of Matatā looking north towards Waitepuru Stream.

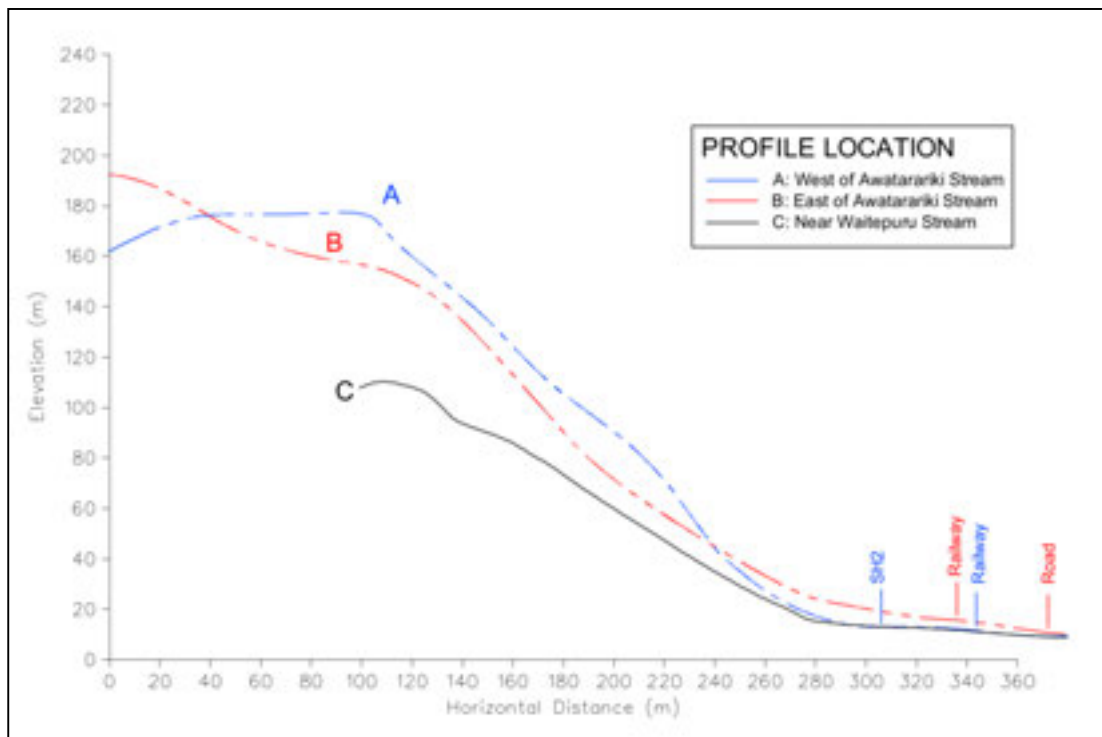
Figure 5.5 Representative slope profiles along the Matatā Escarpment

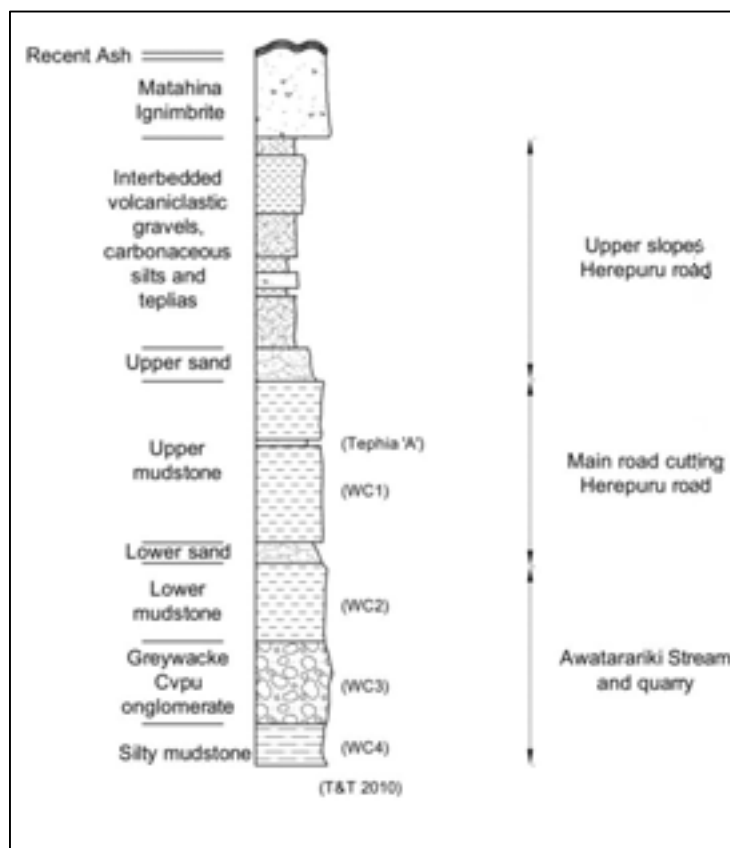
Figure 6.2: Stratigraphic column for Matatā (modified from Costello, 2007)

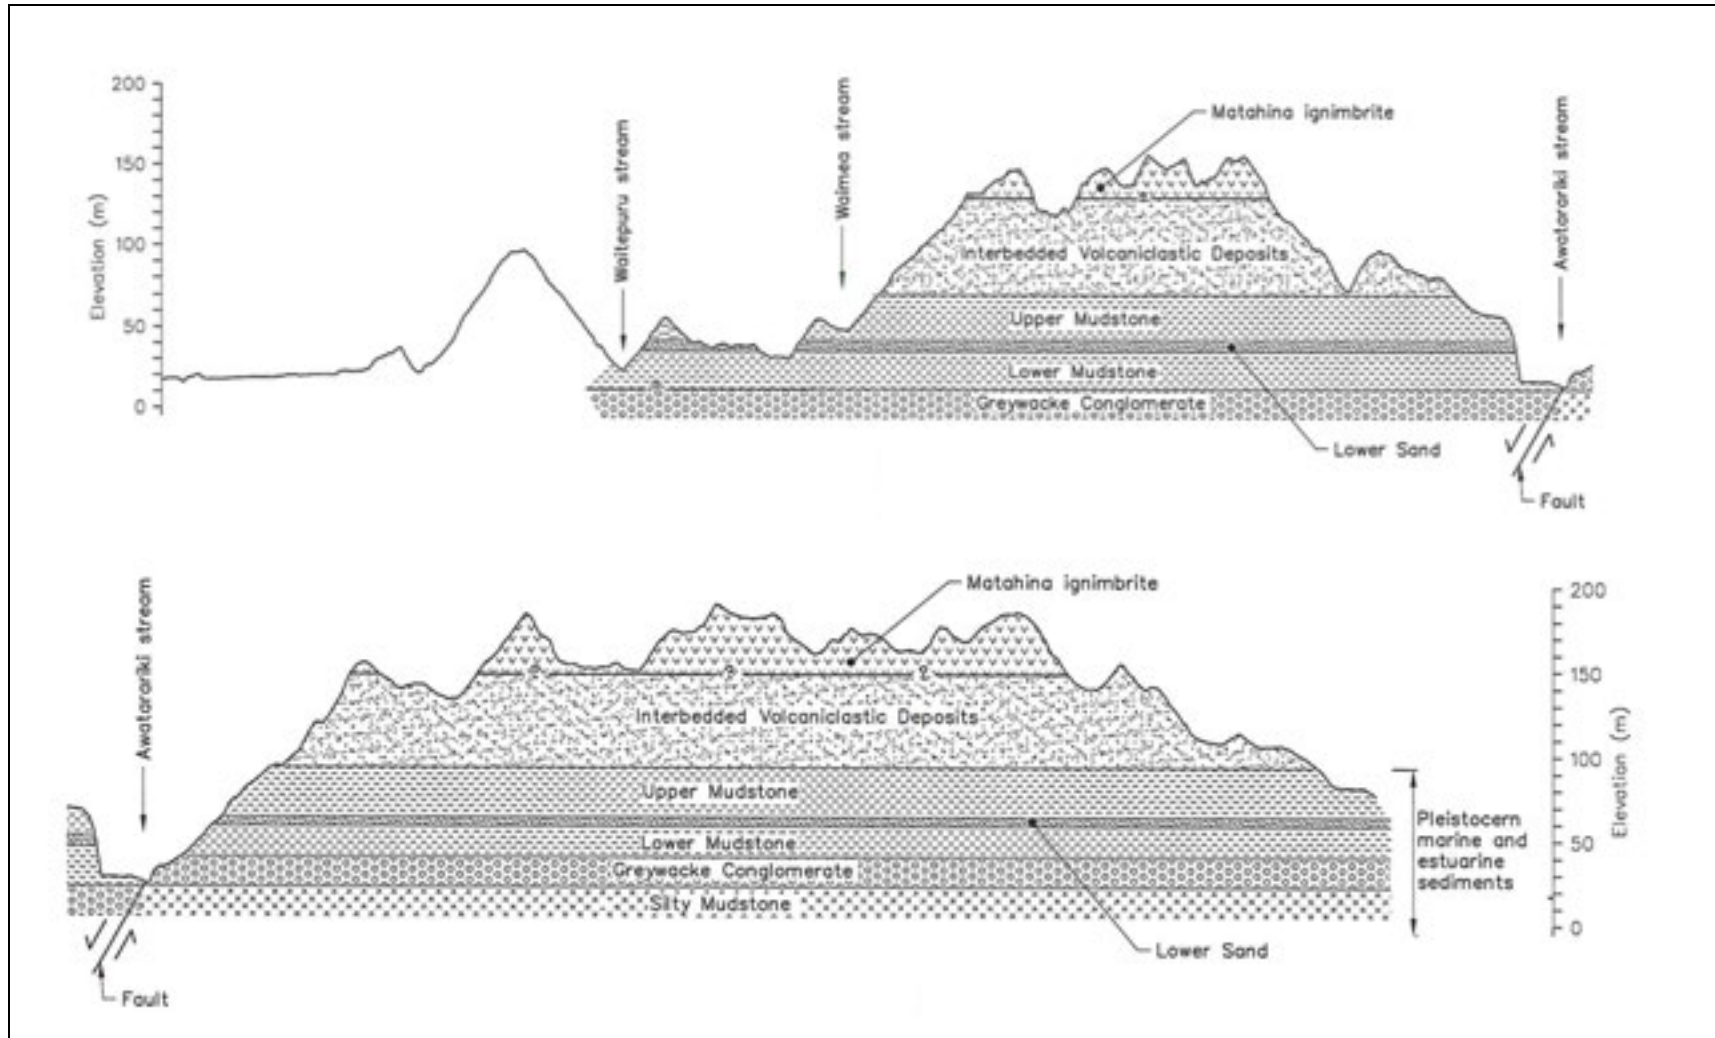
Figure 6.3: Generalised geological section nominally along the front of the Matatā Escarpment. View from the flatlands to the hills

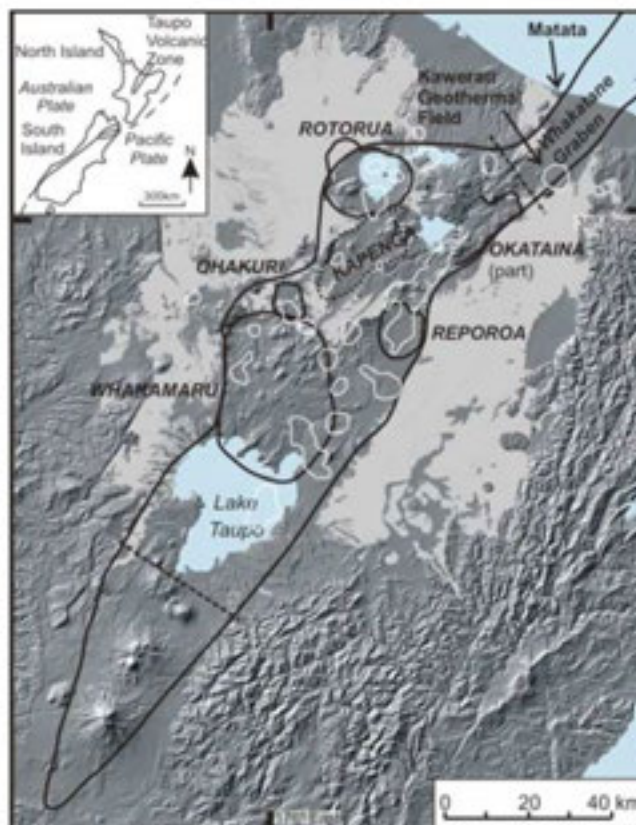
Figure 6.4: The location of Matatā relative to the Taupo Volcanic Zone and Whakatāne Graben (Modified from Hochman, date unknown)

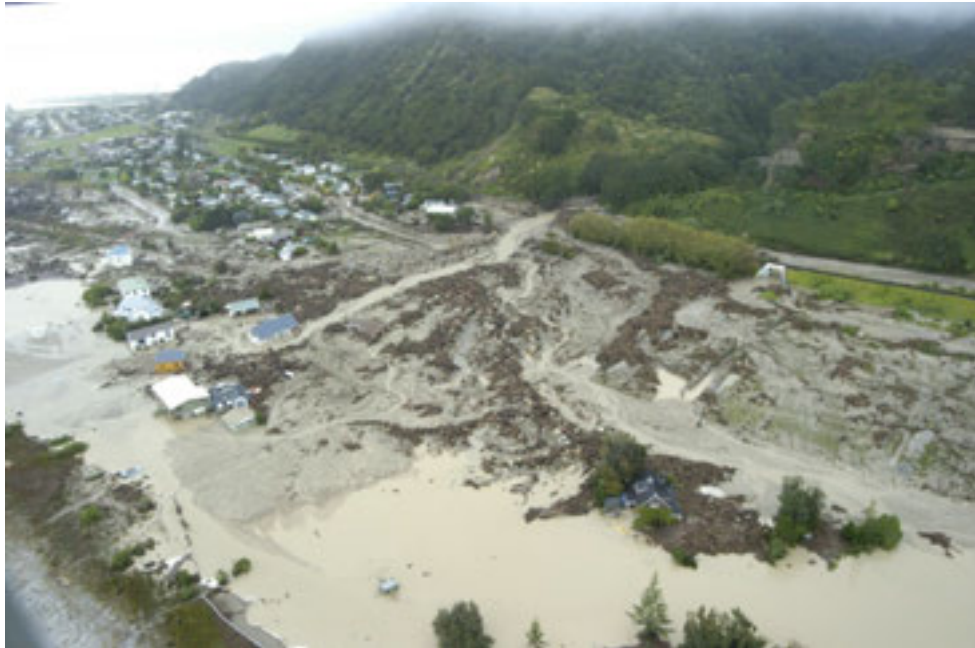
Figure 8.1: View of the 18 May 2005 debris flow deposits, Awatarariki Stream

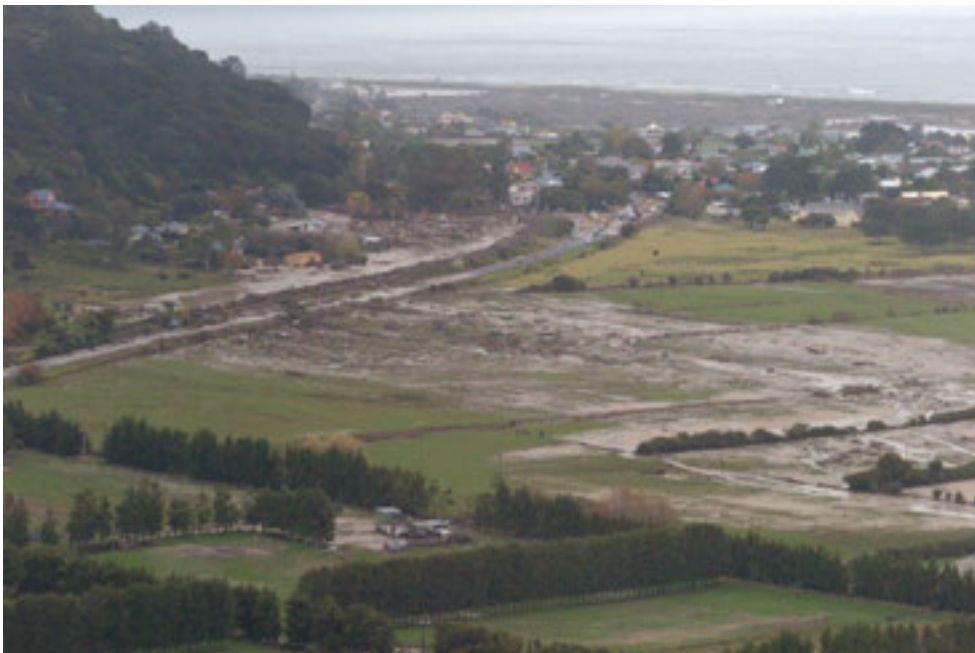
Figure 8.2: View of the 18 May 2005 debris flow deposits, Waitepuru Stream

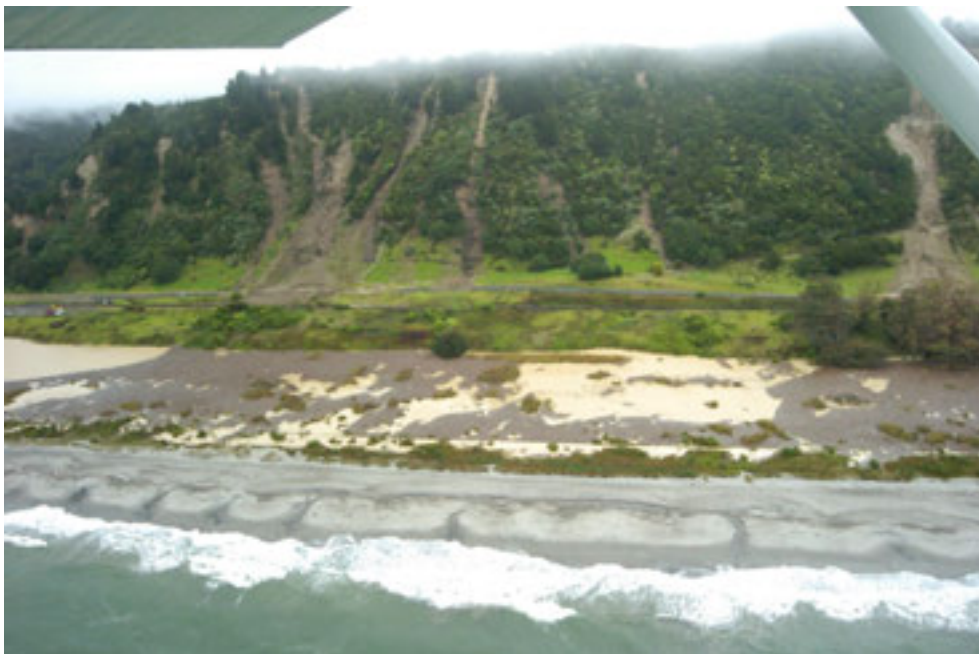
Figure 8.3: View of debris avalanche landslides on the Matatā Escarpment as a result of the rain that generated the 18 May 2005 debris flow event

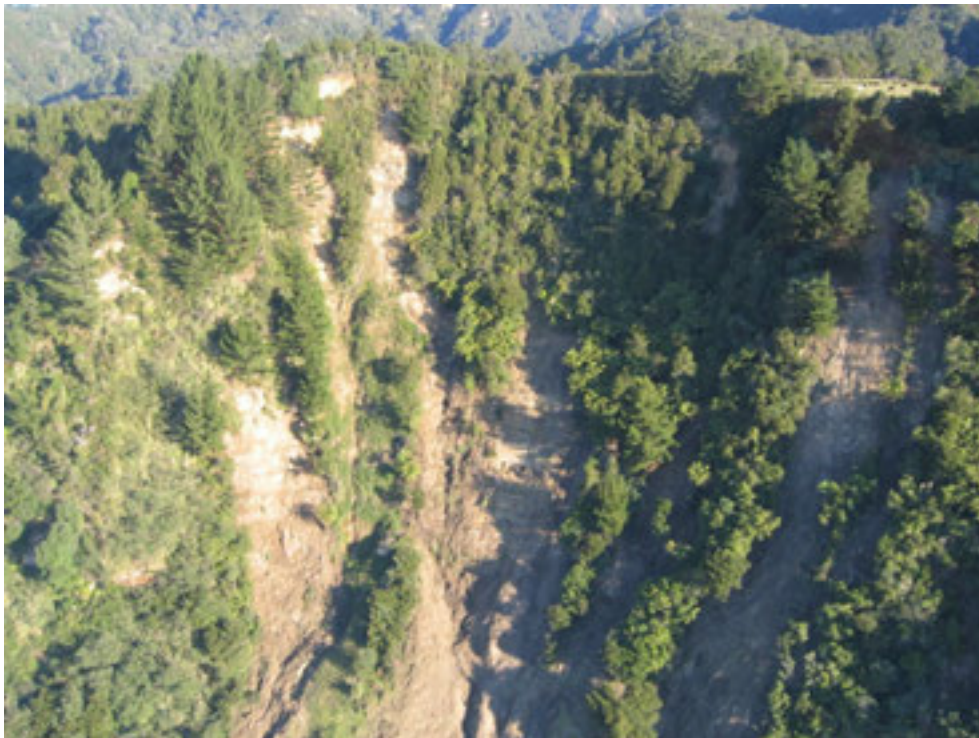
Figure 8.4: View of the debris avalanche landslides typical of those that occurred within the hills behind Matatā in May 2005

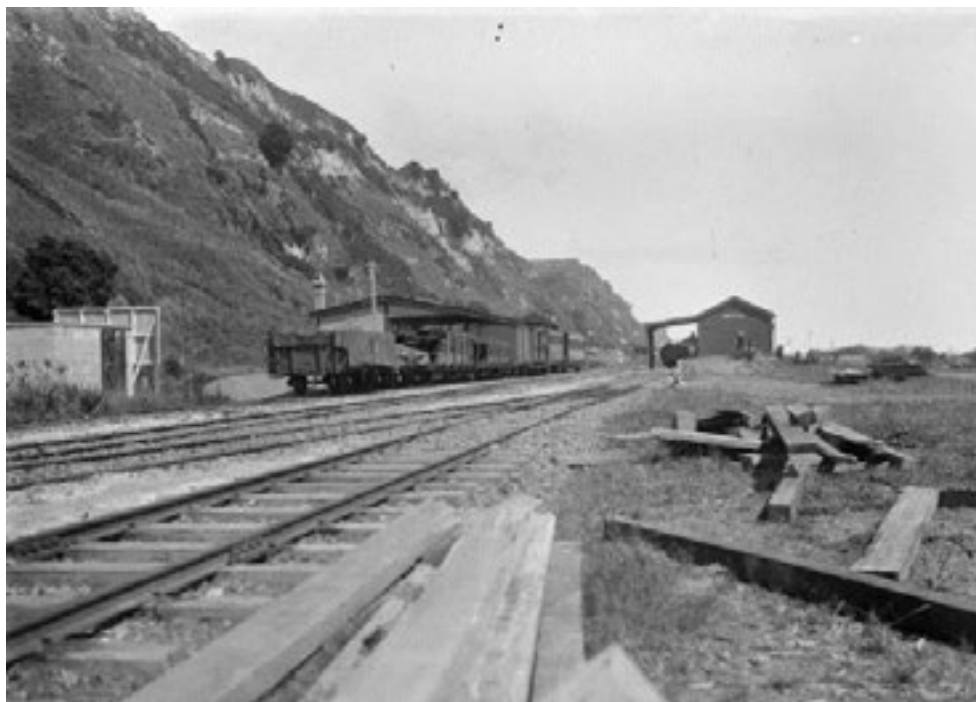
Figure 8.5: View of the former Matatā railway station in 1924. The station was located approximately where the current oversized load bypass rejoins SH2. Note the numerous areas devoid of vegetation and the significant talus slope developed at the base of the escarpment (reproduced with permission of Alexander Turnbull Library)

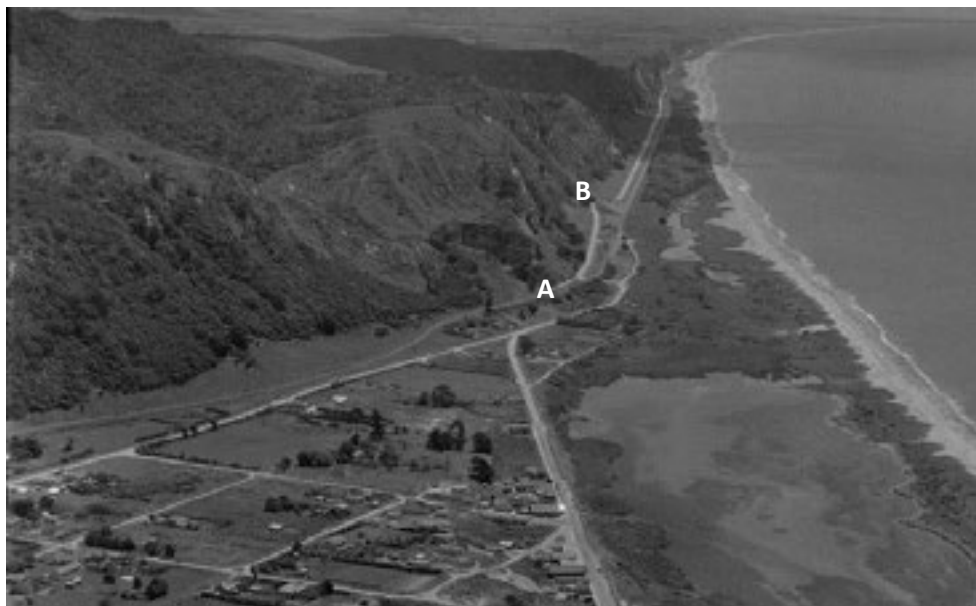
Figure 8.6: View of Matatā in 1953. Awatarariki Stream (A). Note how the former alignment of SH2 goes up and around a debris fan (B). (reproduced with permission of Alexander Turnbull Library).

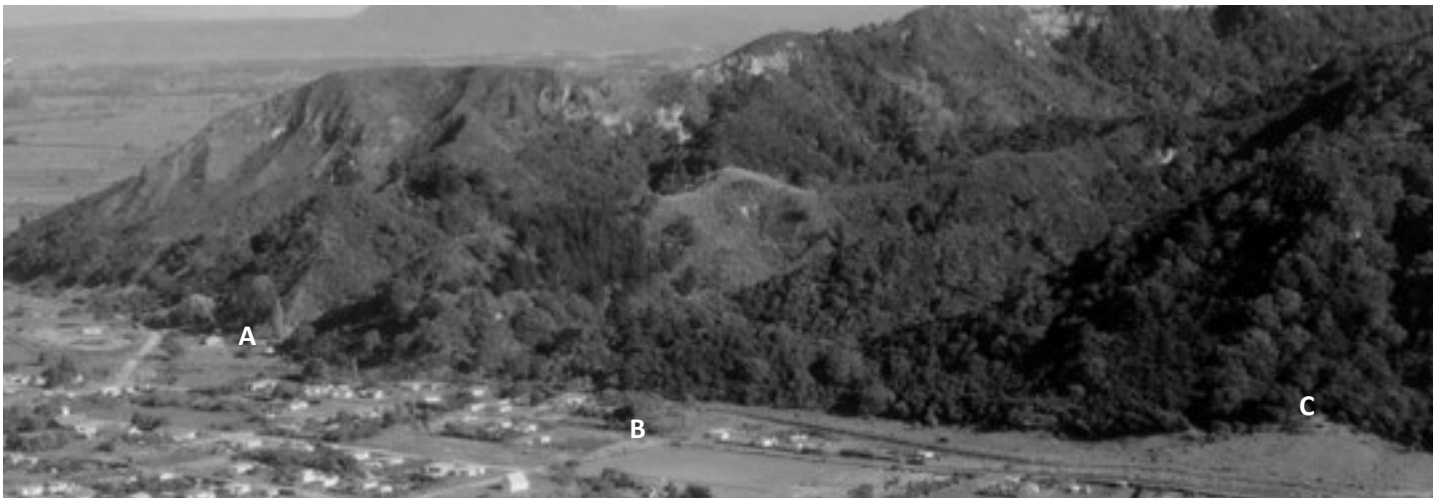
Figure 8.8: View of Eastern & central Matatā in 1965: Waitepuru Stream (A); Division Street (B); Debris Fan (C). Note the limited elevation of the escarpment compared to that west of the town (reproduced with permission of Alexander Turnbull Library)

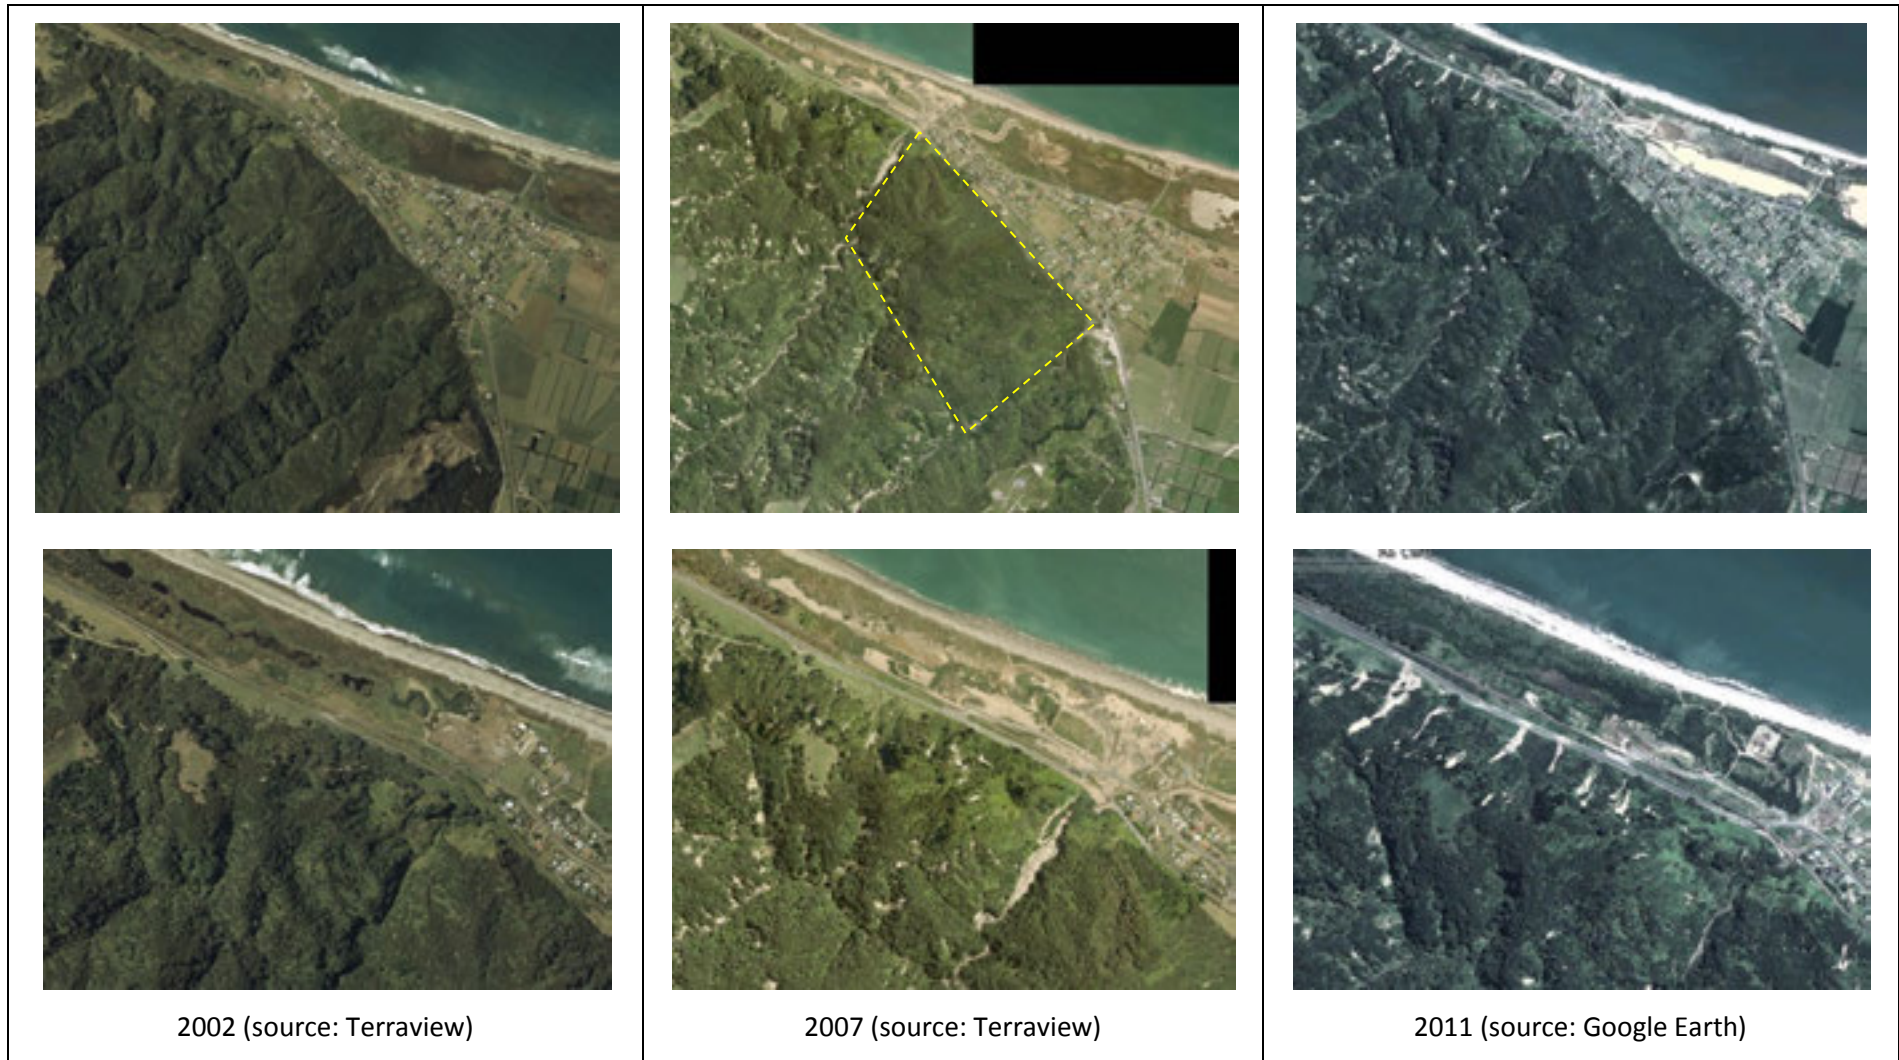
Figure 8.9: Aerial photos showing the density of landslides in the general study area (top) and Awatarariki Stream (bottom between 2002 and 2011). Note the much lower density of landslides in the area between the Awatarariki and Waitepuru streams (yellow box, top middle photo)

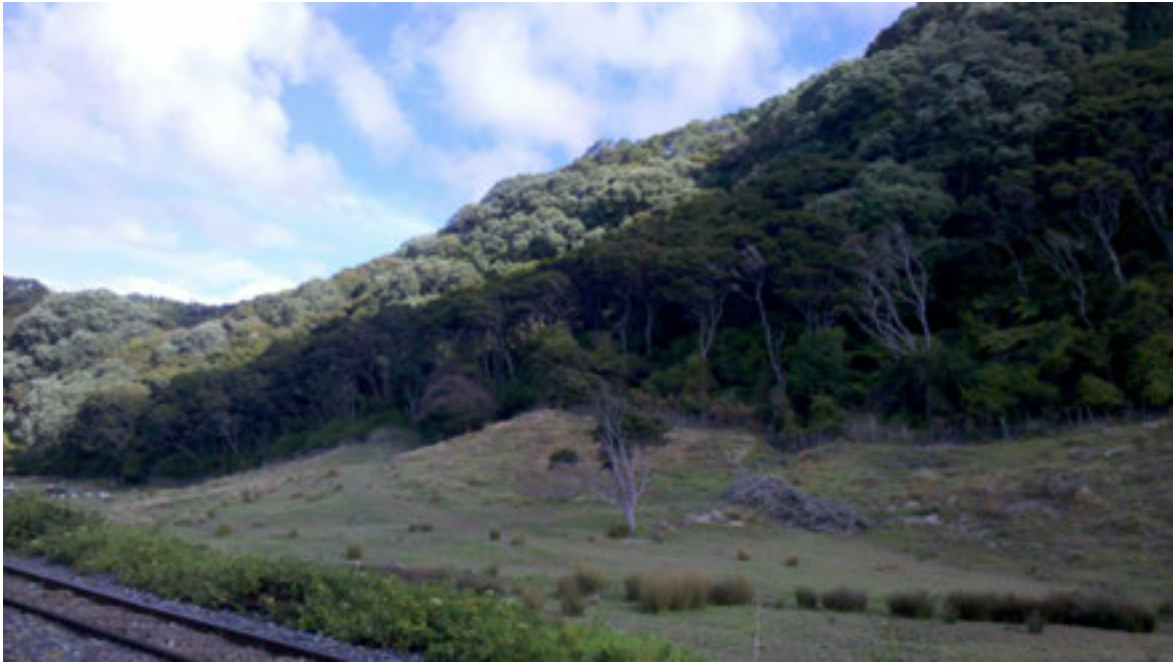
Figure 8.10: Debris fan formed at the base of the Matatā Escarpment in the general vicinity of Clarke Street.

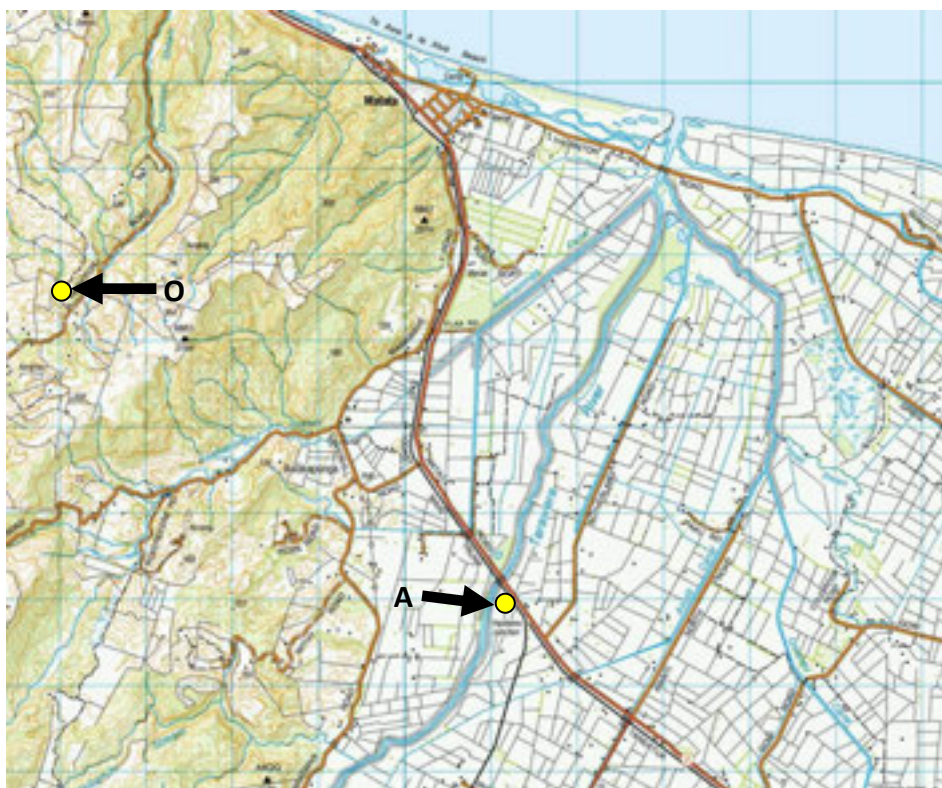
Figure 9.1: Location of the Awakaponga (A) and Ohinekoao (O) rain gauges

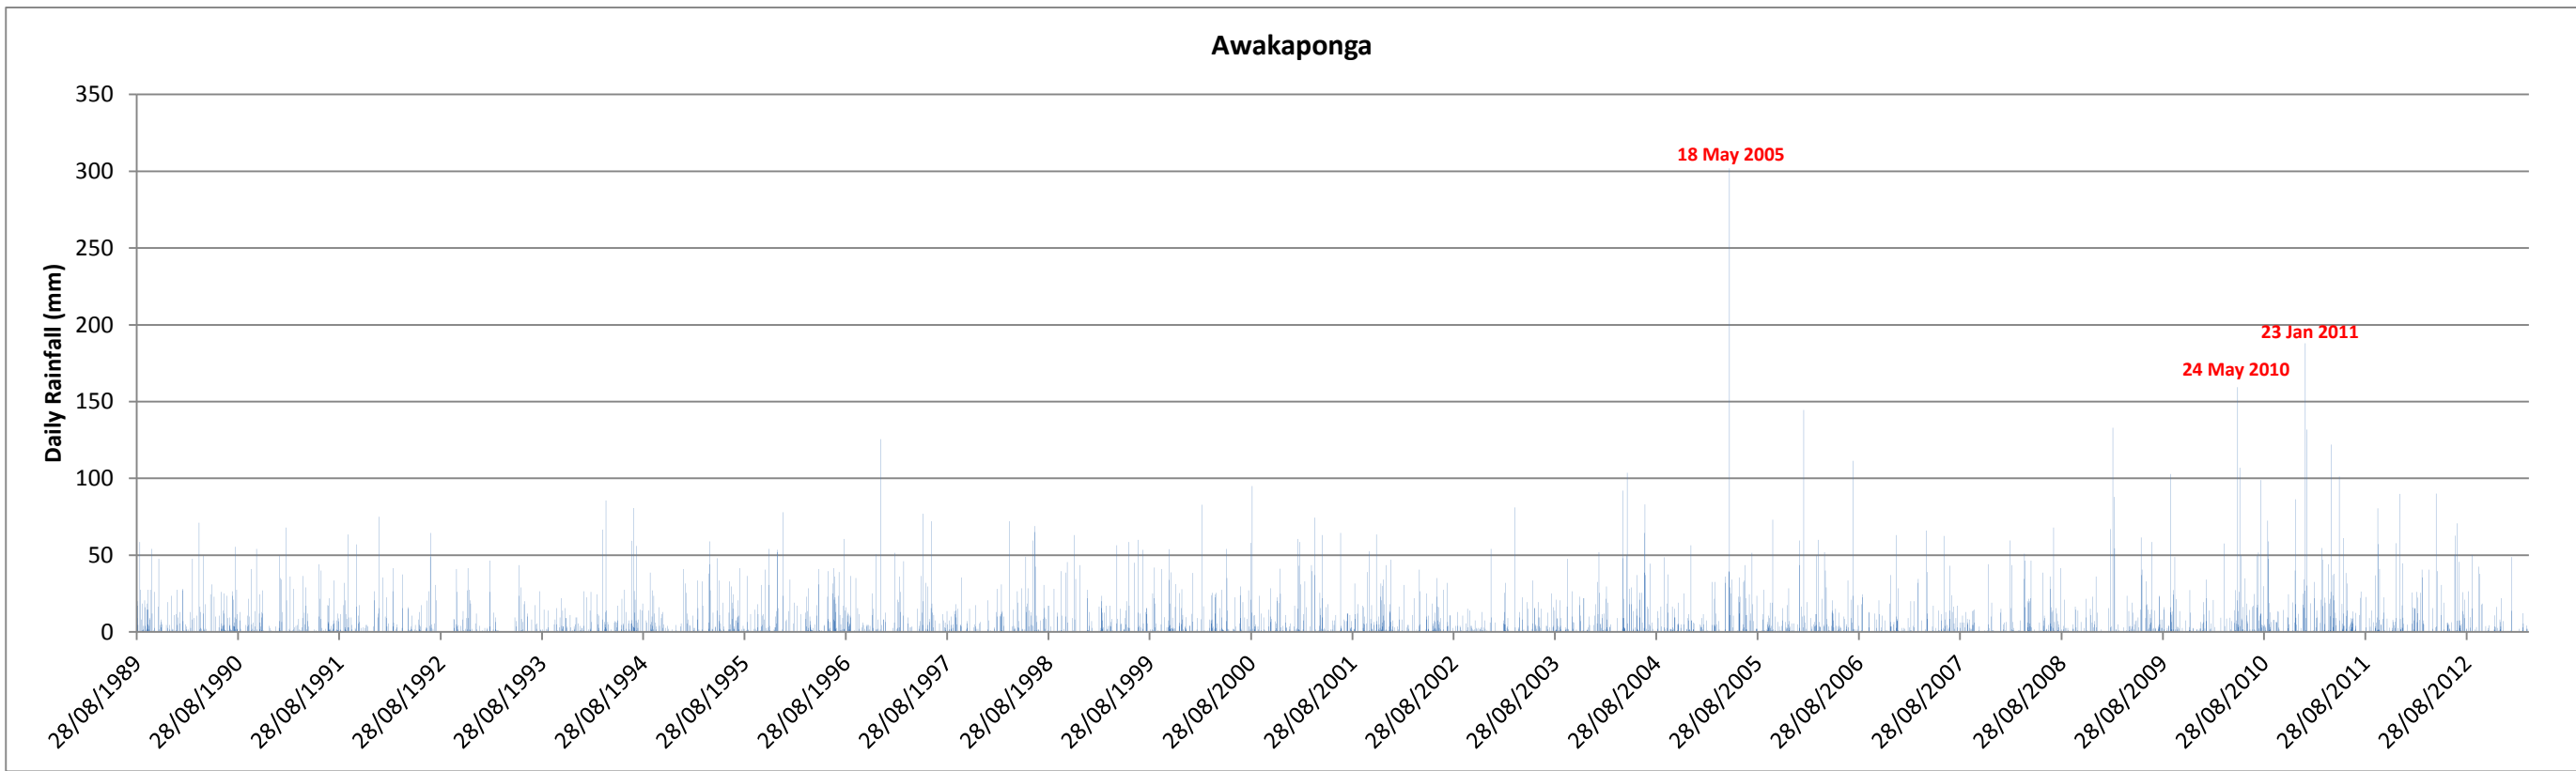
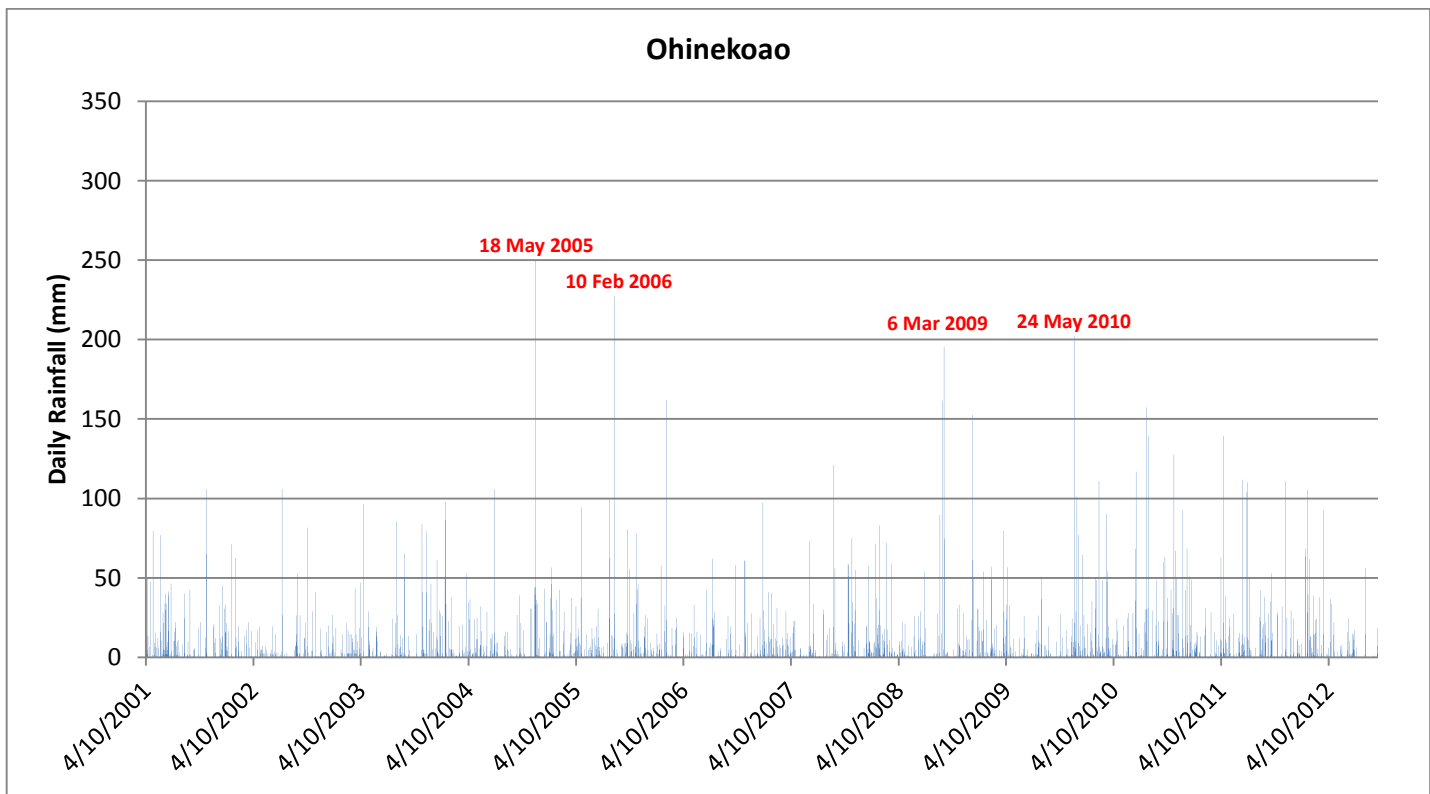
Figure 9.2: Daily rainfall records for raingauge No. 769701 "Tarawera" at Awakaponga and No. 769705 "Ohinekoao" at Harris Saddle, Herepuru Road. Dates of major rainfall events are indicated
