Whakatāne District Council

Quantitative Landslide and Debris
Flow Hazard Assessment
Matatā Escarpment

November 2013

T&T Ref: 29115

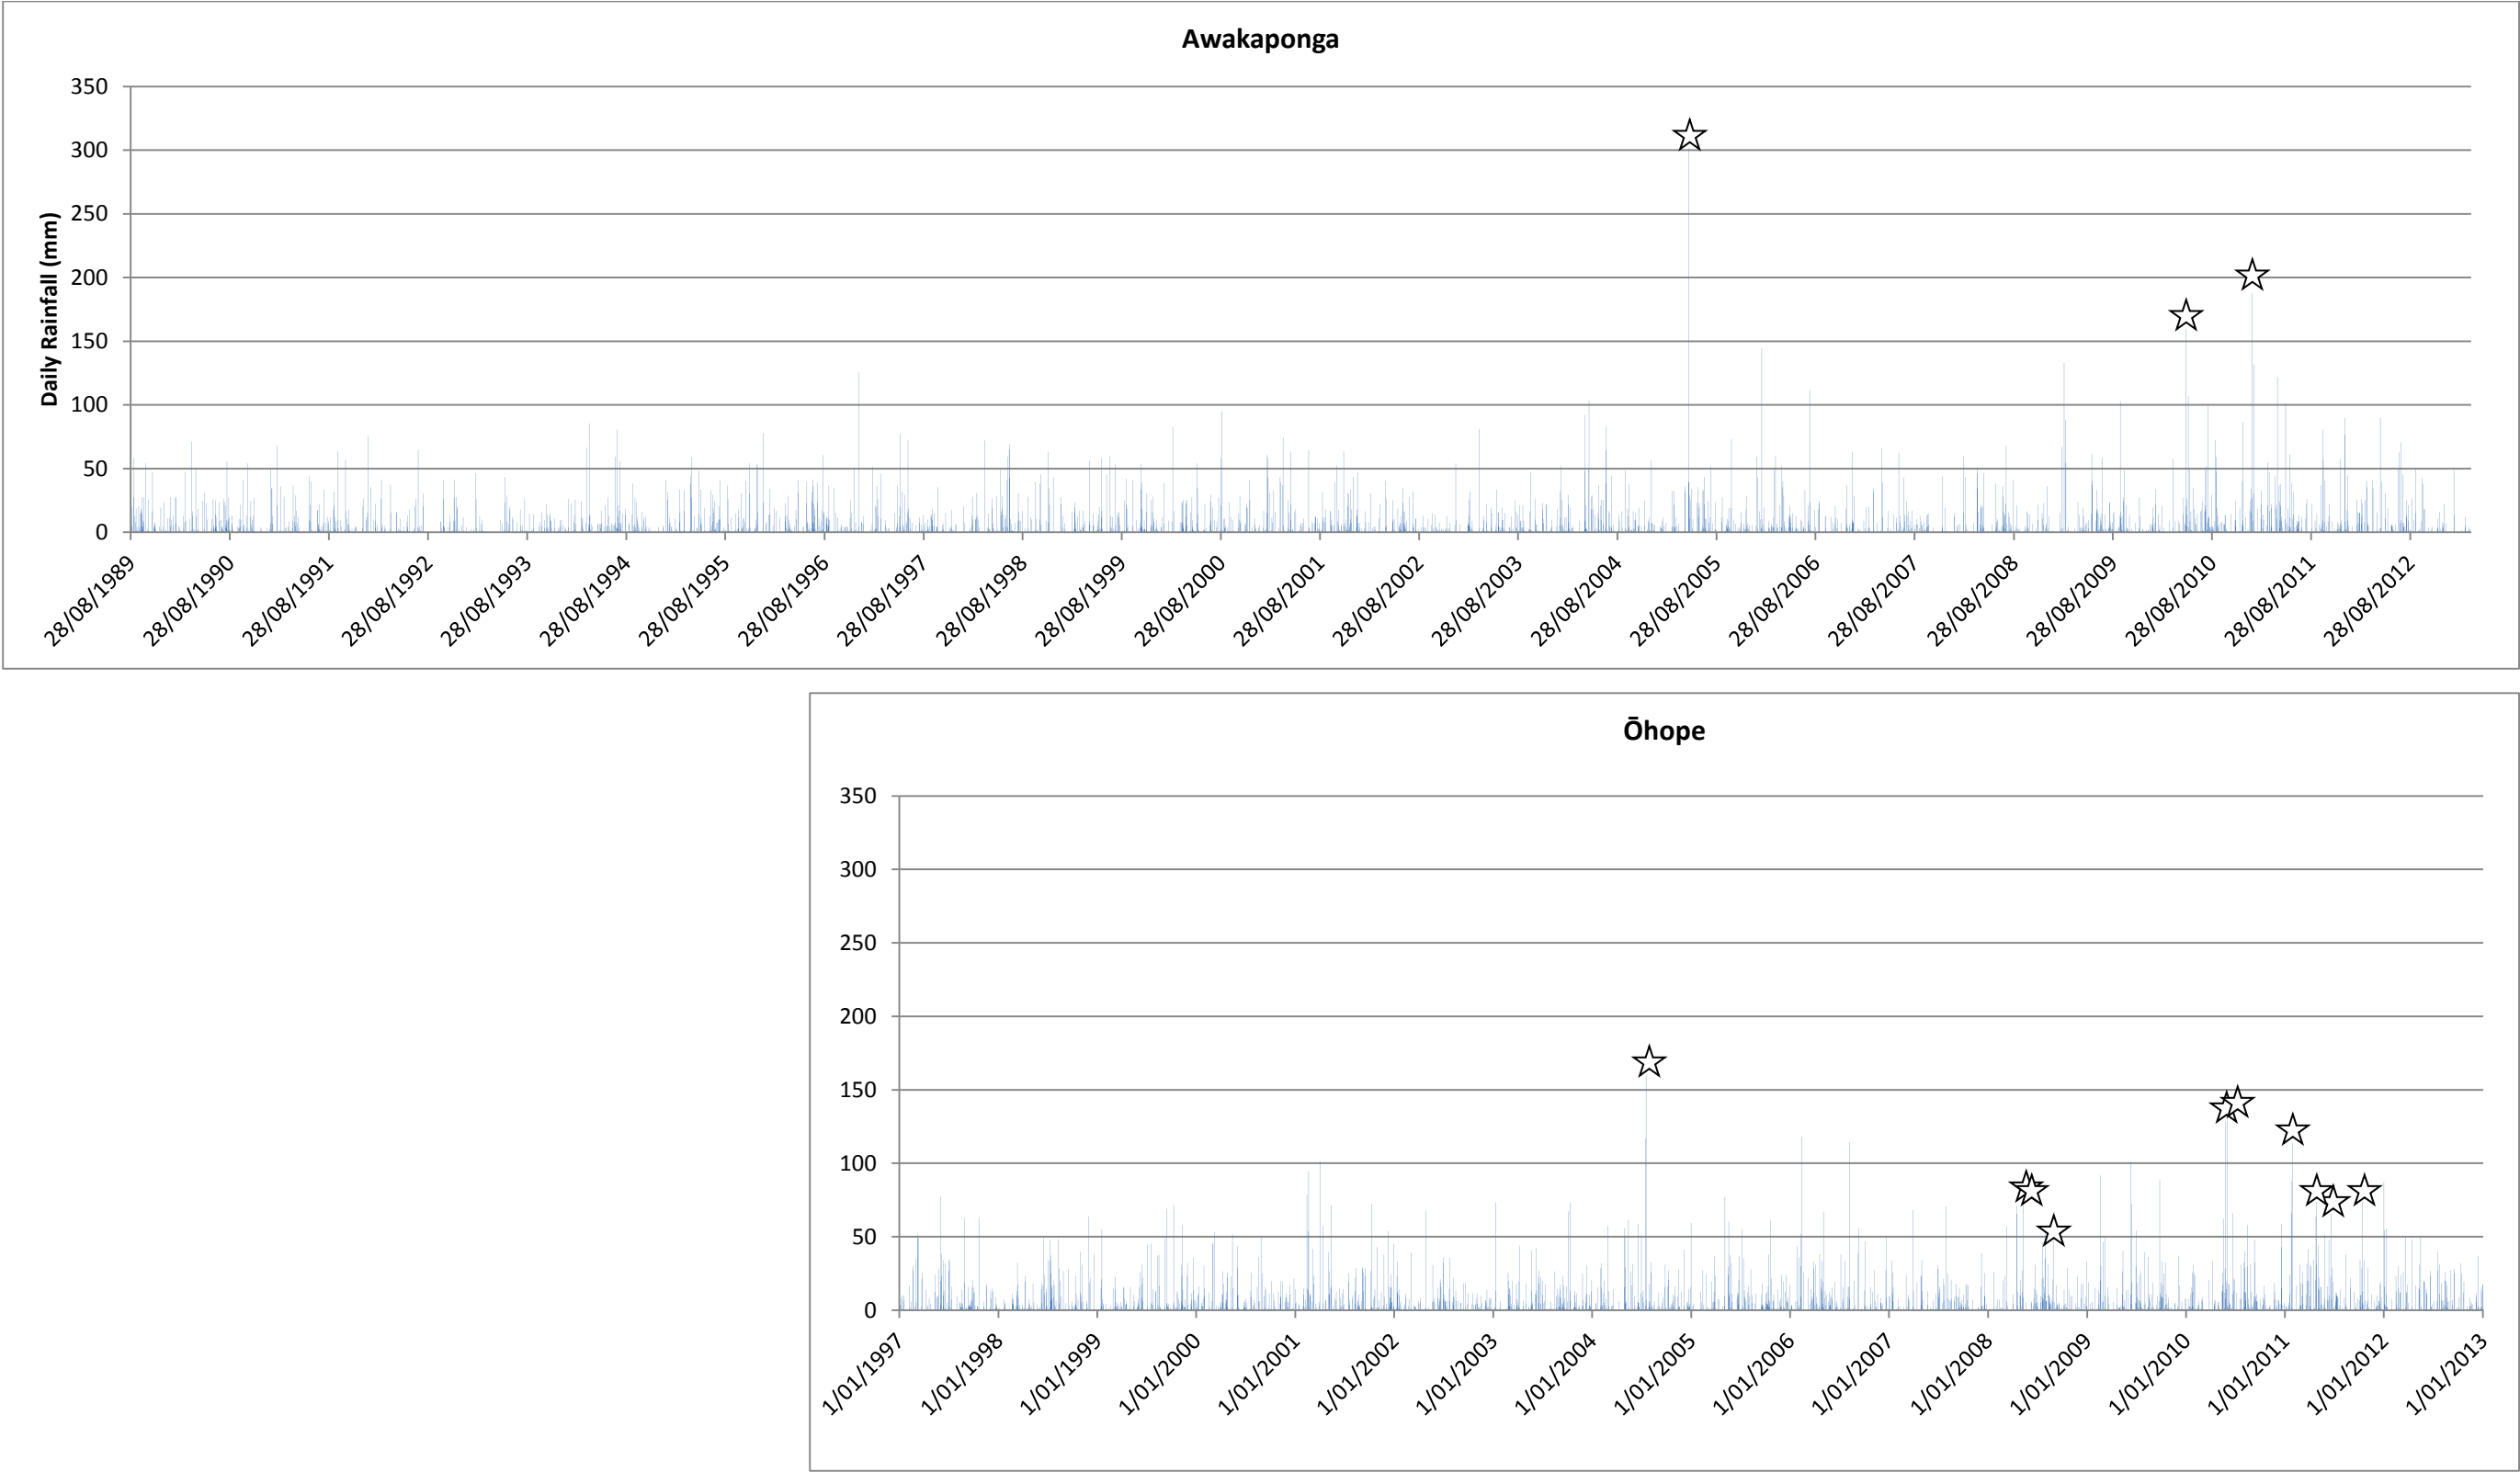
Figure 9.3: Daily rainfall data for Awakaponga and Ōhope. Significant landslide events are indicated by a star.

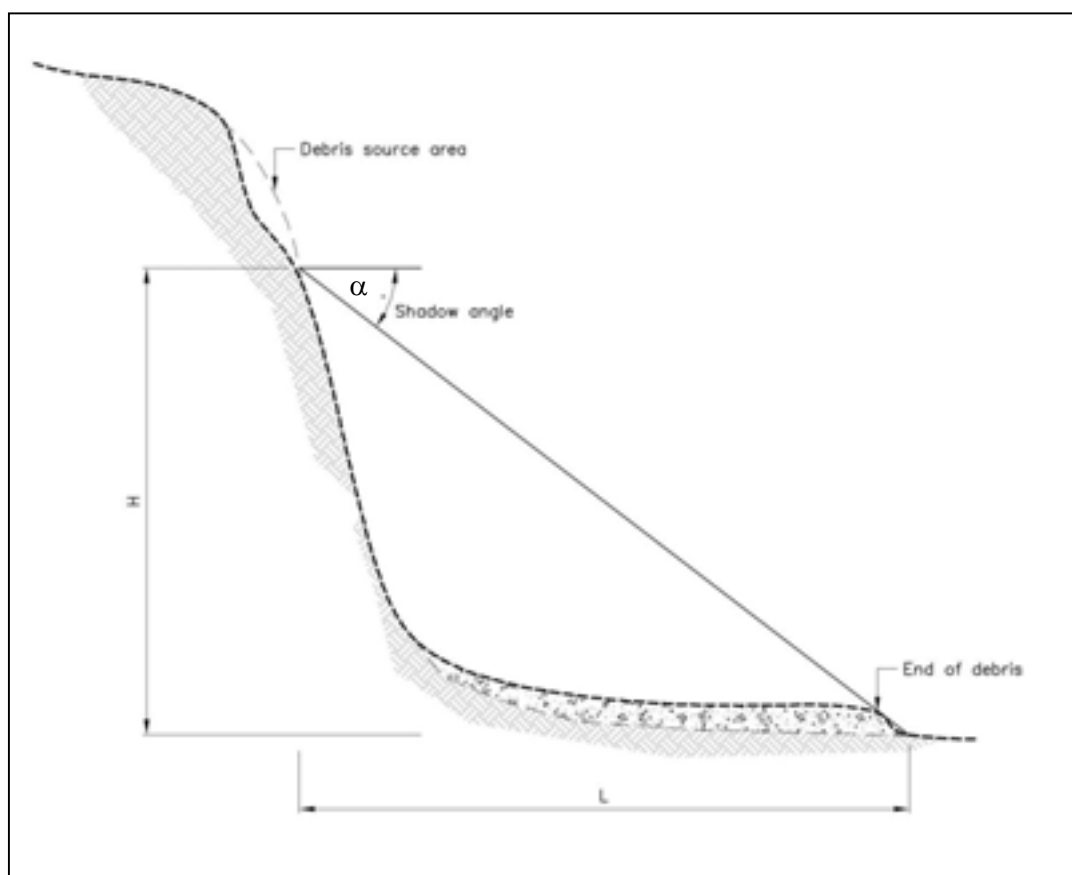
Figure 10.3: Debris travel distance expressed as an H/L ratio. The shadow angle is equivalent to the α angle of Hunter and Fell (2003)

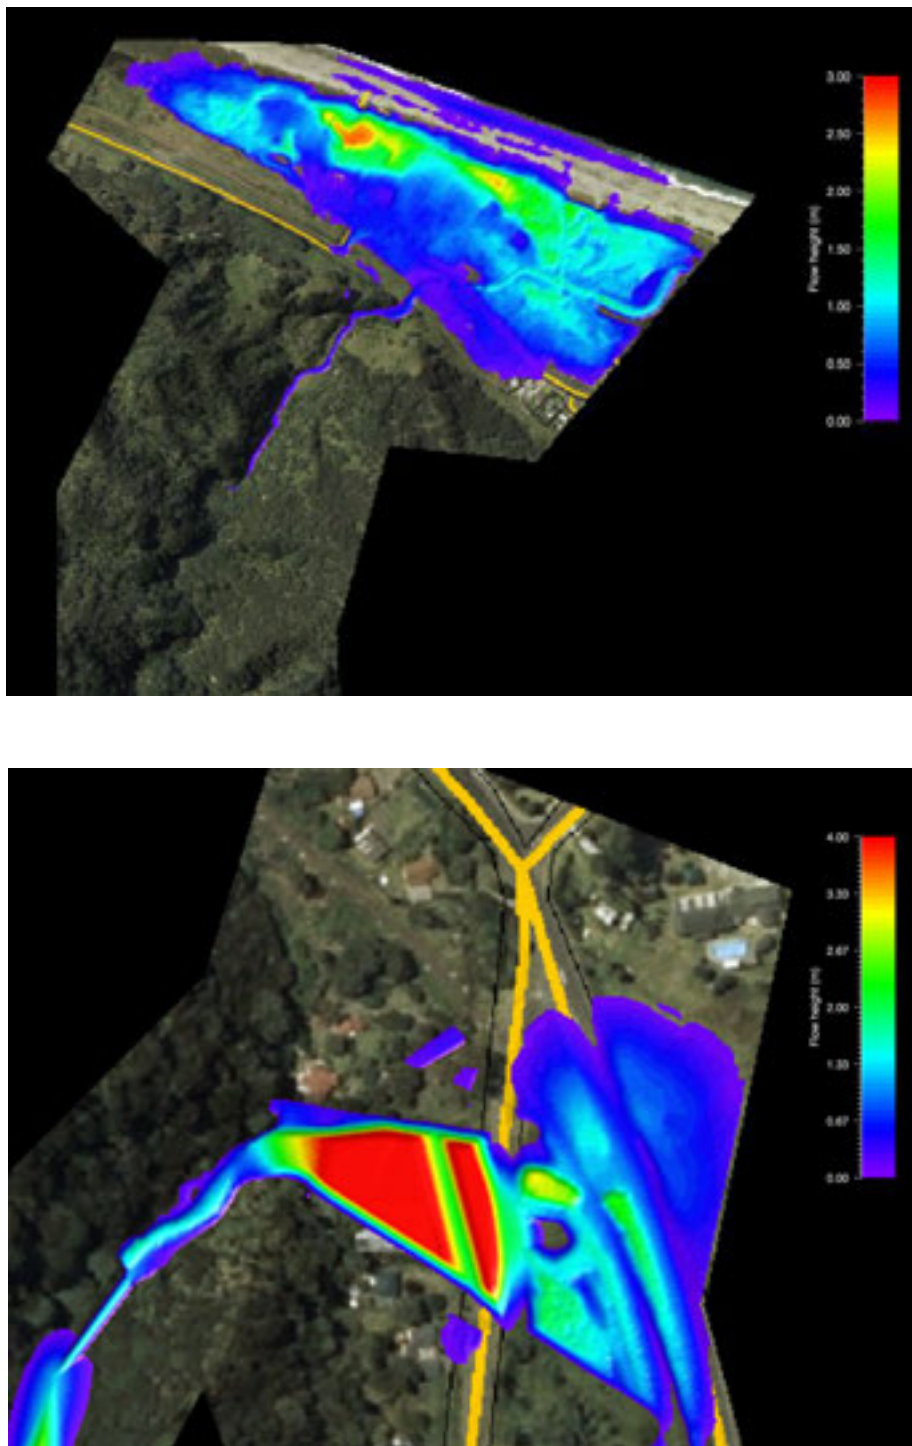
Figure 10.4: Example output from 2009 RAMMS debris flow simulation for the Awatarariki Stream (top) and Waitepuru Stream (bottom)

- Figure 10.4: Example output from 2009 RAMMS debris flow simulation for the Awatarariki Stream (left) and Waitepuru Stream (right)
- Figure 11.1: Comparison of Individual Fatality Risk for Different Hazards in New Zealand

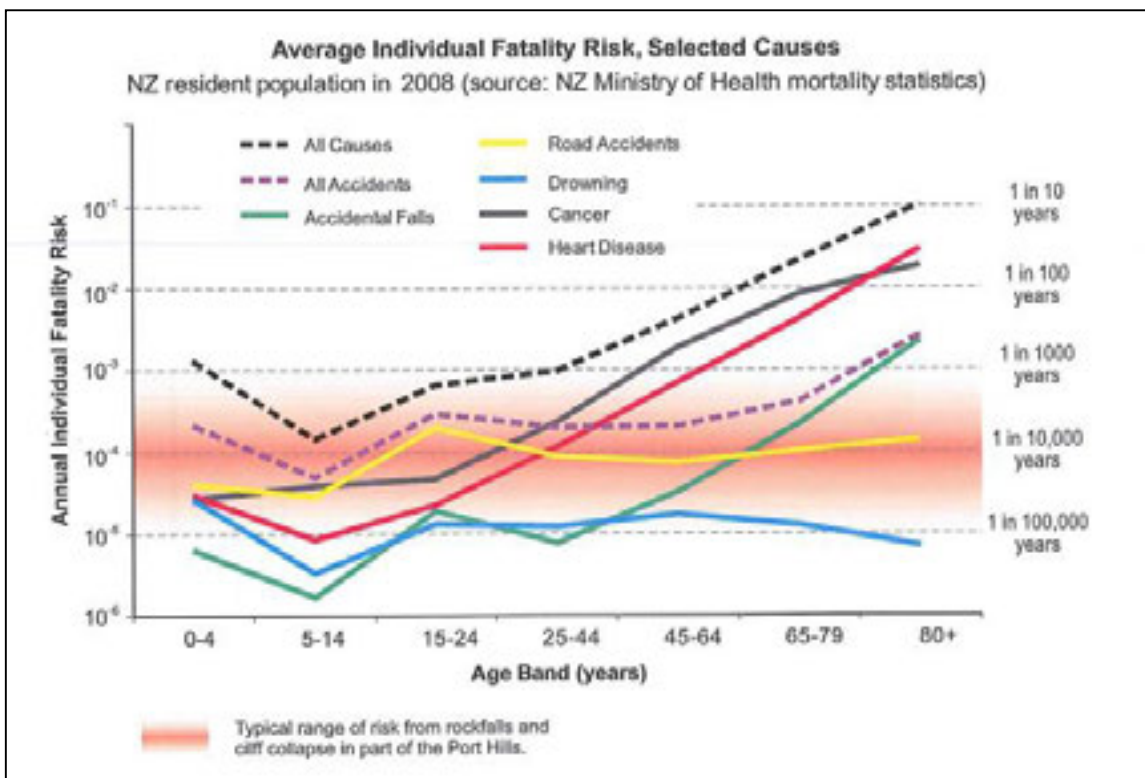
Figure 11.1: Comparison of Individual Fatality Risk for Different Hazards in New Zealand (Source: GNS, 2012)

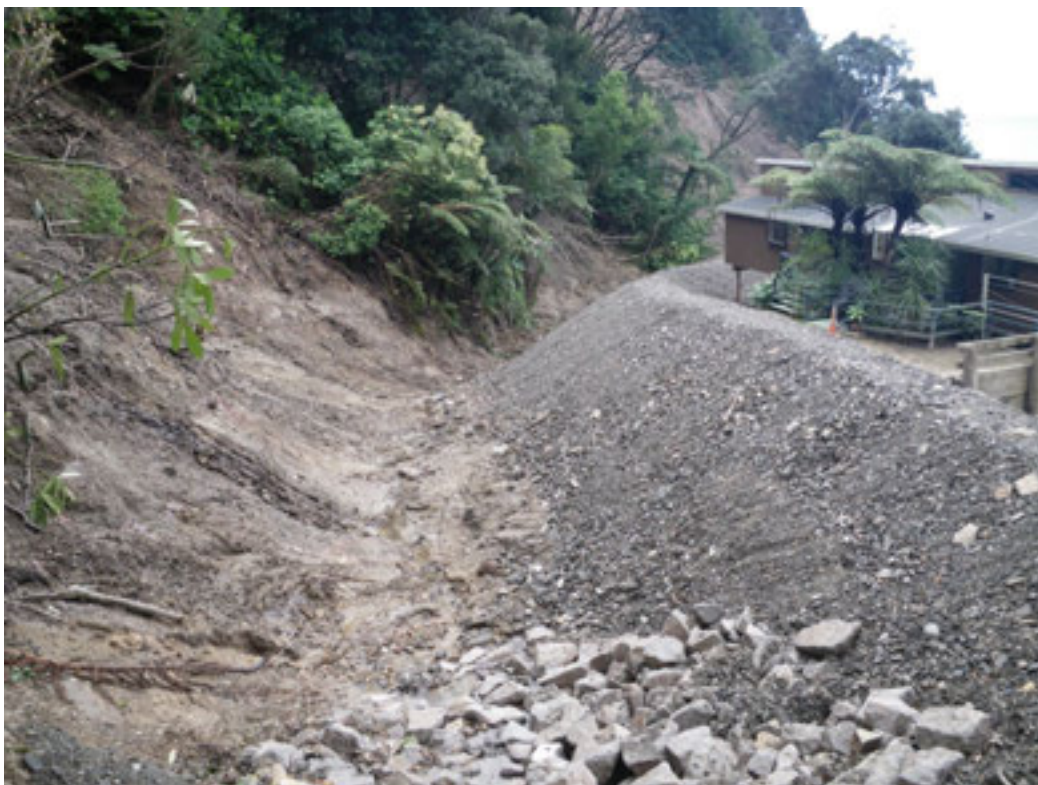
Figure 12.1: Earth bund constructed behind 71/71a West End Road, Ōhope

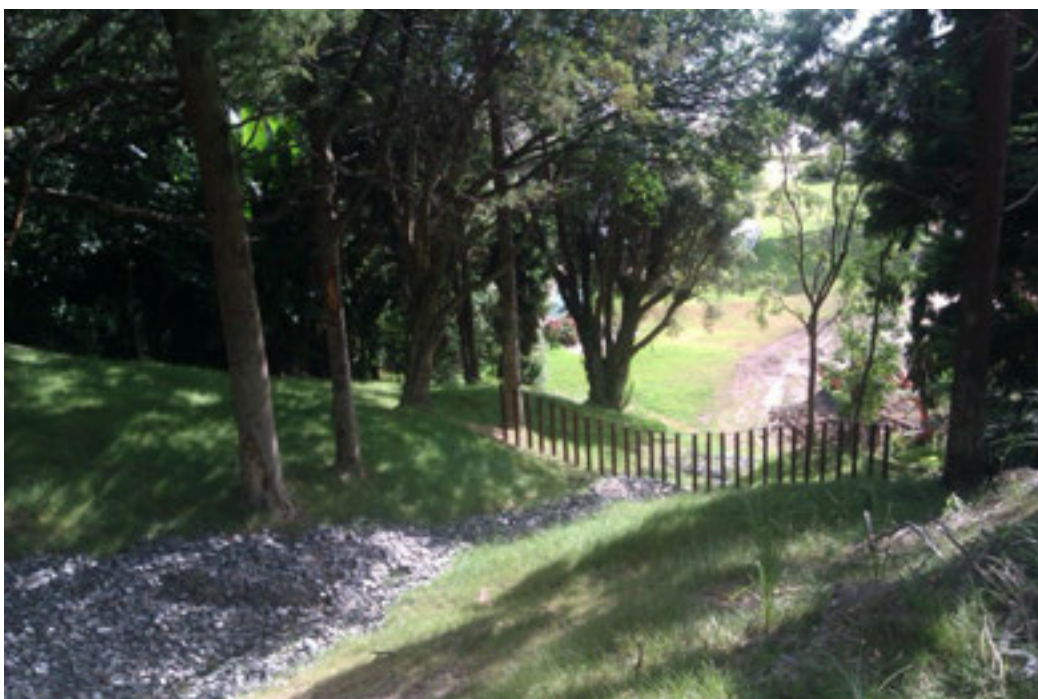
Figure 12.2: Line of steel posts providing protection across a potential landslide path, West End Road, Ōhope

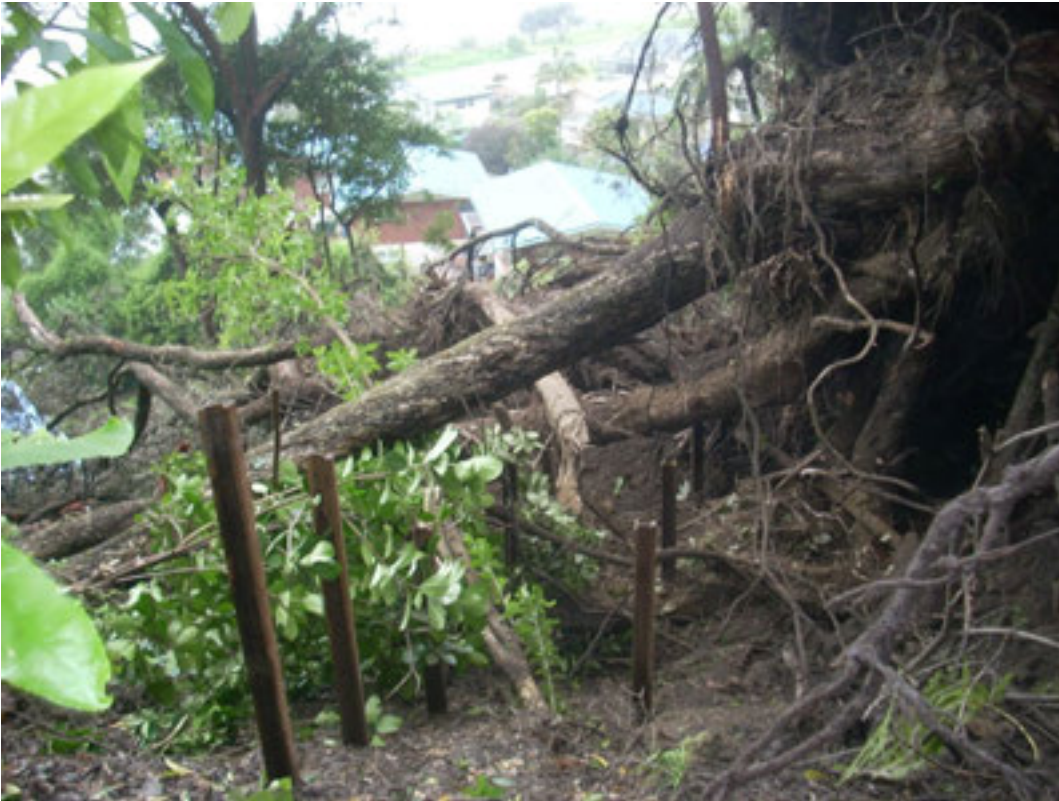
Figure 12.3: Informal line of iron posts which successfully prevented several large trees from impacting a rear dwelling on West End Road, Ōhope

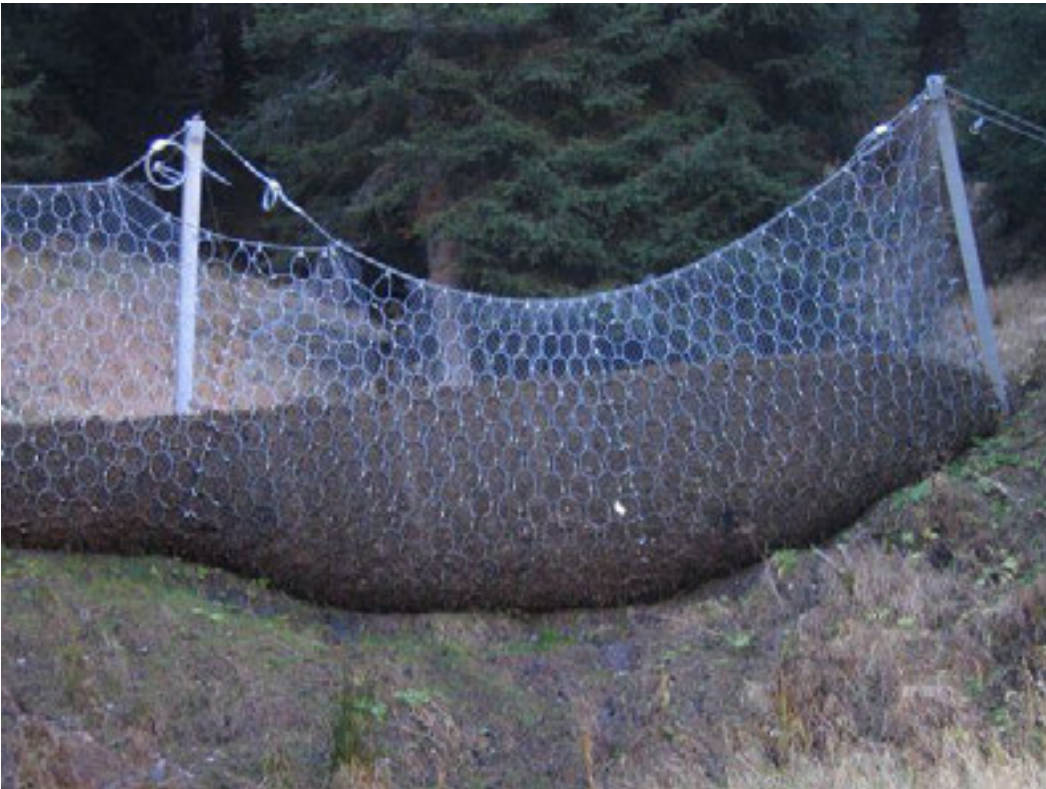
Figure 12.4: Example of flexible ring-net barrier

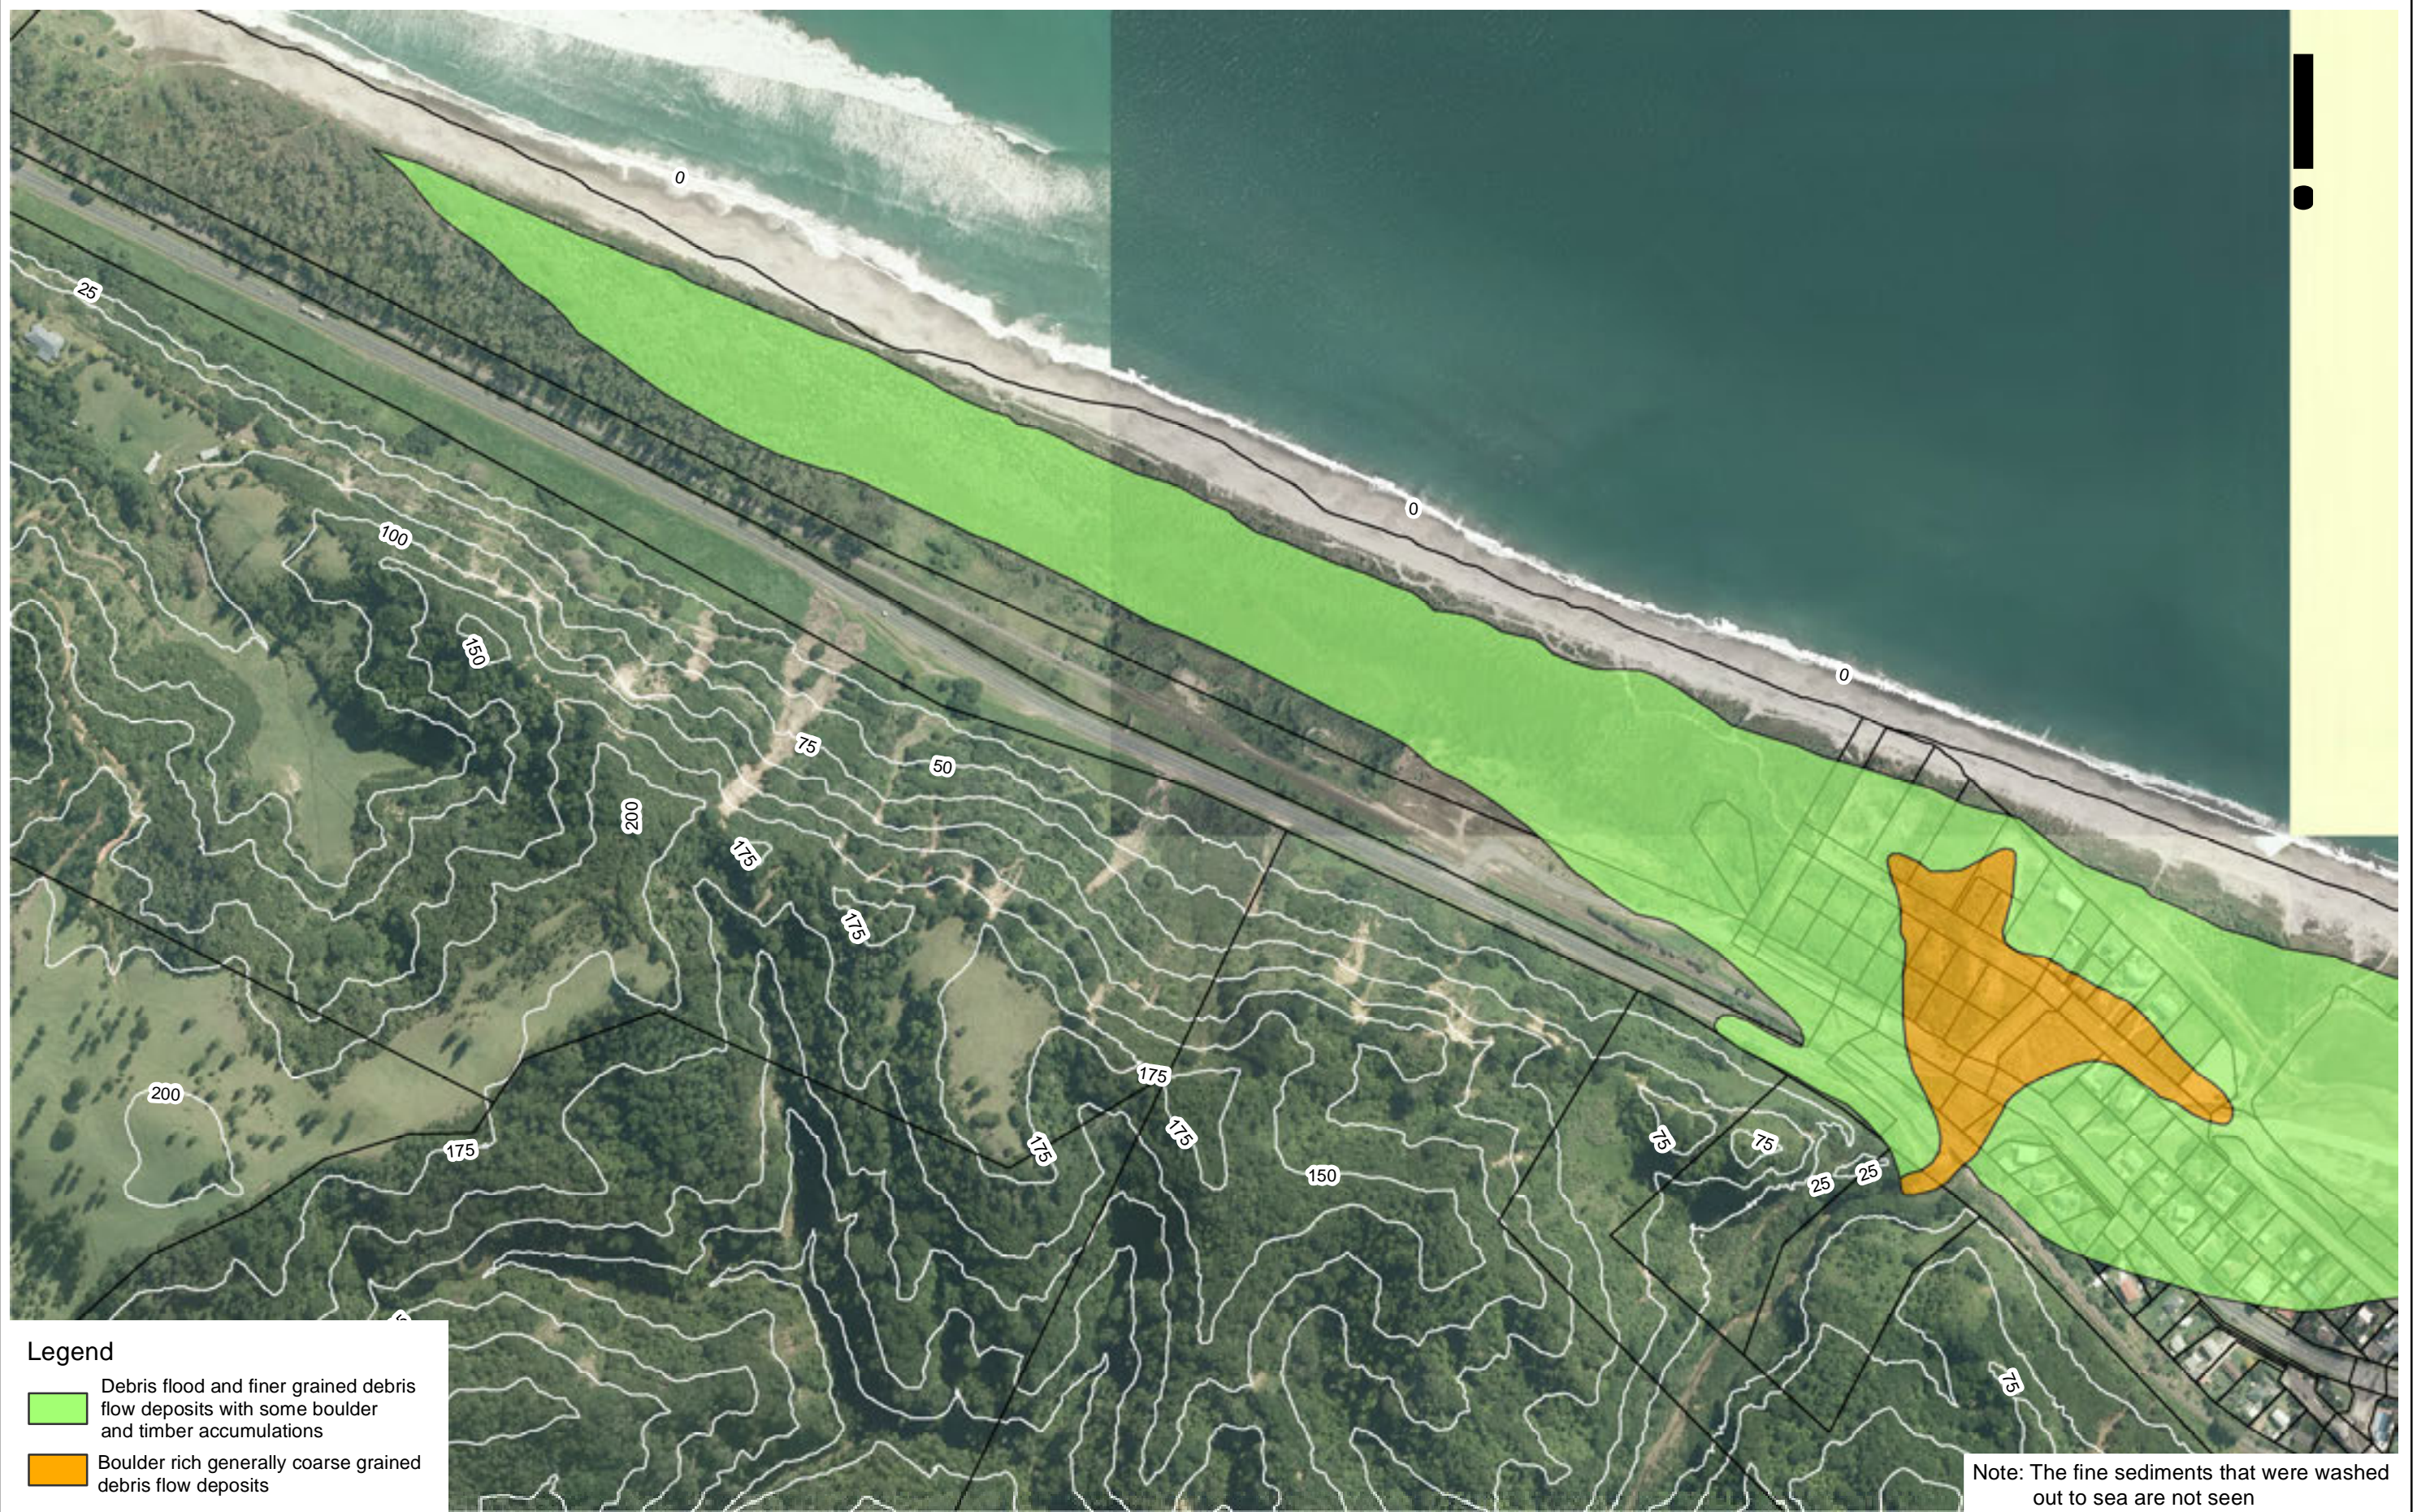
- Legend**
- Debris flood and finer grained debris flow deposits with some boulder and timber accumulations
 - Boulder rich generally coarse grained debris flow deposits

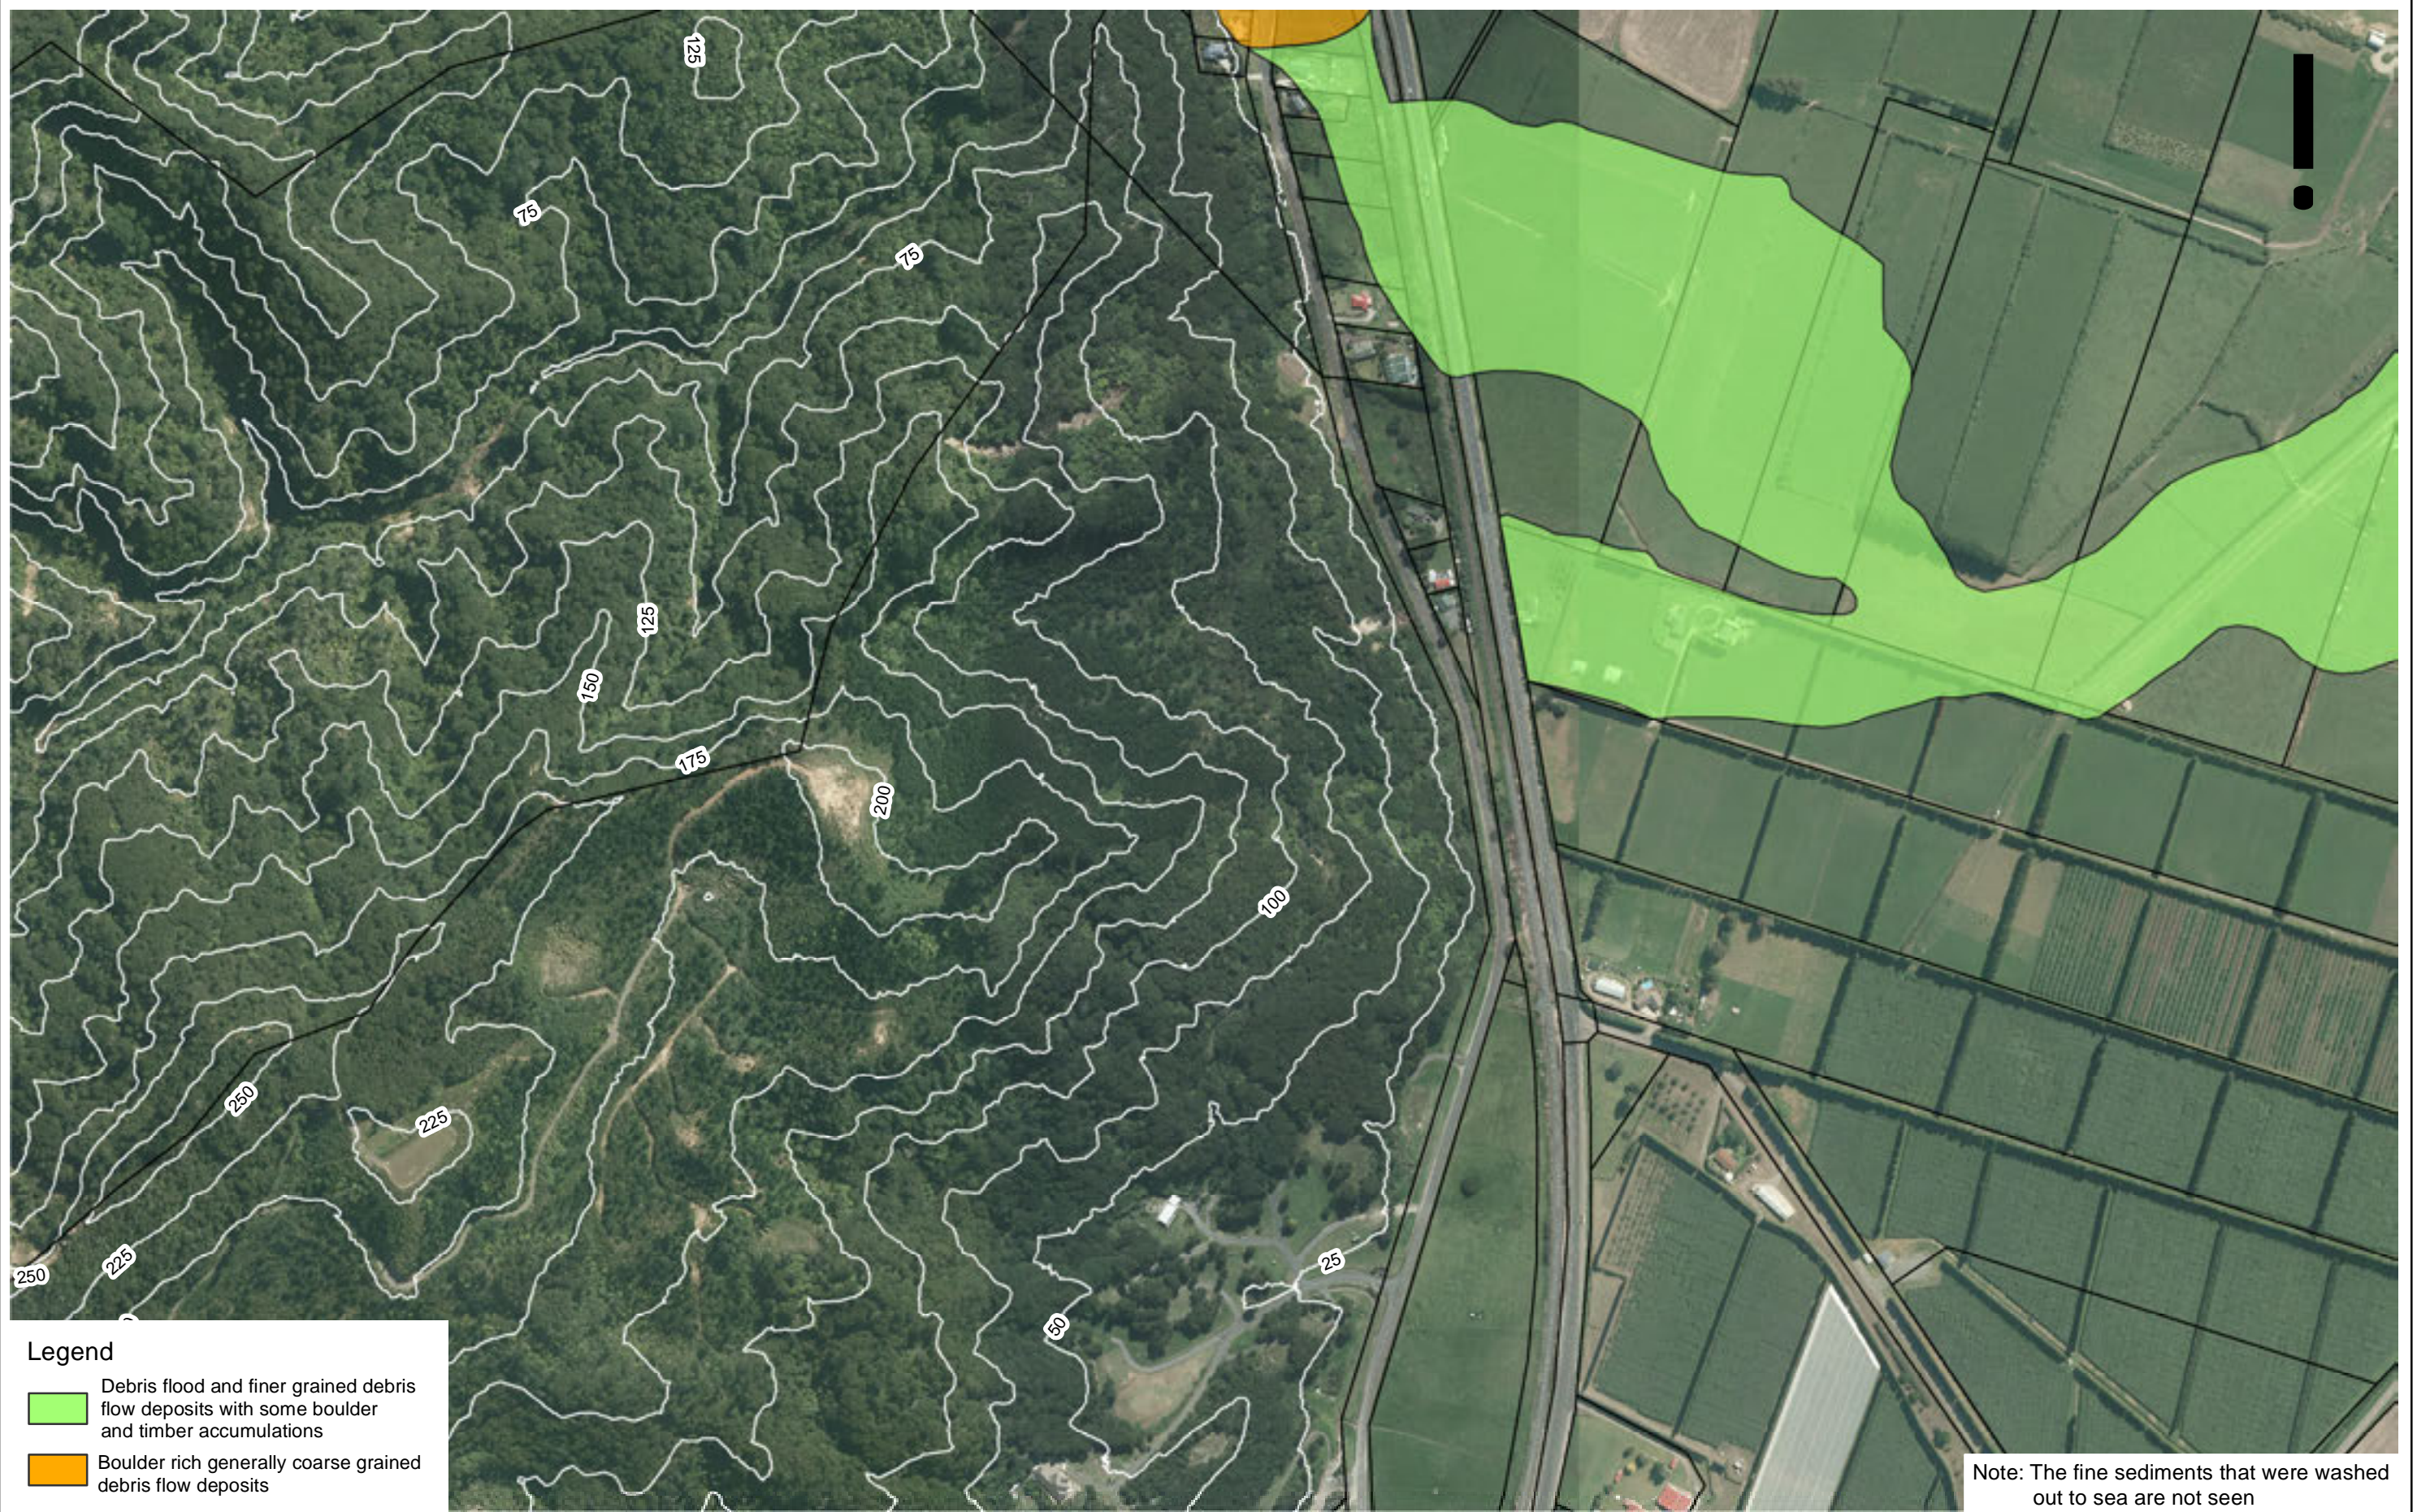
- Legend**
- Debris flood and finer grained debris flow deposits with some boulder and timber accumulations
 - Boulder rich generally coarse grained debris flow deposits

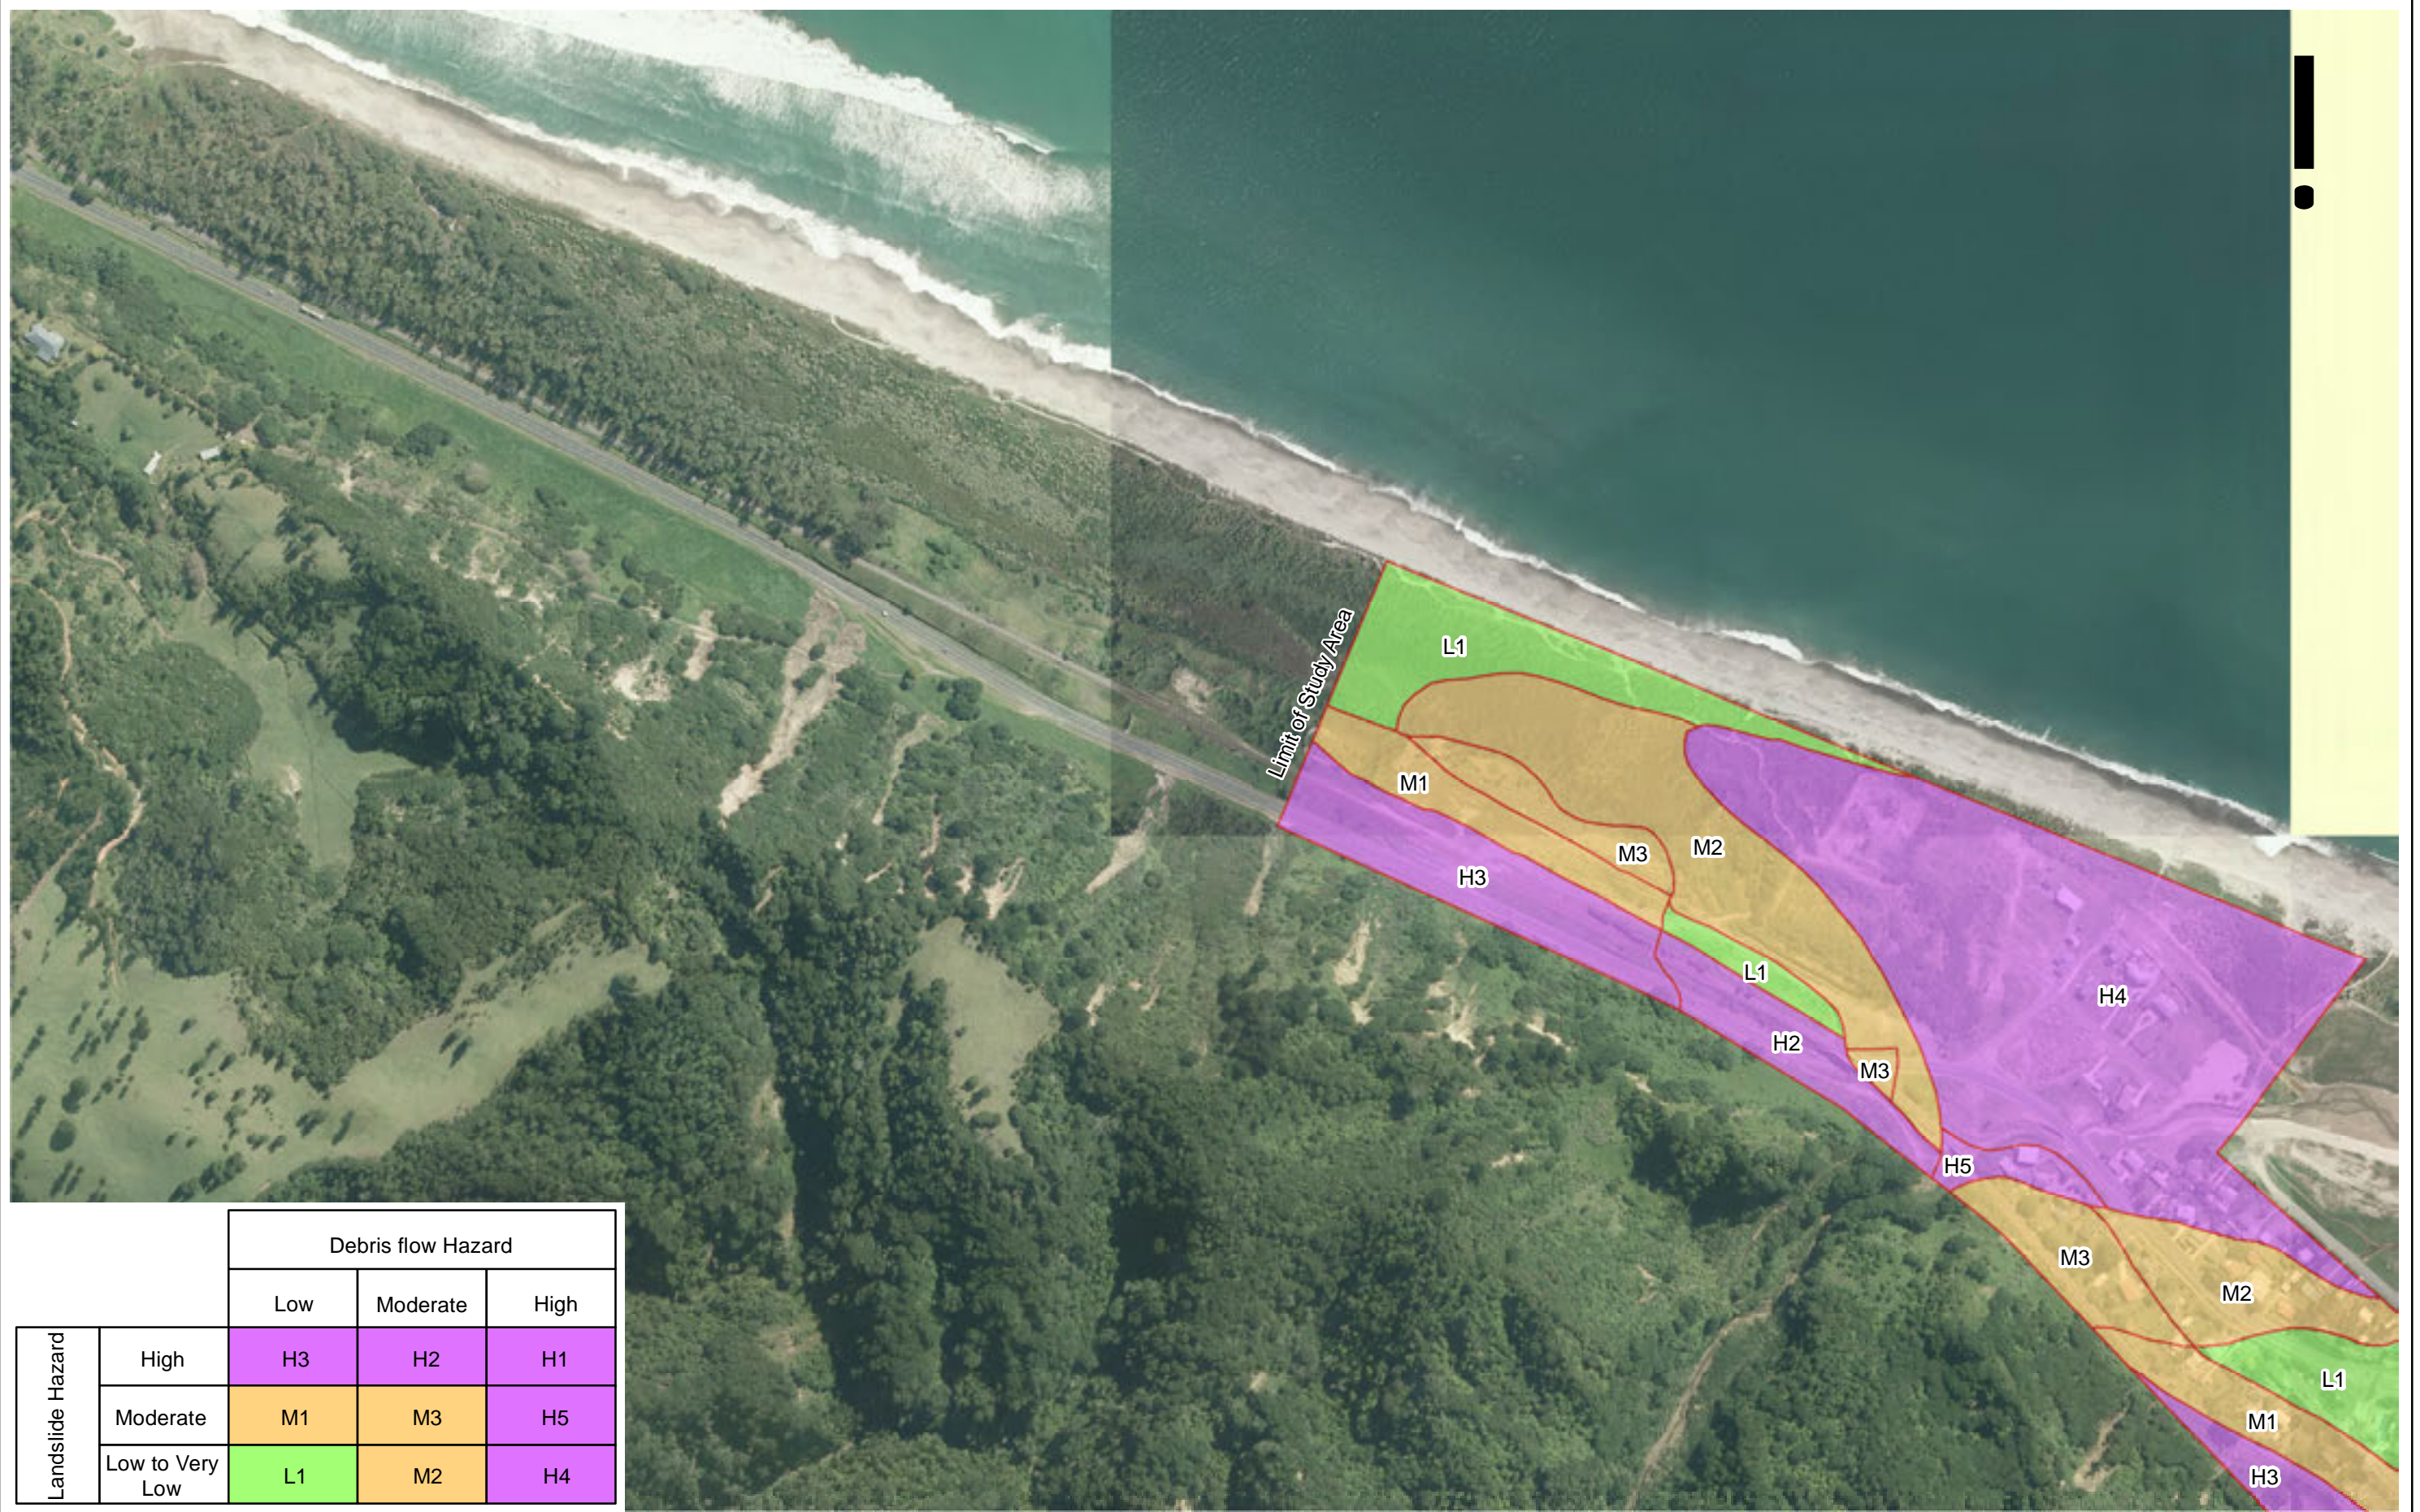
Debris flow Hazard		
		Low	Moderate	High
Landslide Hazard	High	H3	H2	H1
	Moderate	M1	M3	H5
	Low to Very Low	L1	M2	H4

The combined hazard map has been developed from a consideration of how the landslide and debris flow inundation hazards overlap. Any particular area will have a specific combination of landslide hazard (high, moderate, low to very low) and debris flow hazard (high, moderate, low). A hazard matrix, presented at Table 10.6, is used to define each of the combined hazard zones shown on the maps in Appendix G. Areas outside of the mapped hazard zones are assigned a “no credible hazard” rating.
