Whakatāne District Council

Quantitative Landslide and Debris
Flow Hazard Assessment
Matatā Escarpment

November 2013

T&T Ref: 29115

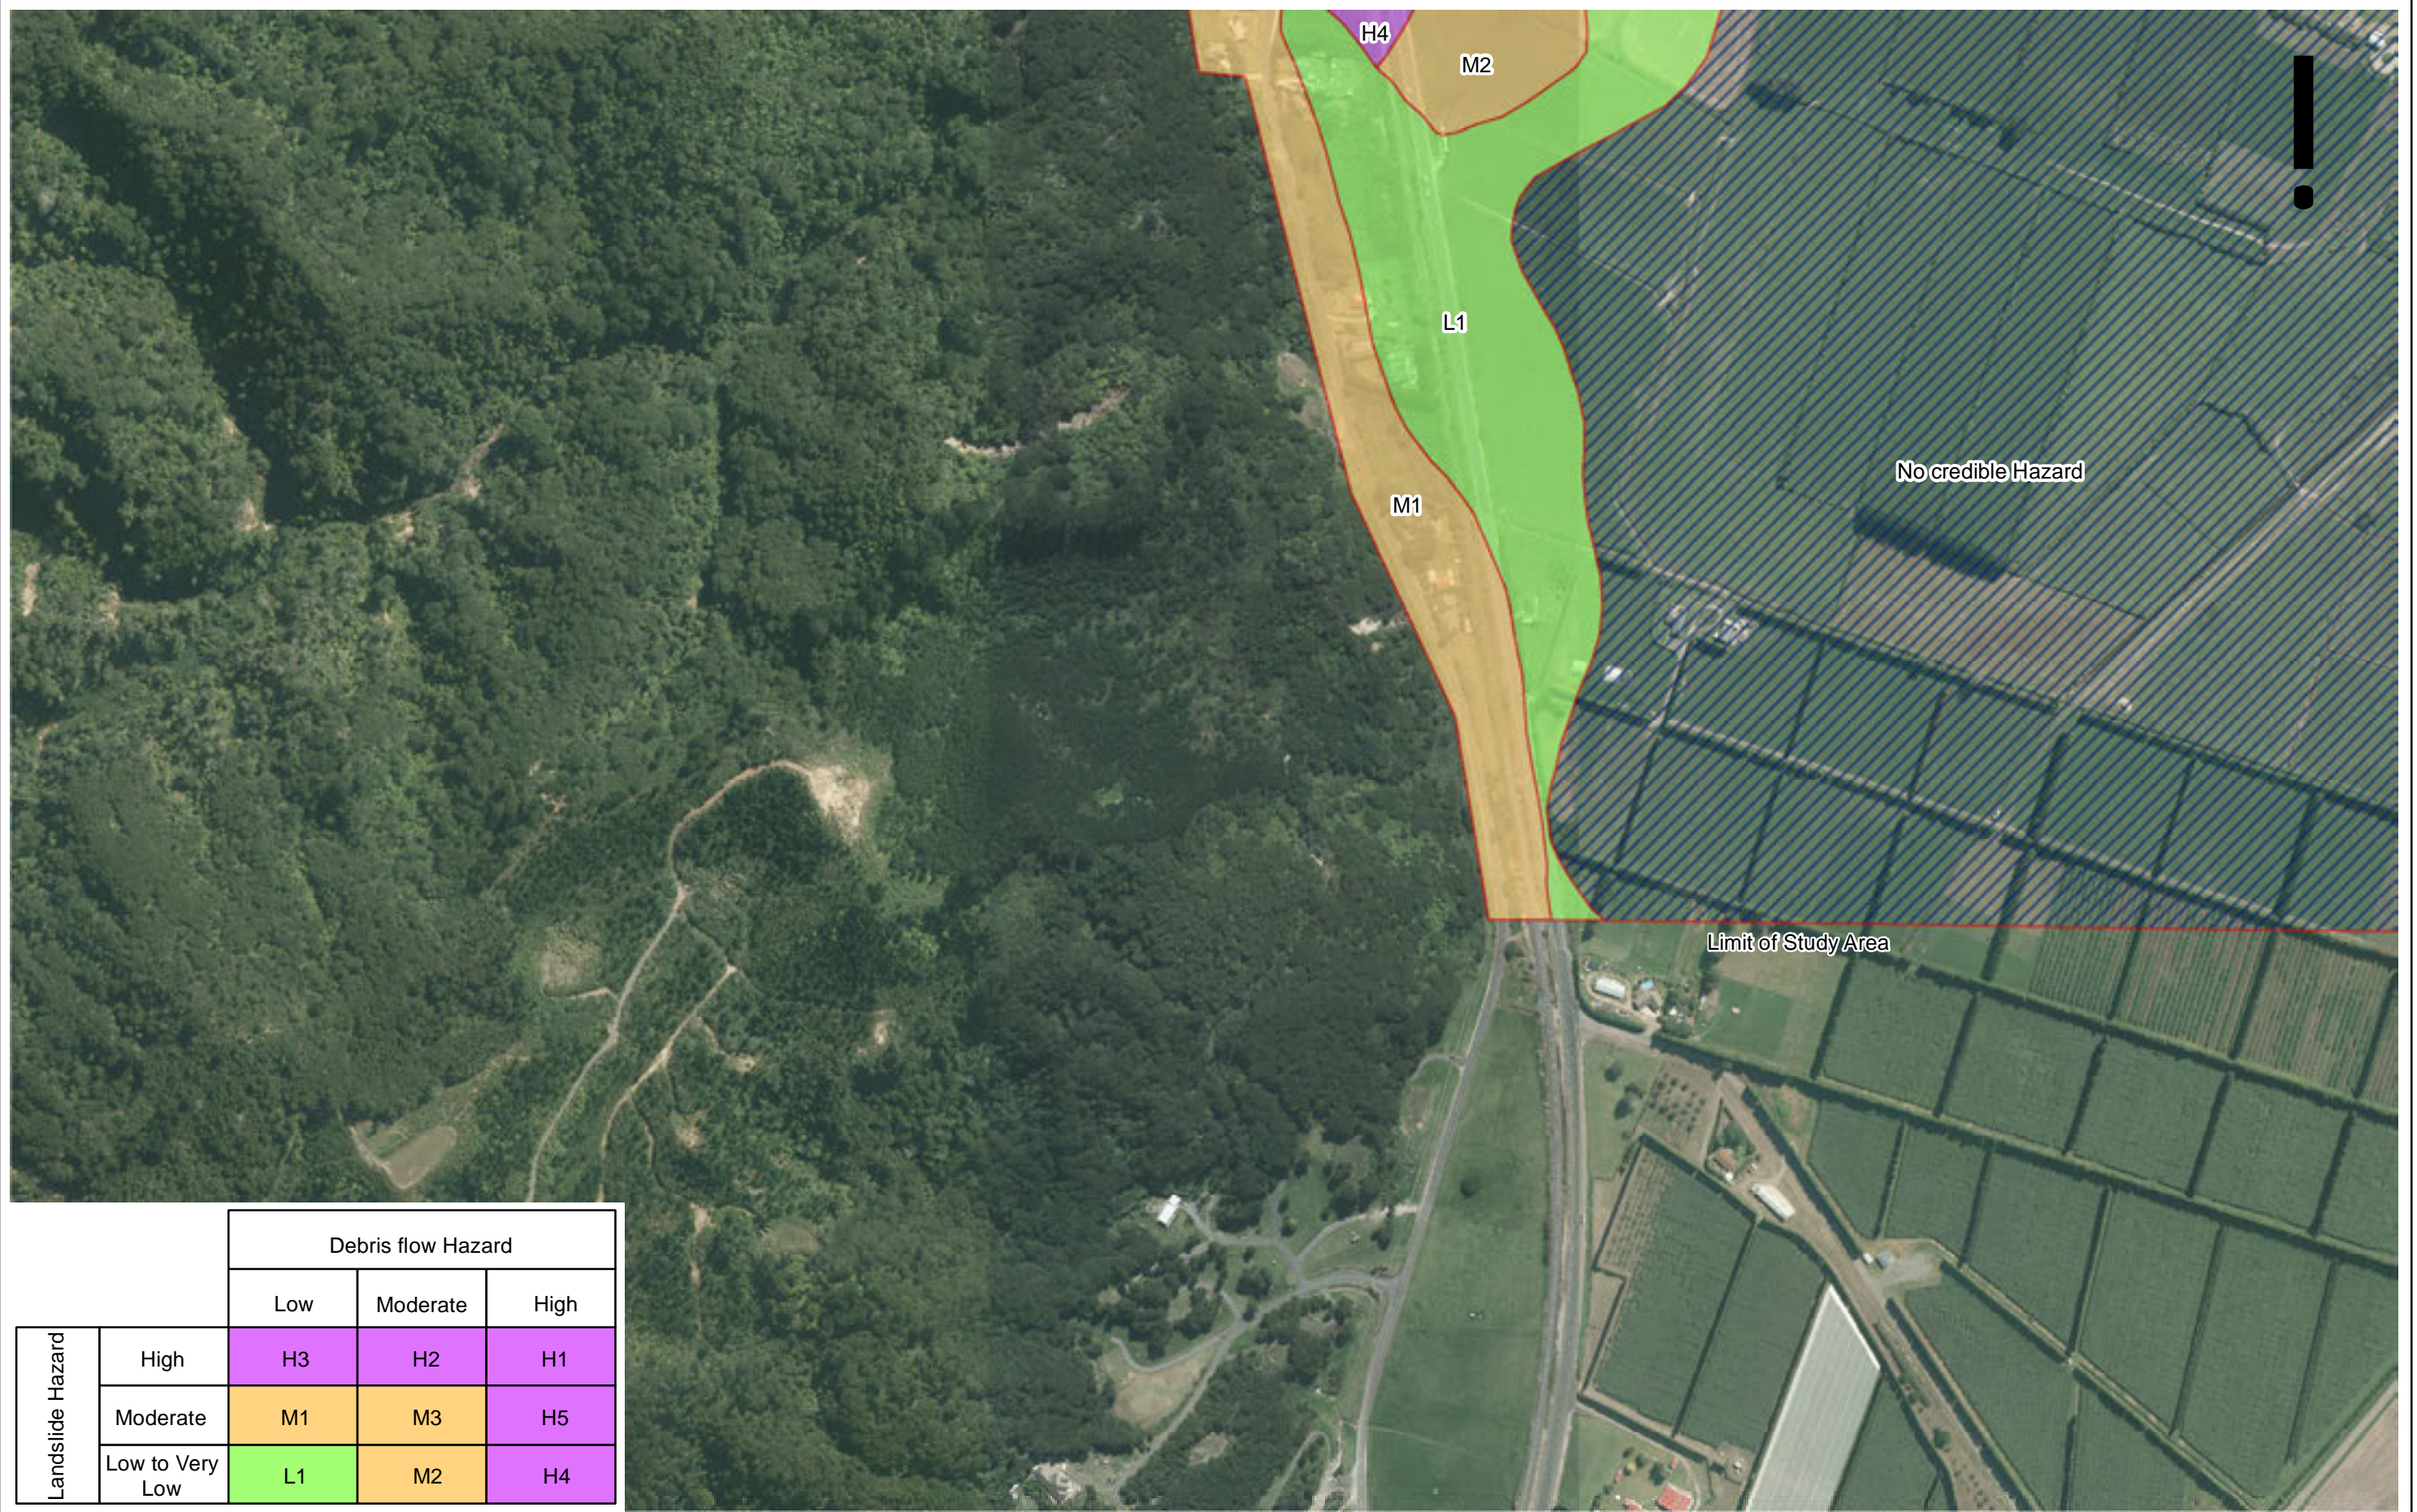
Debris flow Hazard		
		Low	Moderate	High
Landslide Hazard	High	H3	H2	H1
	Moderate	M1	M3	H5
	Low to Very Low	L1	M2	H4
