Whakatane District Council

Quantitative Landslide Risk
Assessment
Whakatane and Ohope Escarpments

Report prepared by:
Tonkin & Taylor Ltd

June 2013

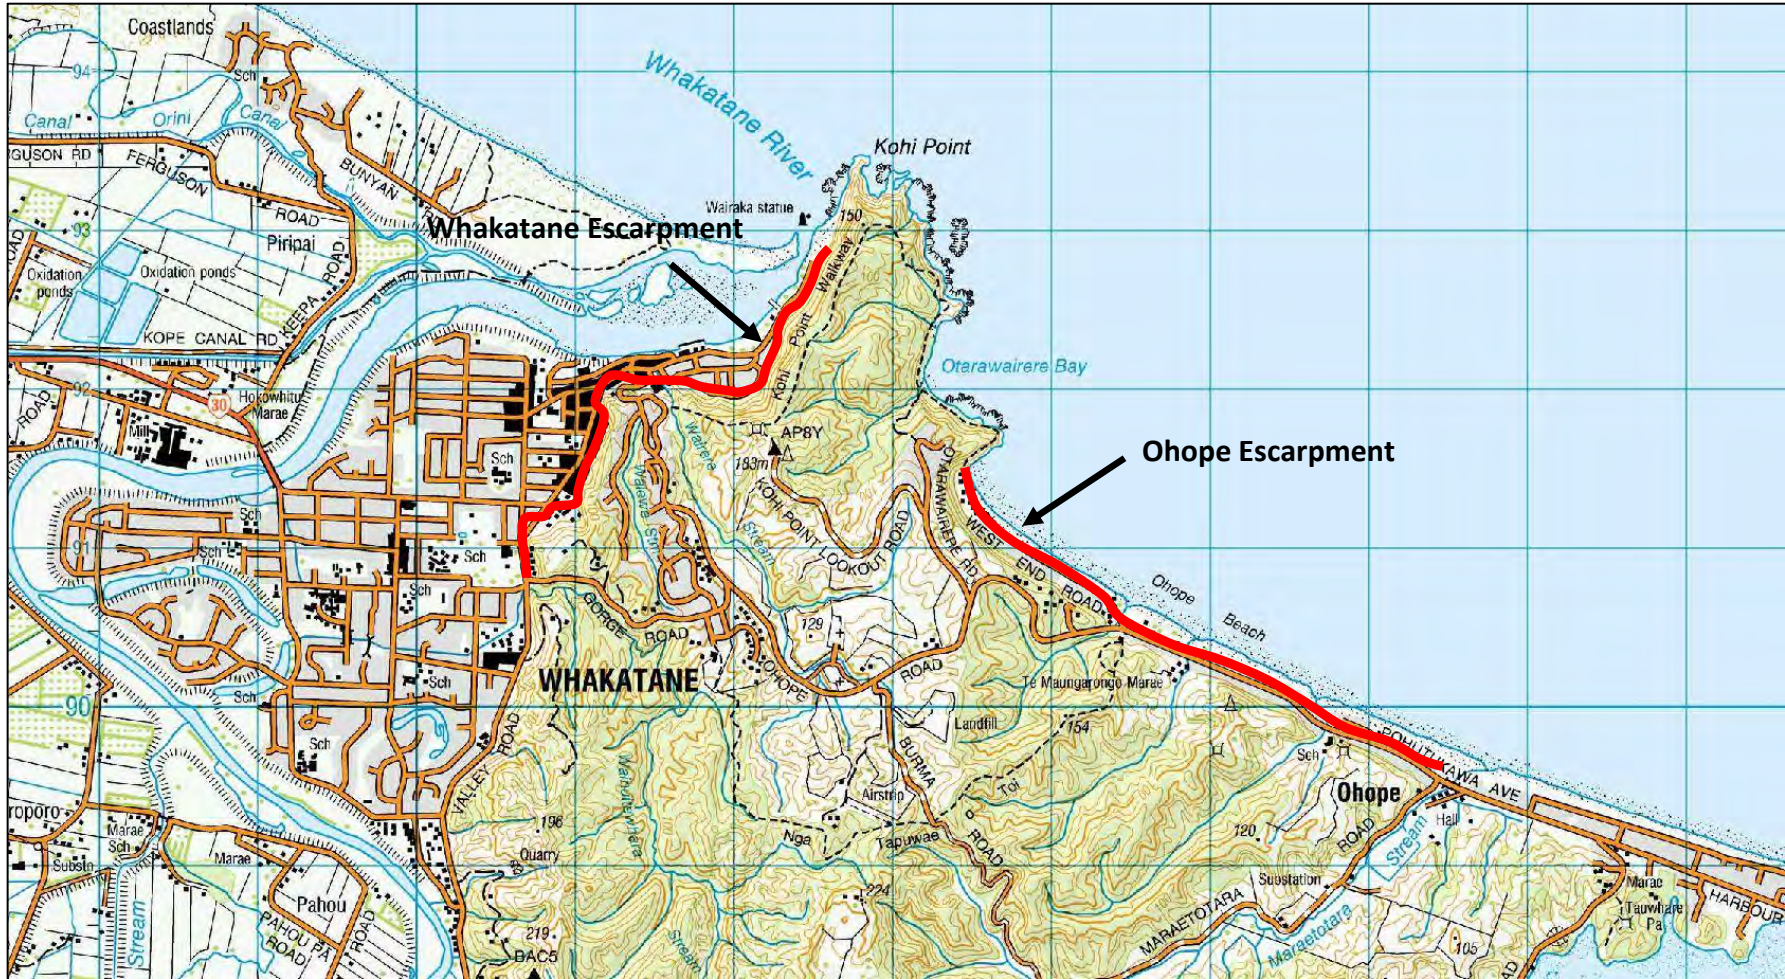
Figure 2.1: Location plan indicating the extent of the QLRA study.

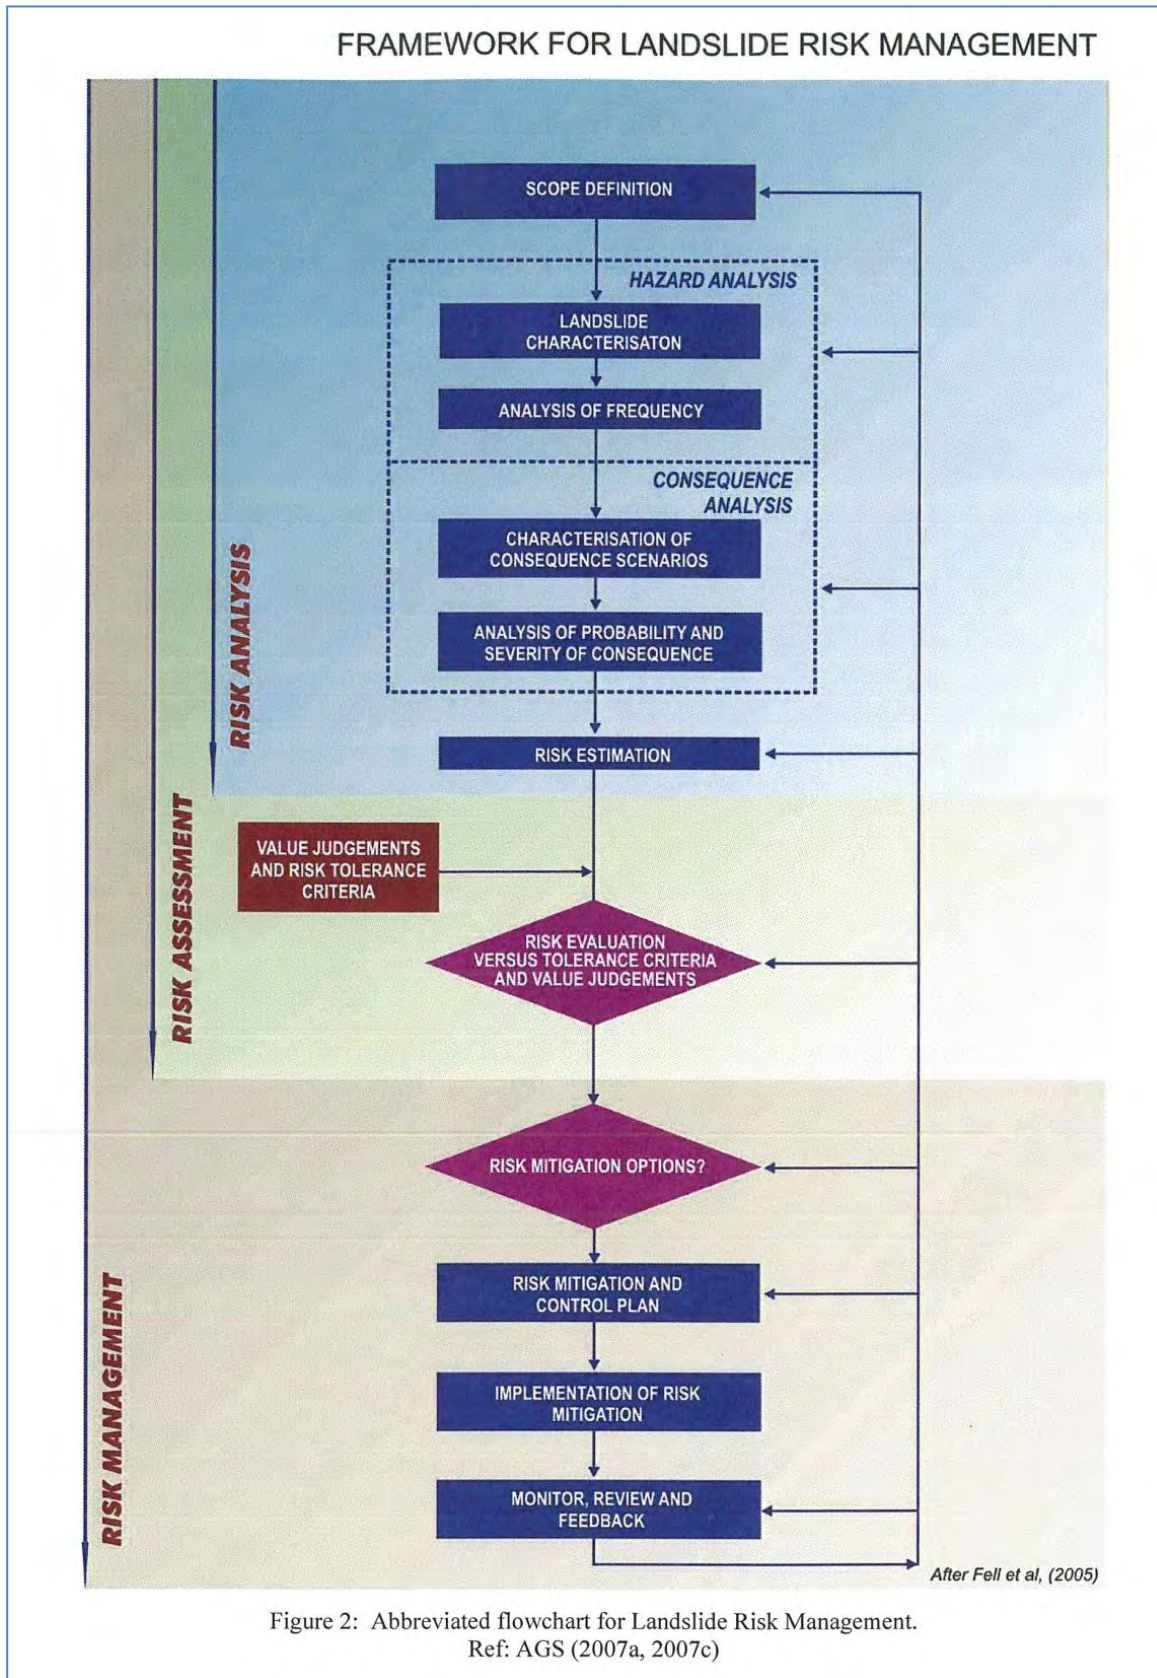
Figure 3.1: Landslide Risk Management Framework from AGS (2007).

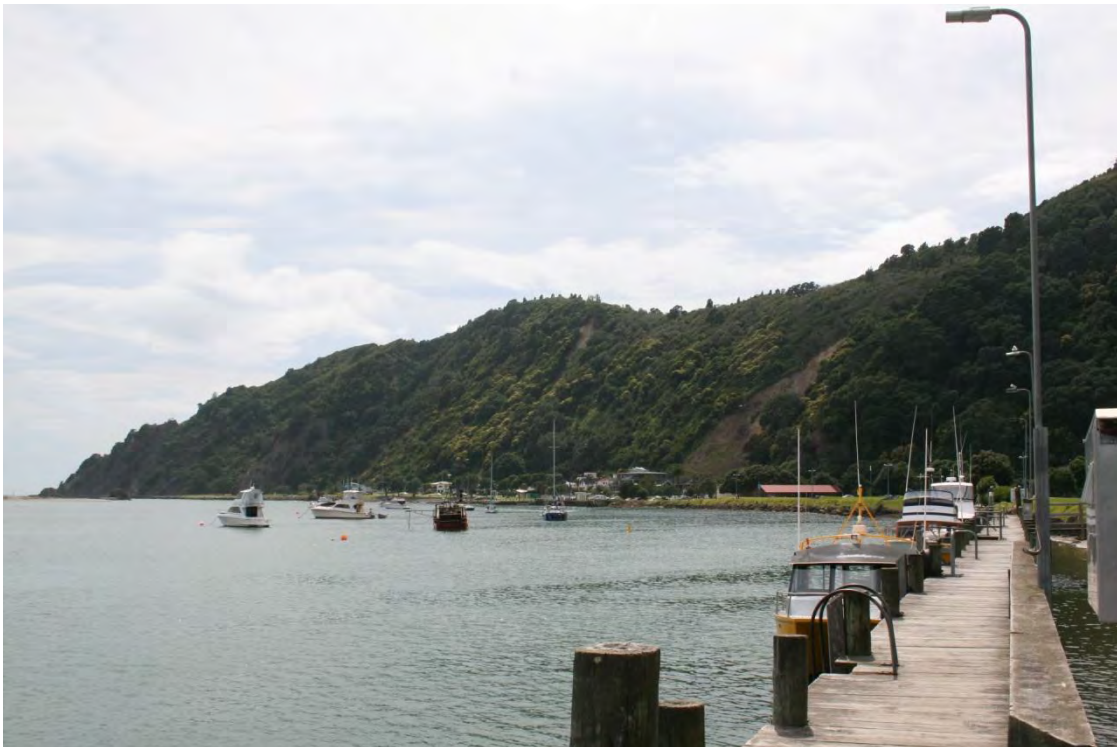
Figure 5.1: View of the Whakatane Escarpment from the junction of Muriwai Drive and the Strand, Whakatane.

The Whakatane Escarpment (Figure 5.1) represents the eastern limit of the Whakatane Graben, a regional-scale down-thrown tectonic block that has been partially infilled with a range of volcanic and marine sediments to form the Rangitikei Plains. The Whakatane Escarpment can be divided into two discrete parts. The northern section runs approximately parallel to the Whakatane River and Muriwai Drive. Here it is a steep linear feature rising from sea level to a single knife-edge ridge striking NNE-SSW (Figure 5.2). The ridge has an elevation of approximately RL160m.

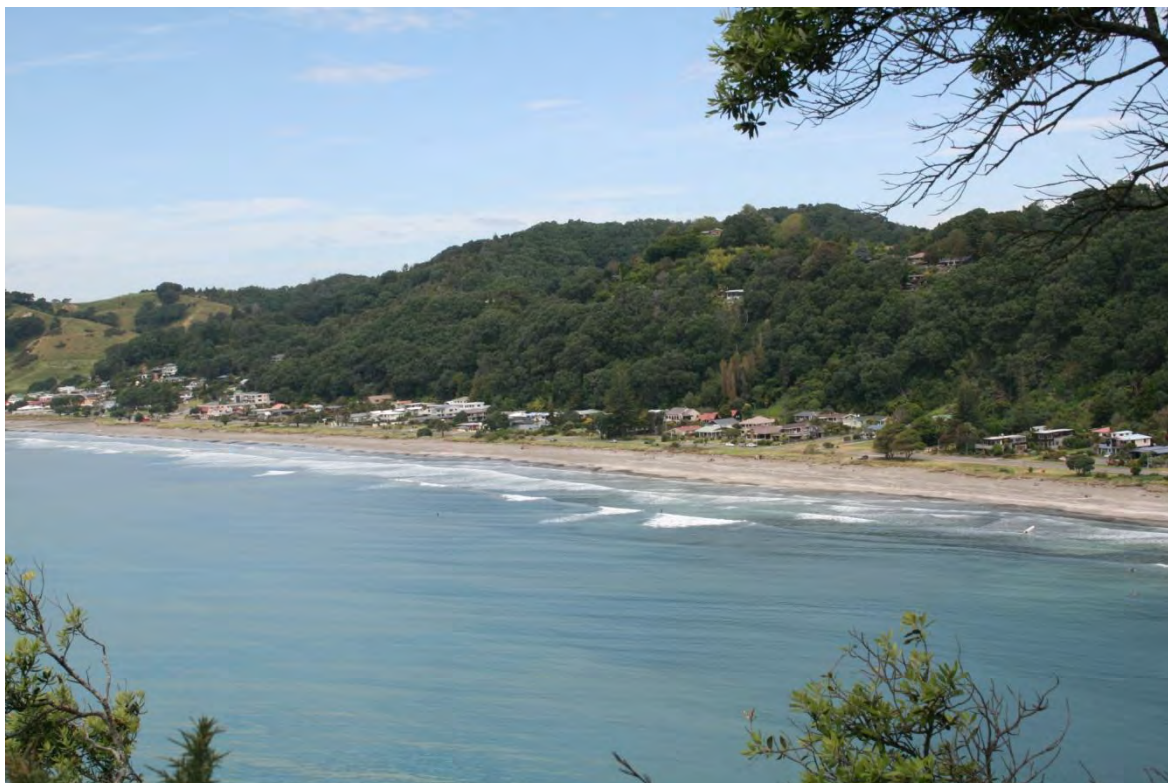
Figure 5.3: View of Ohope Beach and the Ohope Escarpment from the Otarawairere Bay track.

The Ohope Escarpment is a steep vegetated line of cliffs and steep slopes located between Ohope Beach and an upper dissected plateau (Figure 5.3). A discontinuous bench is apparent at an elevation of approximately RL70m (Figure 5.4). This bench is the location of the Cliff Road residential settlement and the Ngati Awa farm block.

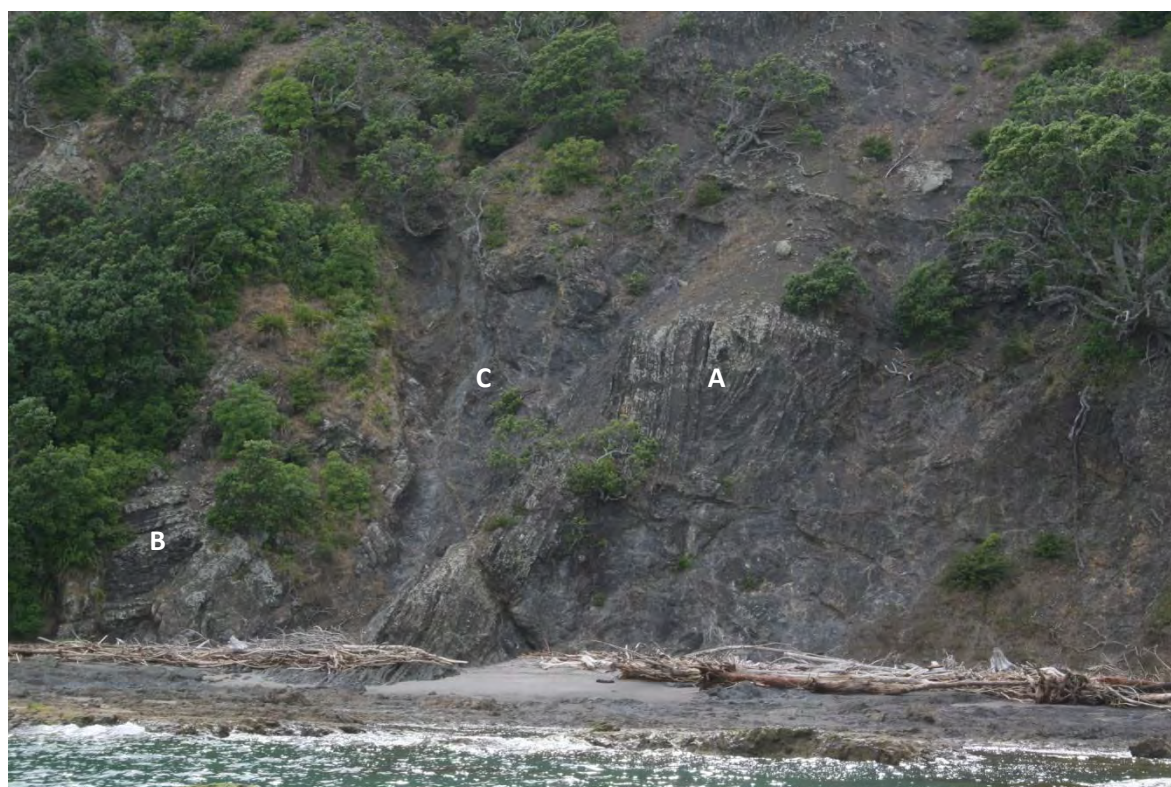
Figure 6.2: Whakatane Mélange exposed at the Whakatane Heads. Displaced but coherent blocks of steeply dipping (A) and flat dipping (B) bedded greywacke and argillite can be seen enclosed within an intensely deformed and sheared matrix (C).

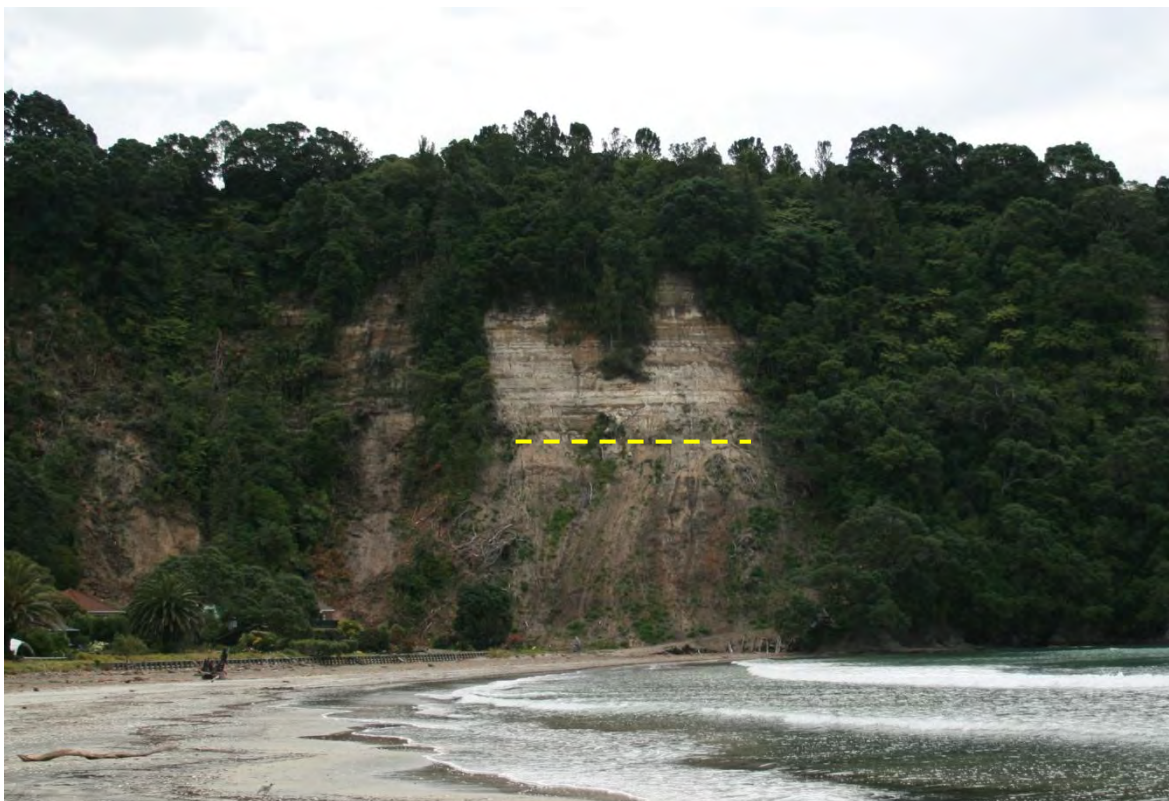
Figure 6.3: View of the western end of Ohope Beach showing Lower Ohope Beds unconformably overlying basement greywacke. The contact is indicated.

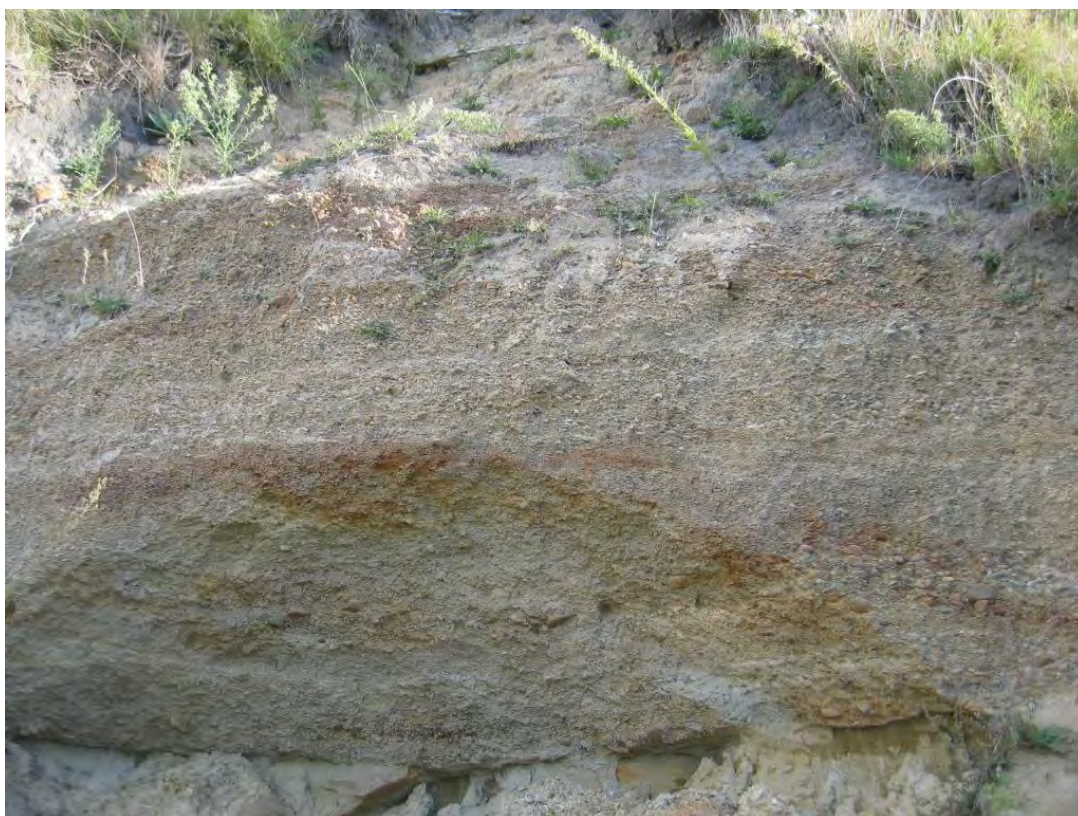
Figure 6.5: *Gravel bed within the Upper Ohope Beds which generally marks the level of the intermediate bench.*

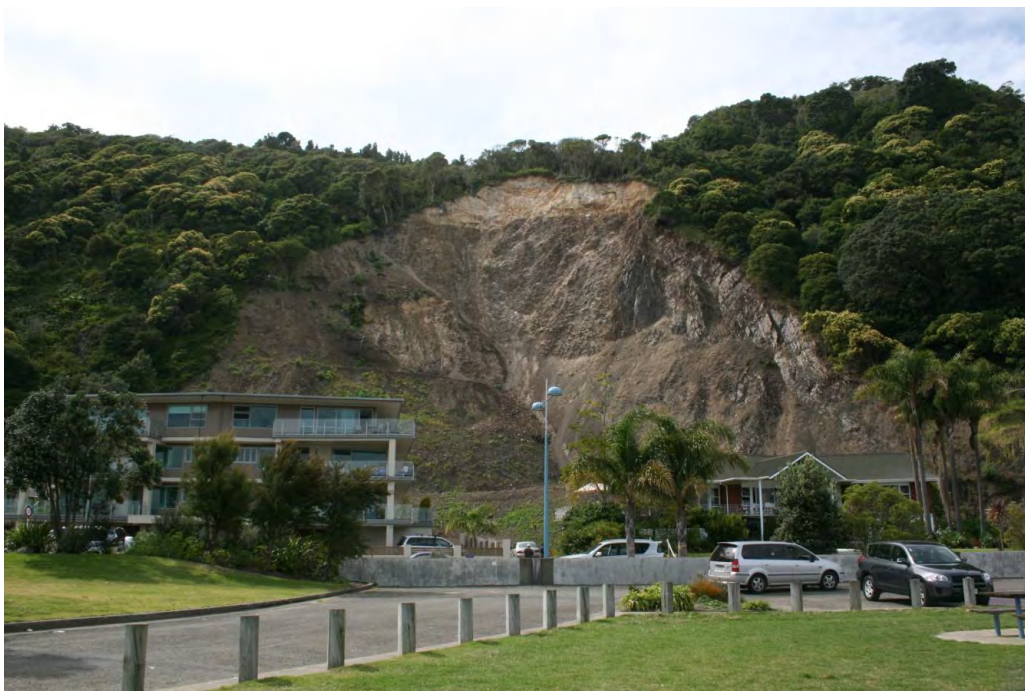
Figure 6.6: Light-coloured Upper Ohope beds overlying a highly disturbed greywacke rock mass (*mélange*), seen in the large Muriwai Drive landslide.

The higher elevation of the greywacke to the west means that only the Upper Ohope Beds overlie the greywacke on the Whakatane Escarpment (Figures 6.6 and A1). Stratigraphic profiles along the Ohope Escarpment are presented in Figure A5. Figure 6.7 is a photograph of the Ohope Escarpment showing the major geo-topographic features.

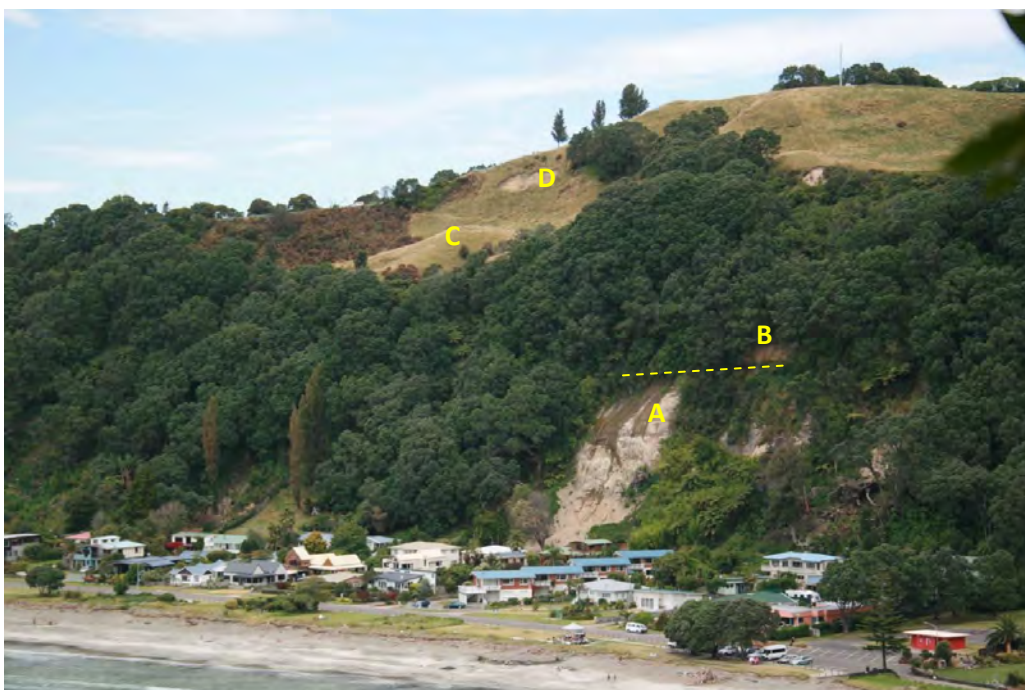
Figure 6.7: View of the Ohope Escarpment from the Otarawairere Bay track. The main elements of the escarpment can be seen: Lower Ohope Sandstone (A); Upper Ohope Sandstone (B); Upper Ohope Beds (with landslide debris) (C); Young Pumice Ash exposed in a landslide headscarp (D).

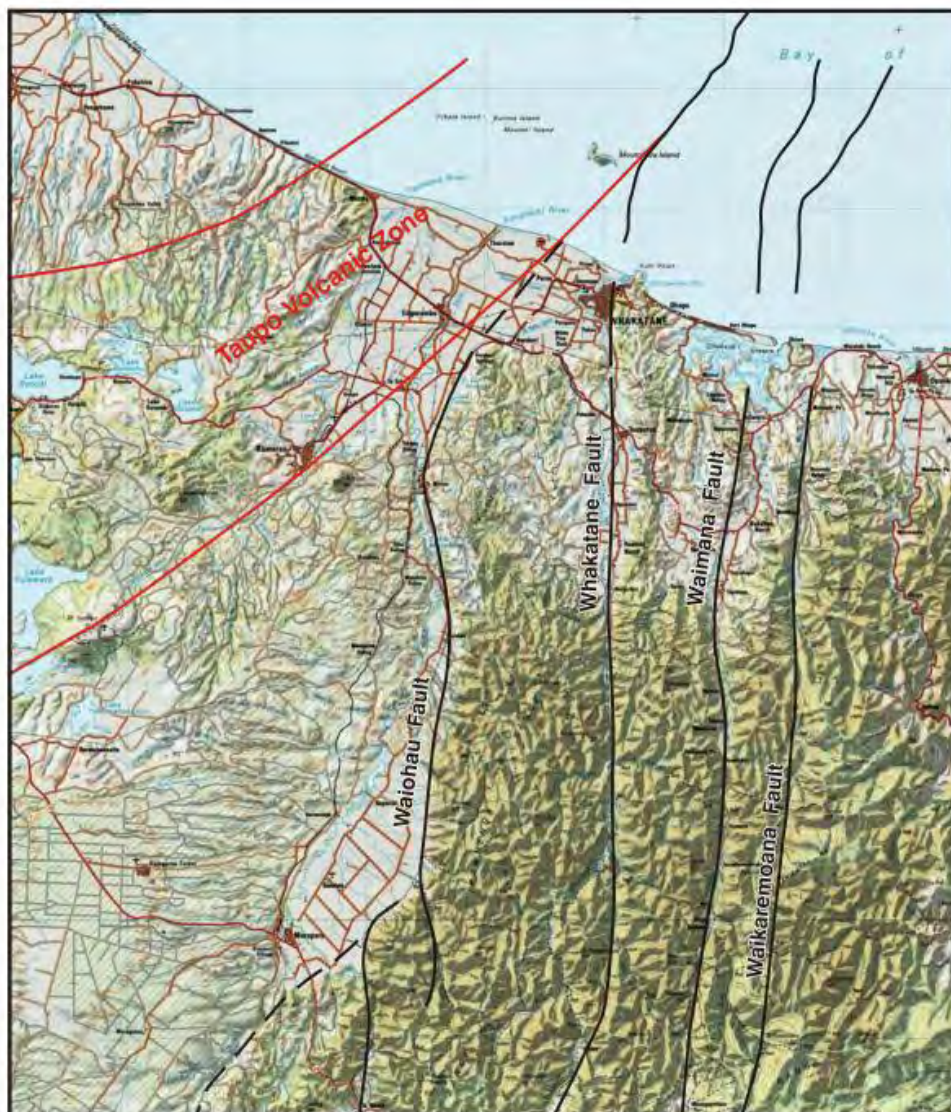
Figure 6.12: Geological structure of the eastern Bay of Plenty. Whakatane and Ohope lie at the junction of the Taupo Volcanic Zone and the North Island Shear Belt³ (Source: Beetham et al (2000))

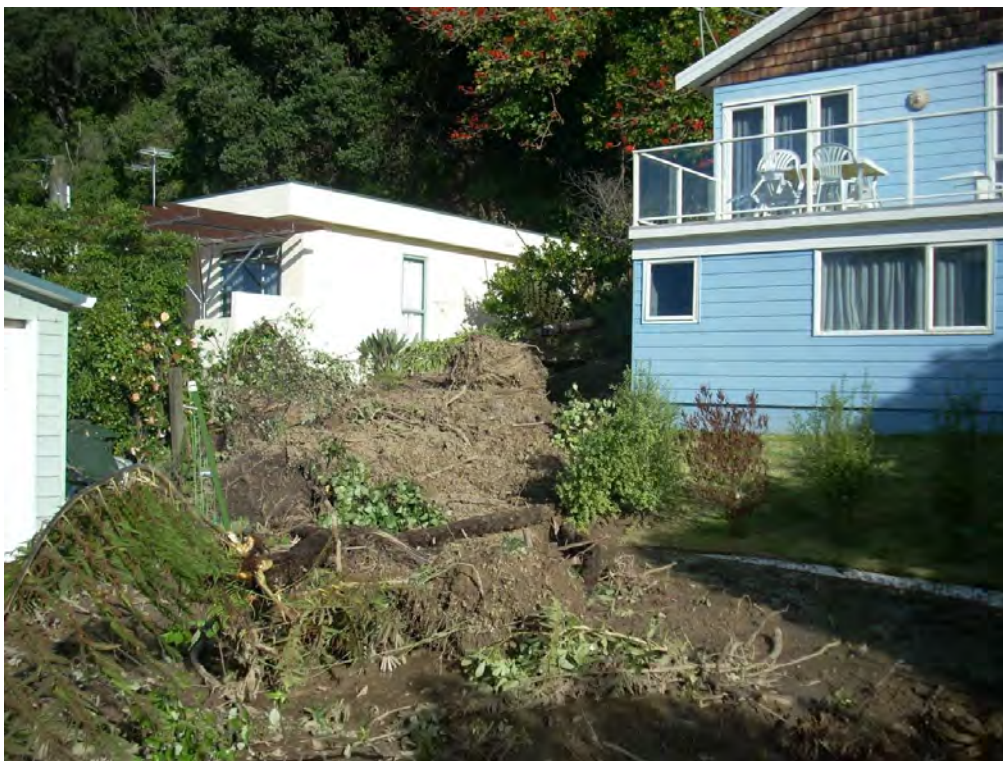
Figure 7.2: Landslide debris deposited between No 22 and 23 West End Road in June 2010. This is an example of landslide debris extending to the edge or a little beyond the recognisable edge of the talus slope. This is also an example of a landslide occurring entirely within the talus slope rather than the steep escarpment.

Observations made of the 2010 and 2011 landslides confirmed these characteristics (Figure 7.2). In a relatively limited number of cases however, highly fluidised debris and entrained vegetation may extend well beyond the recognised edge of the talus slope, as was the case with the 2010 landslide at No. 67 and 68 West End Road (Figure 7.3).

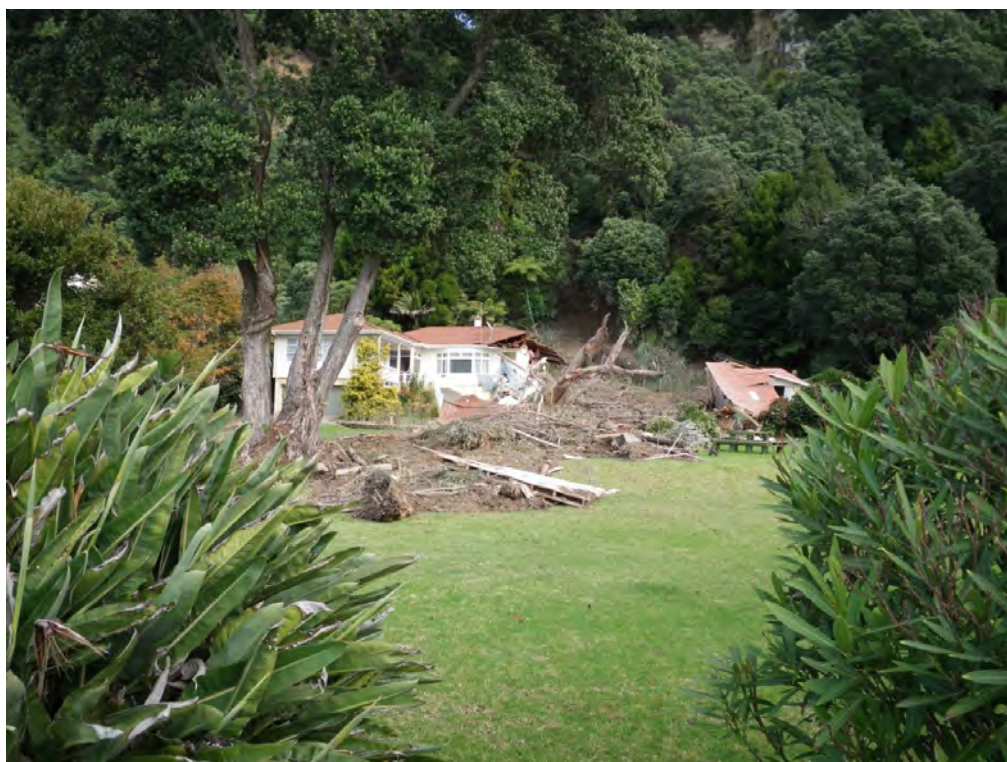
Figure 7.3: View of highly fluidised debris which travelled significantly beyond the recognised extent of the talus slope at 67 West End Road in 2010.

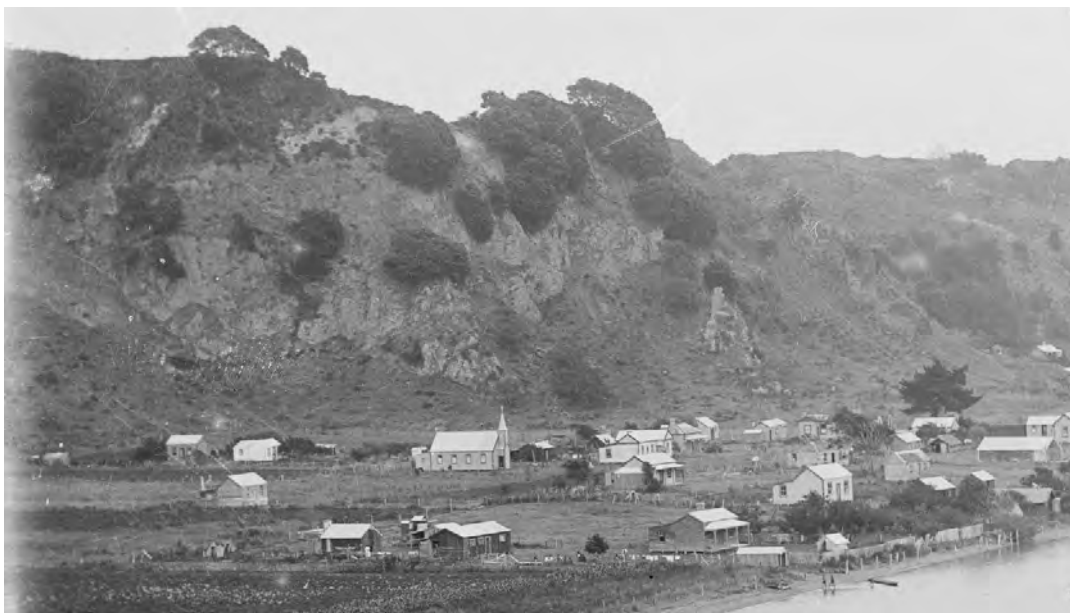
Figure 8.1: View of the Wepiha St/Harvey St area c1900-1910 showing the presence of shallow landslides within the Ohope Beds. A talus slope has developed below the denuded greywacke rock face (Reproduced with permission of Alexander Turnbull Library).

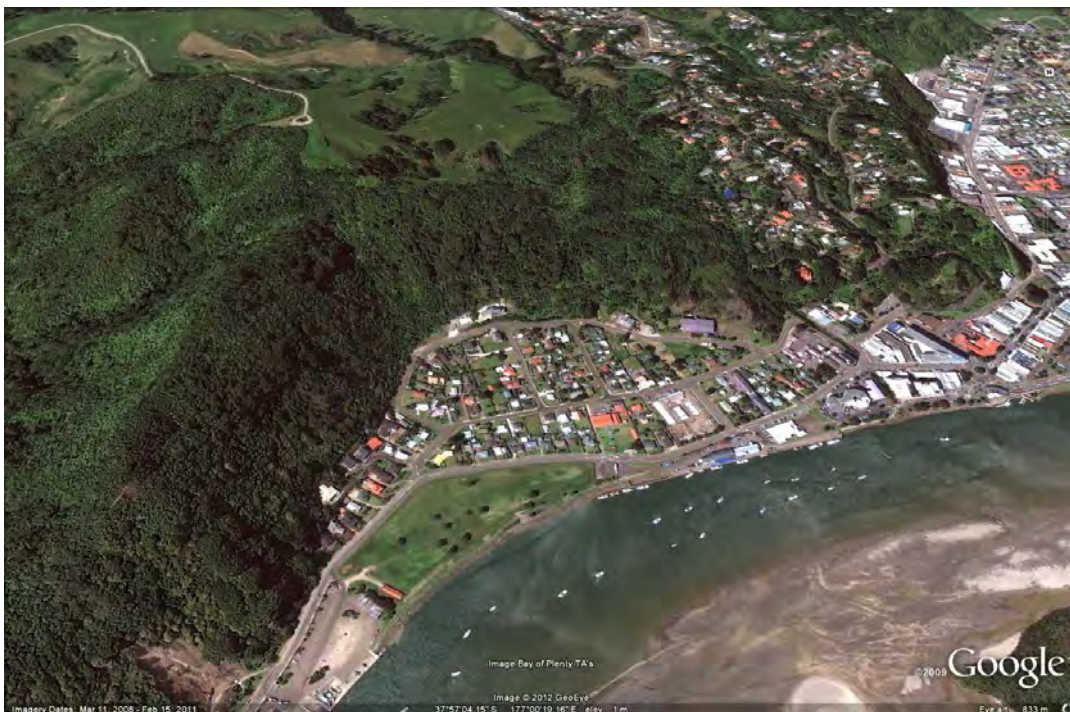
Figure 8.2: Google Earth oblique view of the Wepiha St/Harvey St area showing a near complete vegetation cover (aerial photo dated February 2011).

A photograph of the Wepiha St/Harvey St area taken at the turn of the 20th Century (Figure 8.1) shows not only a significantly less extensive vegetation cover on the Whakatane escarpment than is currently the case (Figure 8.2) but that there is a substantial talus slope present along the base of the escarpment. This talus slope has developed by the accumulation of rock and soil debris that has fallen down the escarpment. Exposures of light coloured Ohope Beds within non-vegetated scars (Figure 8.1) indicate the occurrence of small shallow landslides immediately above the greywacke rock face.

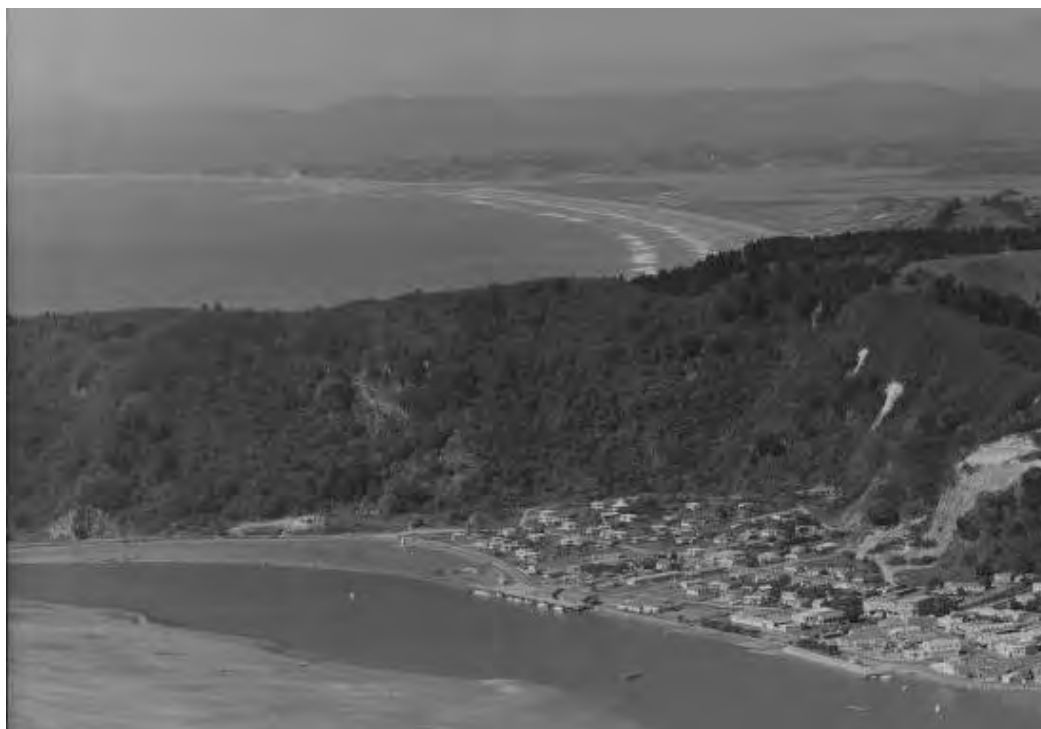
Figure 8.3: View of the Wepiha/Harvey Street area in 1964. Two apparently recent landslides within the Ohope Beds can be seen on the right (Reproduced with permission of Alexander Turnbull Library).

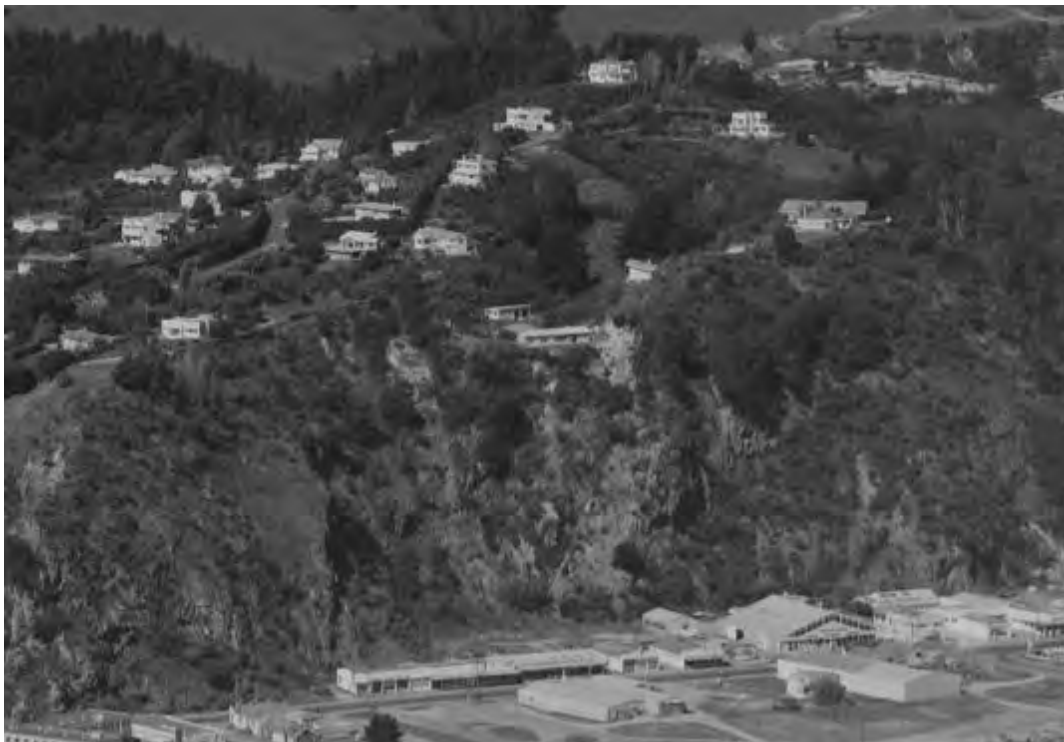
Figure 8.5: *Photo from 1964 showing the greywacke escarpment behind Commerce Street. Note the lack of vegetation on a significant proportion of the greywacke and the presence of a relatively small talus fan. (Reproduced with permission of Alexander Turnbull Library).*

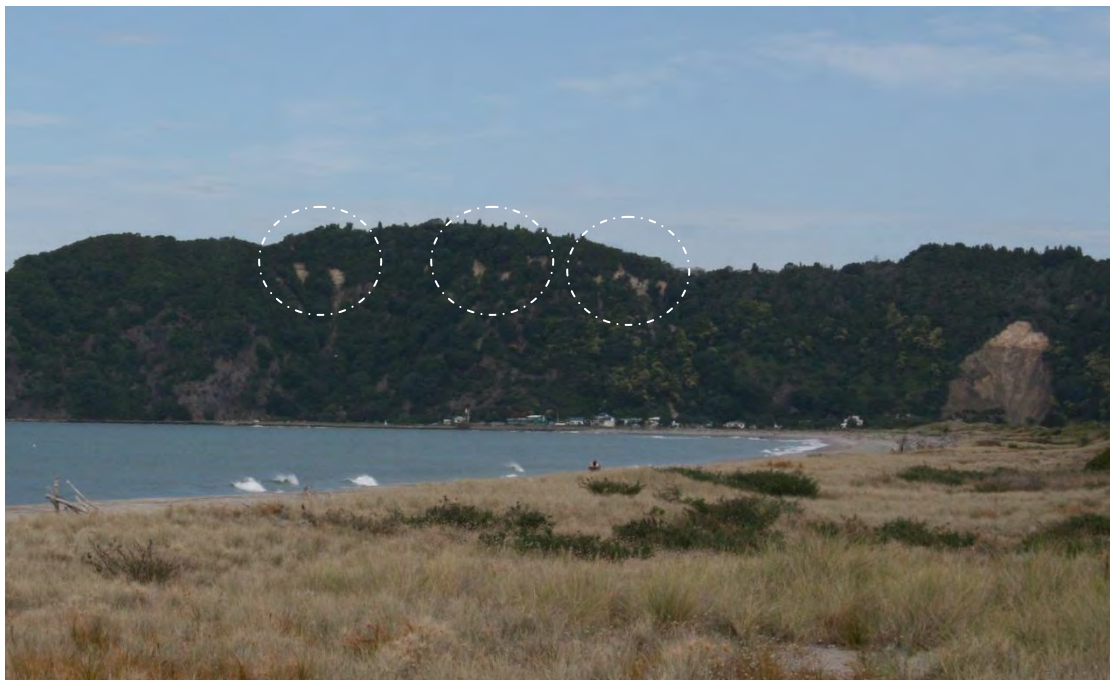
Figure 8.6: *View of the northern end of the Whakatane Escarpment from the Coastlands area. Scars from numerous small landslides within the Upper Ohope Beds can be seen (circled). The large landslide that can be seen on the right is located behind No. 33 Muriwai Drive.*

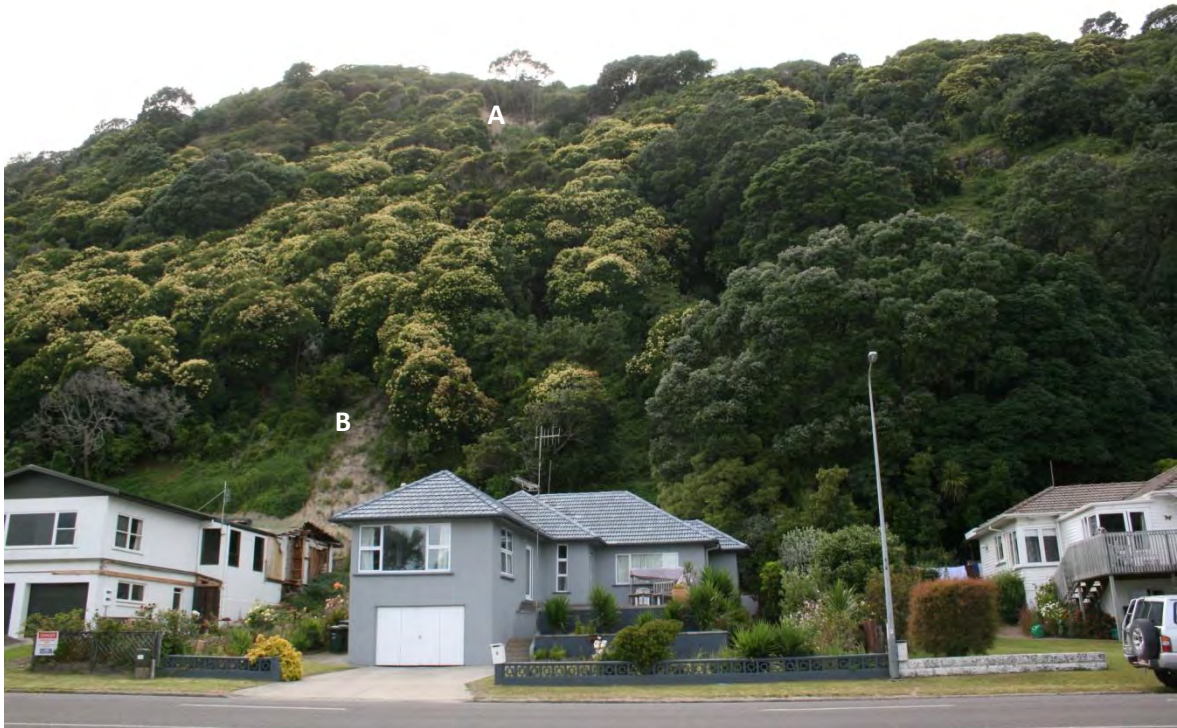
Figure 8.7: Landslide (A) and debris chute (B) behind No. 7 Muriwai Drive.

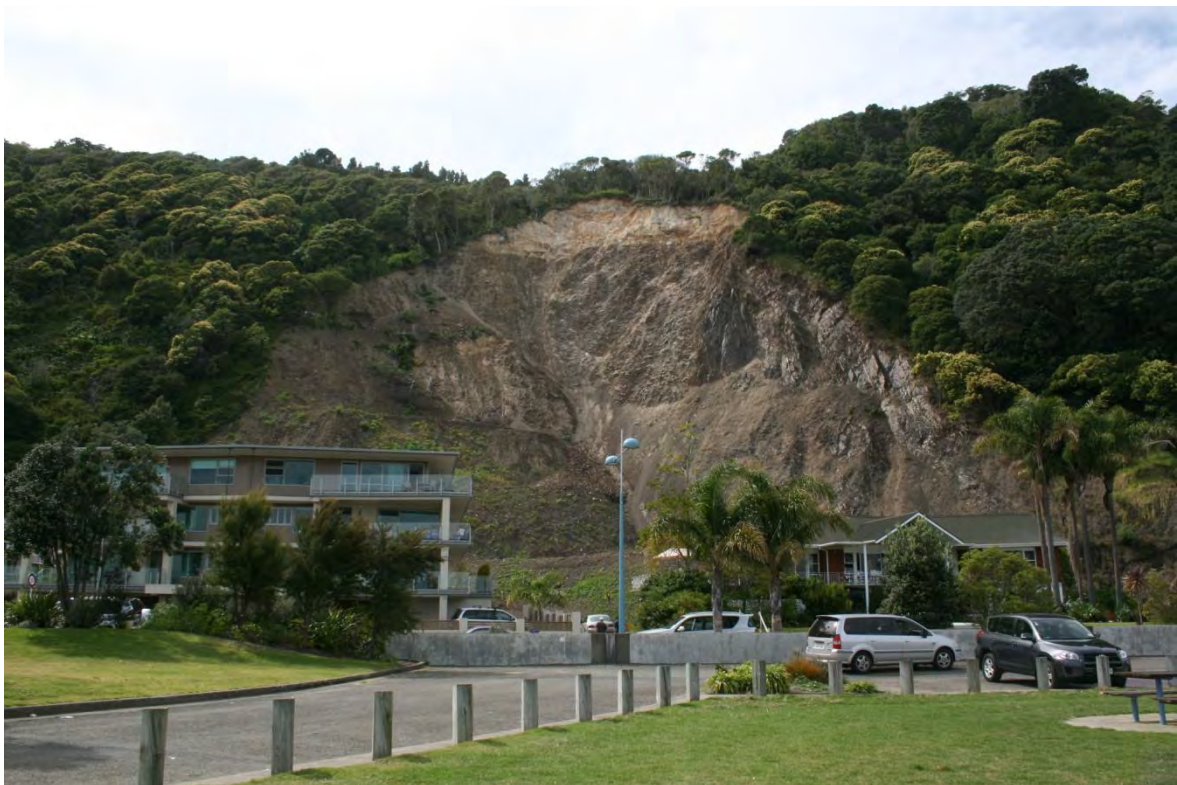
Figure 8.8: Large structurally-controlled landslide behind No. 33 Muriwai Drive. The complexly deformed greywacke of the Whakatane Mélange is overlain by the light coloured Upper Ohope Beds.

Observations made of the large landslide at No. 33 Muriwai Drive have indicated that significant groundwater flows occur within the broken rock mass of the Whakatane Mélange.

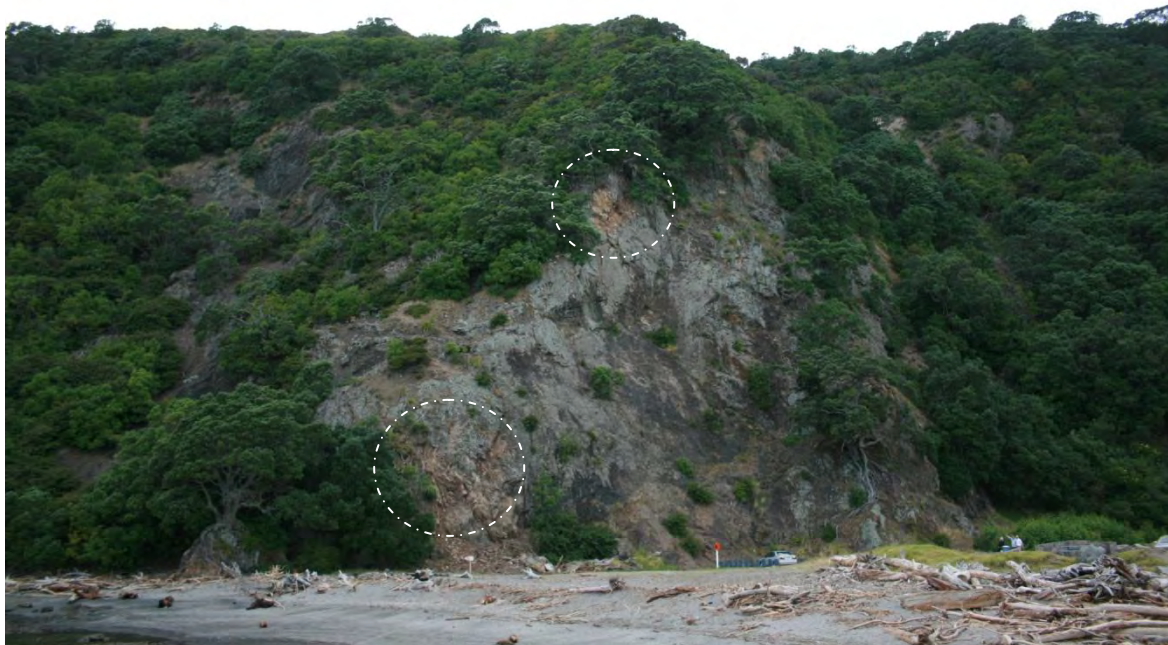
Figure 8.9: Minor rock falls within highly jointed greywacke (circled), Whakatane Heads.

Rock falls are recognisable in a number of areas around Whakatane. Figure 8.9 presents two examples from the Whakatane Heads car park. These are small in size and localised in nature, although repeated historic rock falls of this type have contributed to a noticeable talus slope accumulating near the intersection of Canning Place and Commerce Street.

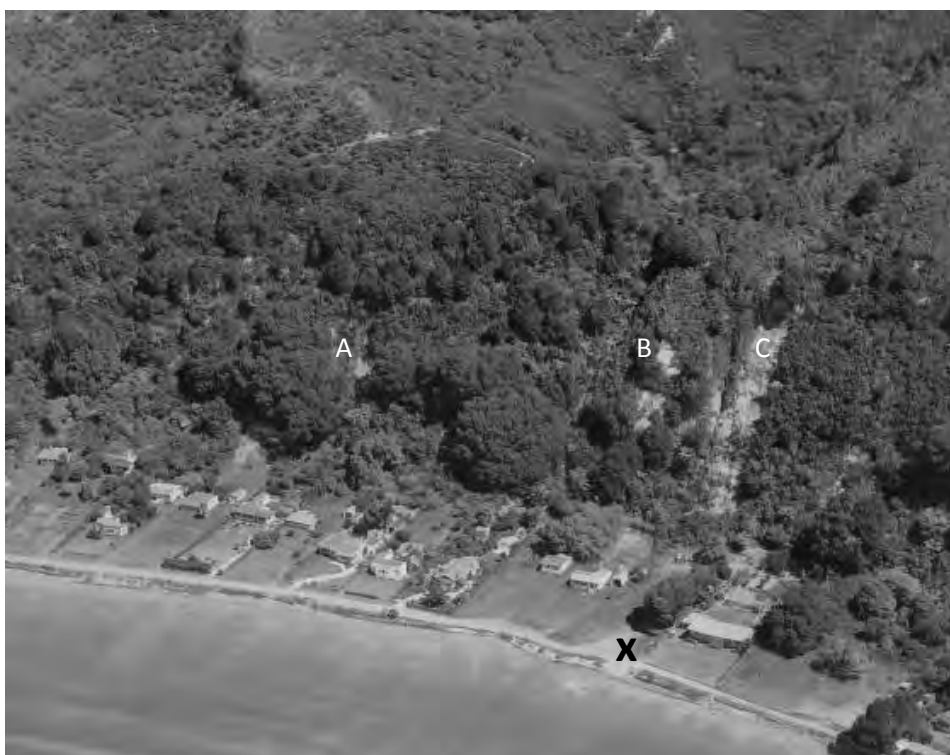
Figure 9.2: West End Road, Ohope, 1955. Slips identified in the text are indicated. "X" indicates the estimated location of where Figure 9.1 was taken. A large pohutukawa effectively blocks much of the Fleming (1955) slide ("A") from view (Reproduced with permission of Alexander Turnbull Library).

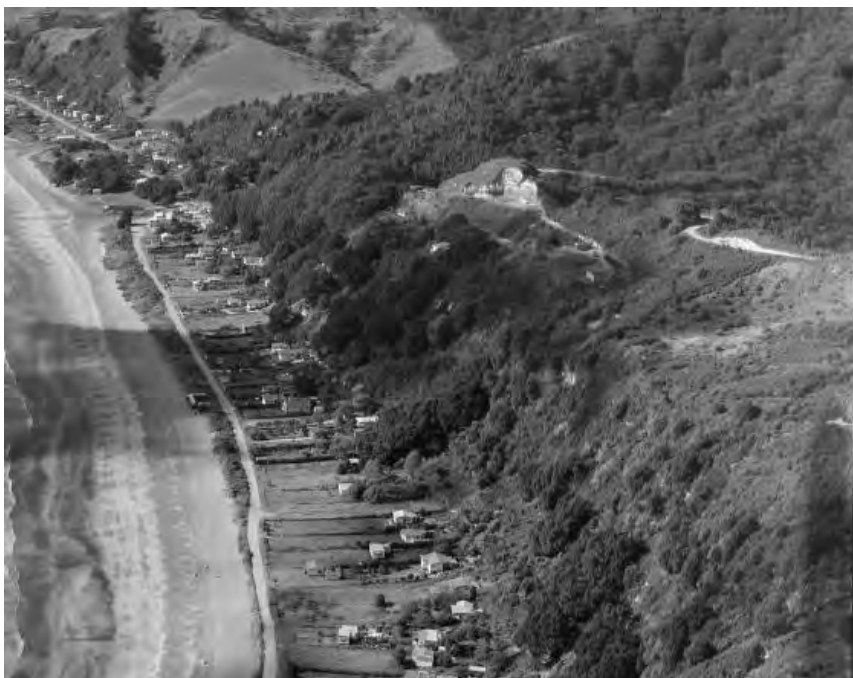
Figure 9.3: West End Road, Ohope, 1951. Even at this relatively early stage in Ohope's development, houses tended to be located at the rear of the properties. Reproduced with permission of Alexander Turnbull Library.

In a more general sense, the presence of a talus slope extending 20 to 30m up the side of the Ohope Escarpment is proof in itself that a significant quantity of debris has periodically fallen from the upper escarpment and been deposited at its toe (Figure 9.3). This talus slope has developed only within the last 5,000 years or so with the mid to late Holocene northward migration of the beach. The extensive talus slopes at Ohope have therefore developed over a relatively short geological period. The thickness and volume of the talus slopes are large compared to the thickness and volume of the debris typically deposited by the many landslides mapped between 2004 and 2012 (<2m), indicating that a significant number of landslides have occurred within each section of escarpment. The cyclic nature of landsliding on the Ohope Escarpment is discussed further in Section 9.4.

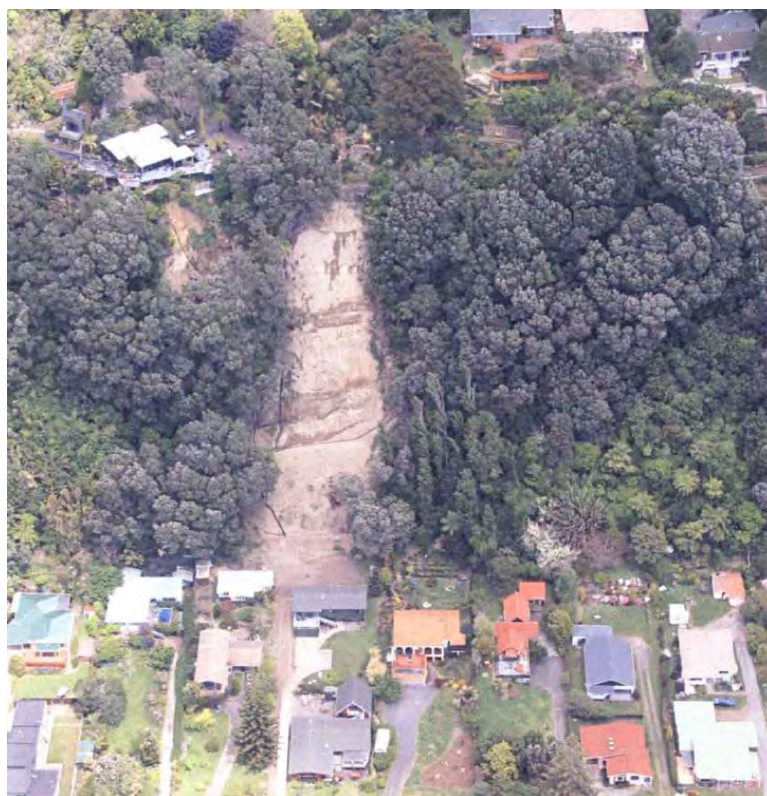
Figure 9.4: View of the large landslide that occurred above below No. 14 Cliff Road in July 2004. The affected properties at the base of the slope are No. 34 and 35 West End Road. Immediately to the right of the landslide scar is the location of the large landslide recorded in Fleming (1955). This section of slope was fully vegetated by 2004.
