Whakatane District Council

Quantitative Landslide Risk
Assessment
Whakatane and Ohope Escarpments

Report prepared by:
Tonkin & Taylor Ltd

June 2013

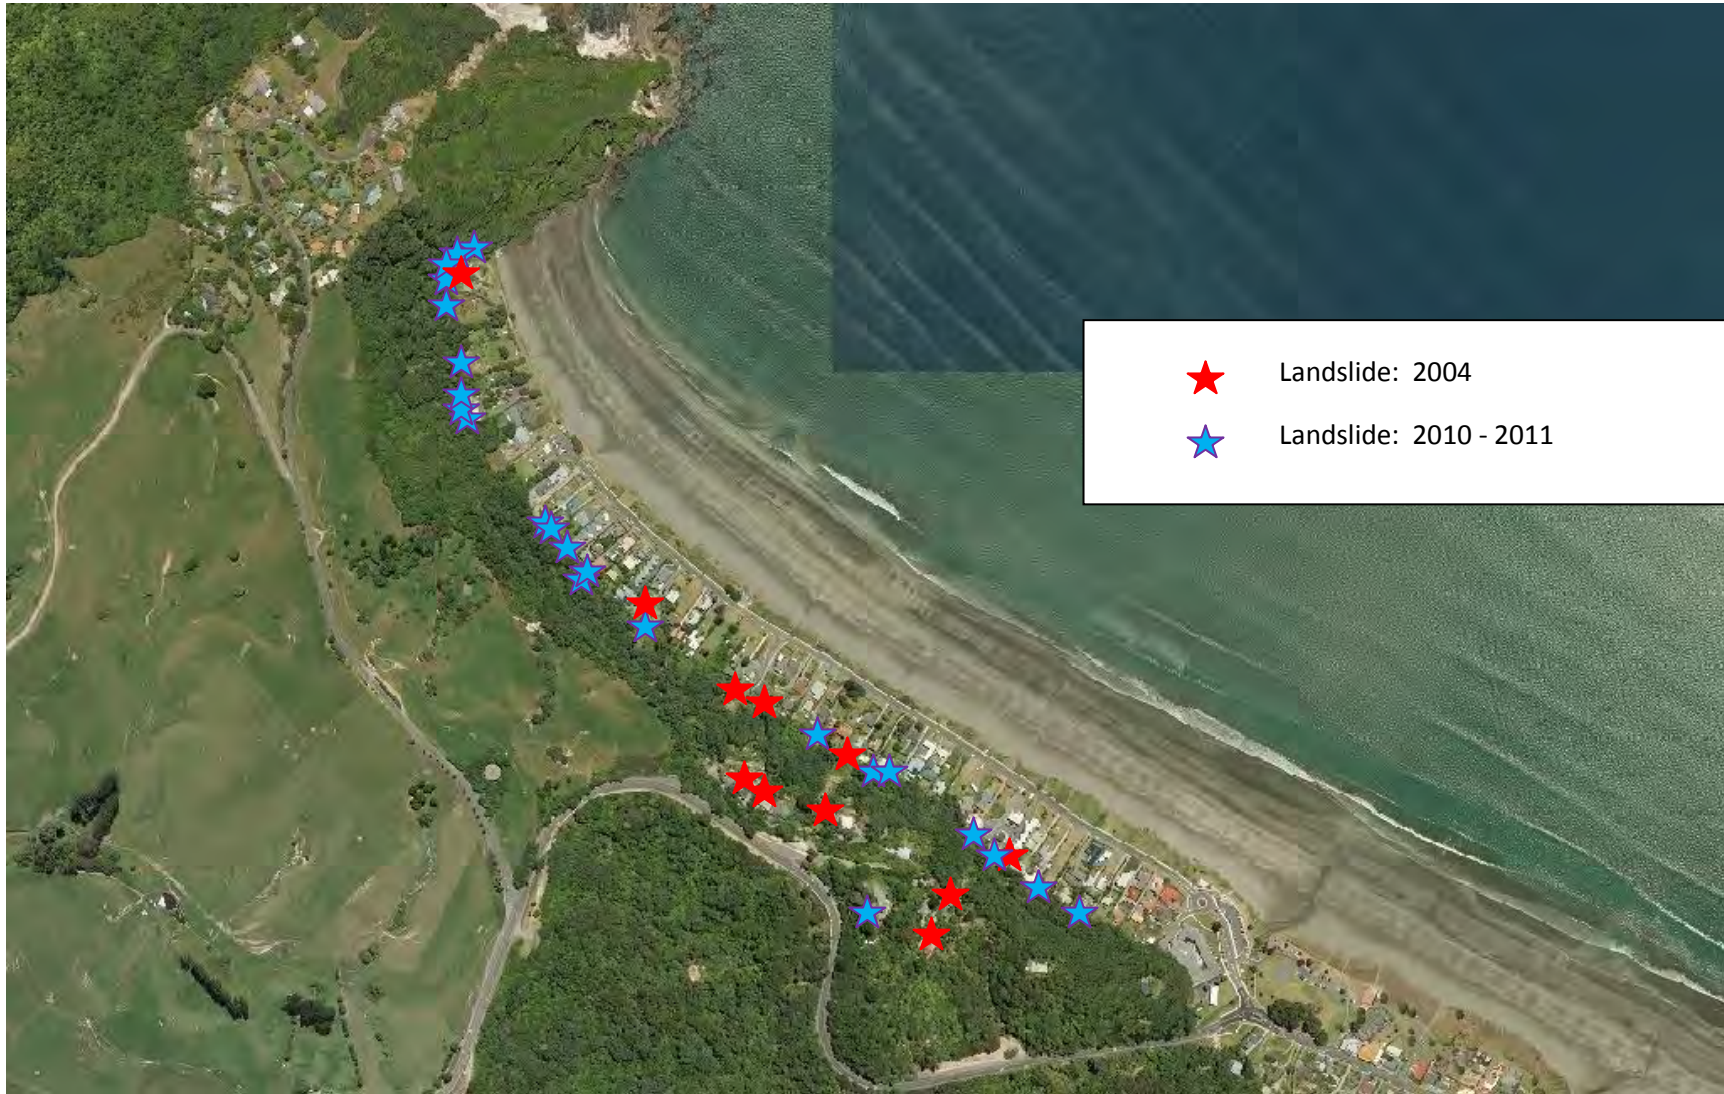
Figure 9.5: General location of landslides on Ohope Escarpment for the periods 2004 and 2011-2012.

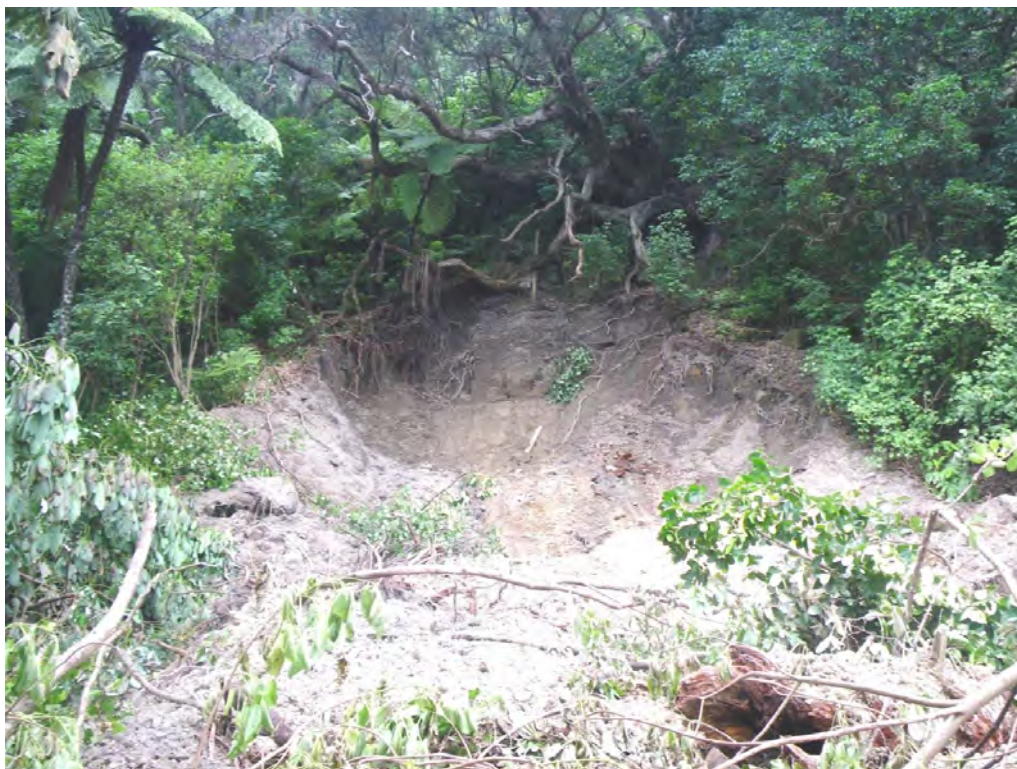
Figure 9.6: Landslide within the talus slope behind West End Road. A large pohutukawa tree mobilised by the landslide caused sufficient damage to the adjacent dwelling.

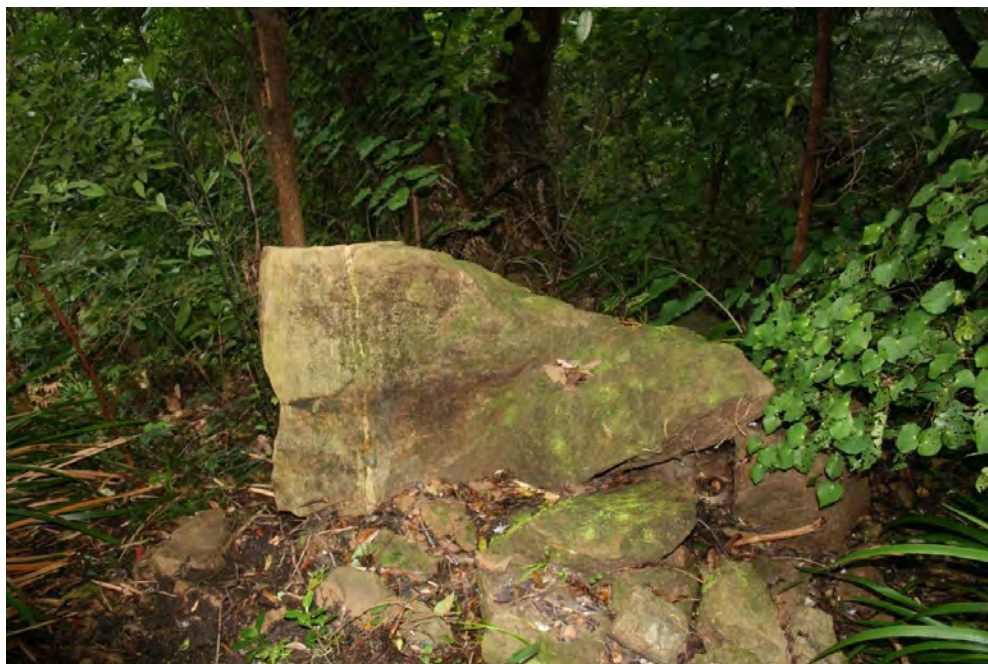
Figure 9.7: Sandstone boulder and smaller rock debris on the talus slope behind the West End property where a rockfall fatality is reported to have occurred in 1959.

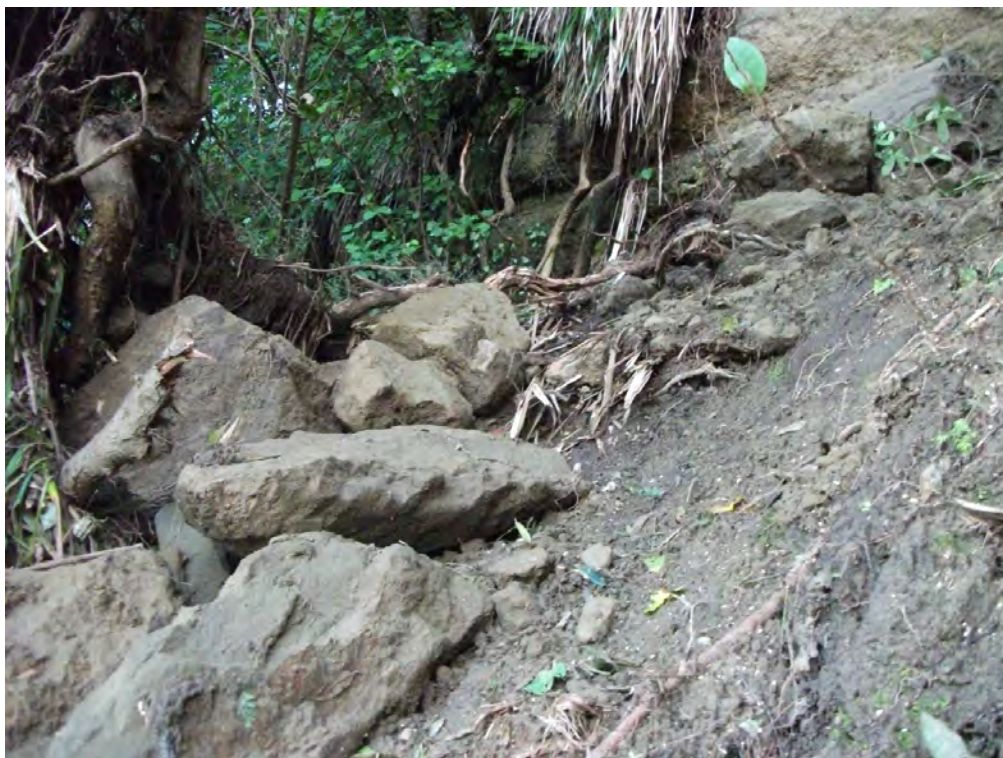
Figure 9.8: Recent rock fall debris from sub-vertical sandstone exposure. The rockfall was associated with the failure of a large pohutukawa tree.

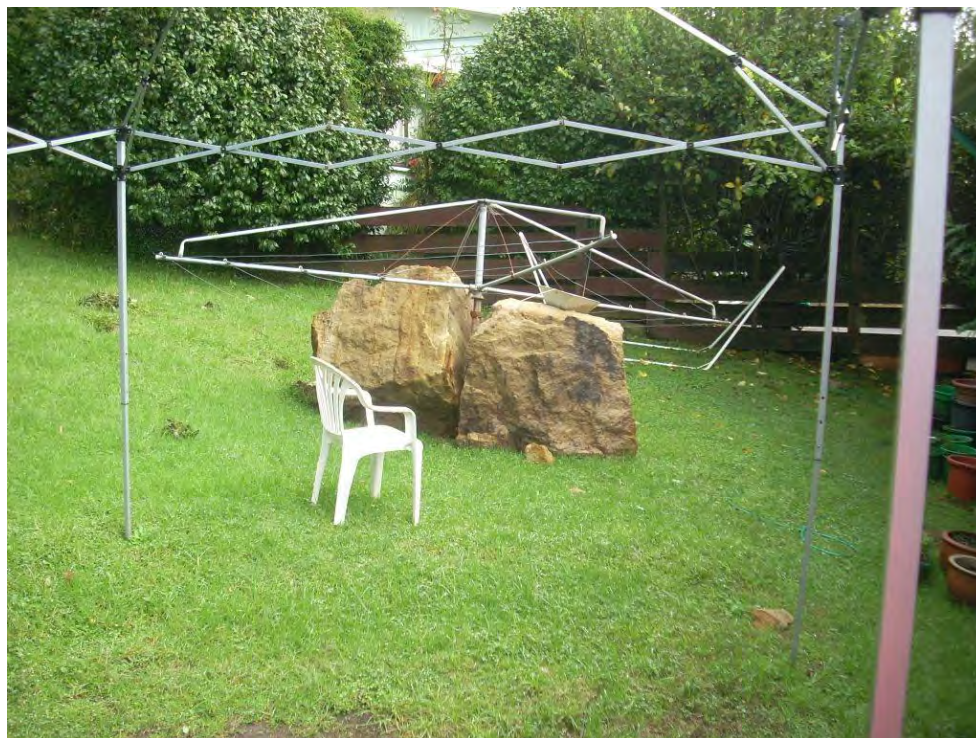
Figure 9.9: Rock fall at the rear of a property on Pohutukawa Ave, Ohope.

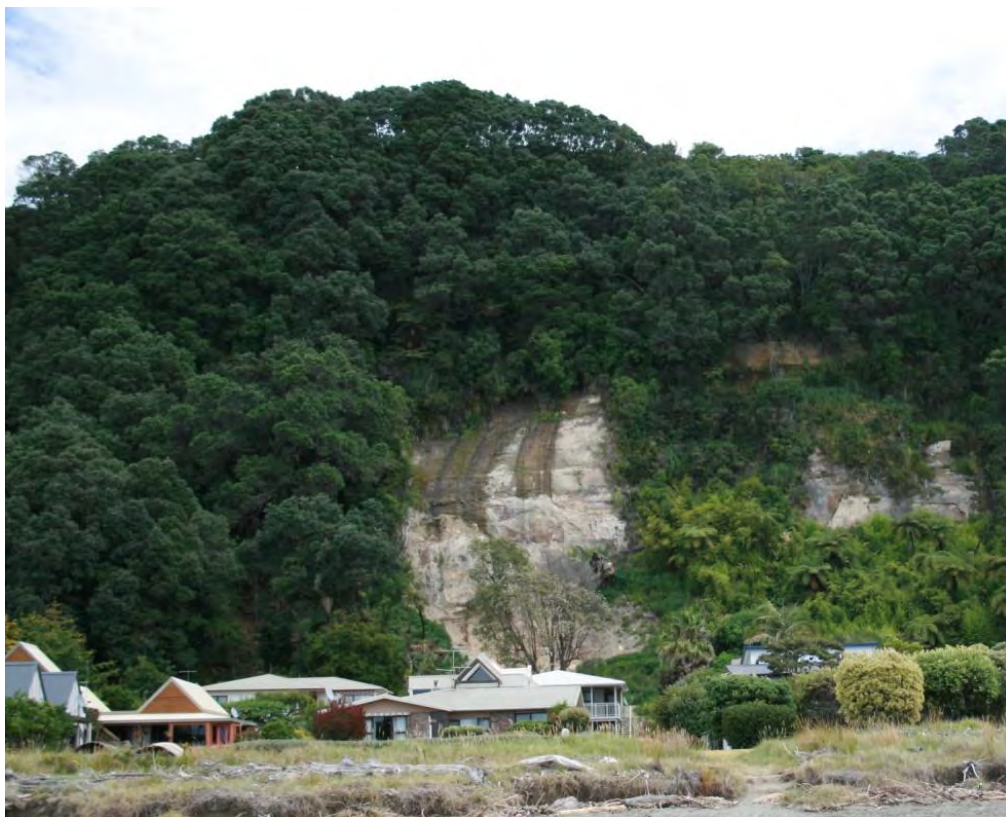
Figure 9.10: View of scar from the fatal July 2011 landslide at 55 West End Road. The sloping bench or contact between the pale Lower Ohope Sandstone and the orange-brown upper Ohope Sandstone was the source of the debris that initiated the landslide.

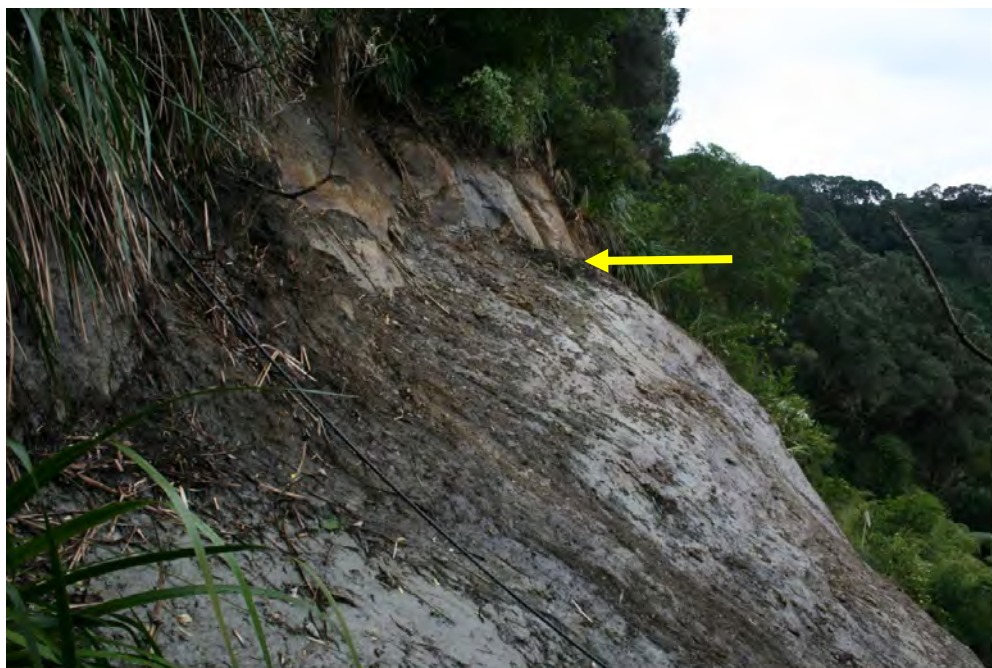
Figure 9.11: Inclined bench marking the contact (arrow) between the Upper Ohope Sandstone and the Lower Ohope Sandstone. The fatal landslide of July 2011 originated at this location.

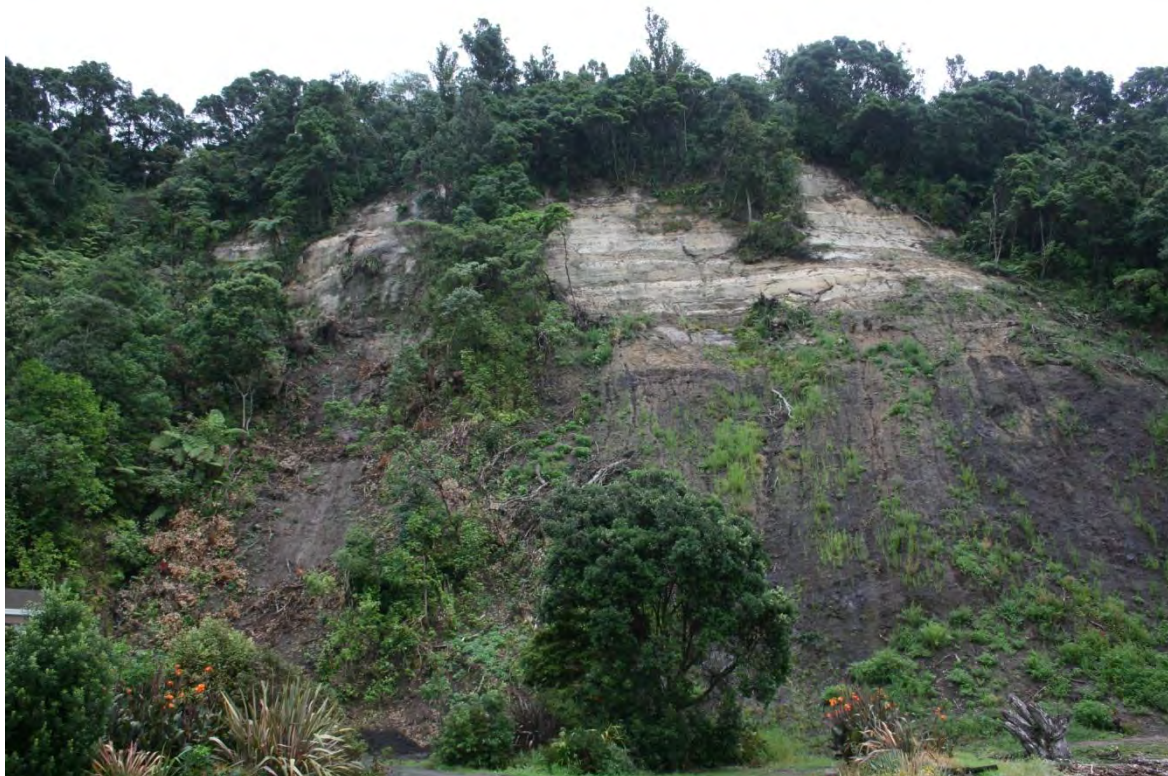
Figure 9.12: Shallow failure of the very thin soil and vegetation cover from a steep face formed from the Lower Ohope Beds. The debris also removed the vegetation cover of the underlying greywacke.

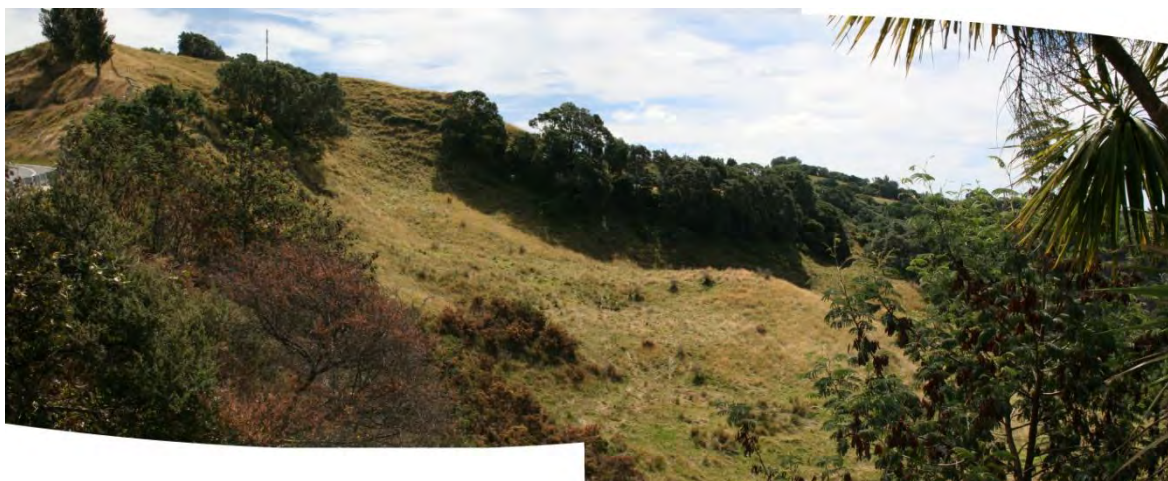
Figure 9.13: View of the top of the Ohope Escarpment adjacent to Ohope Road. Deep seated instability is indicated by large headscarps (left) and hummocky debris field (centre).

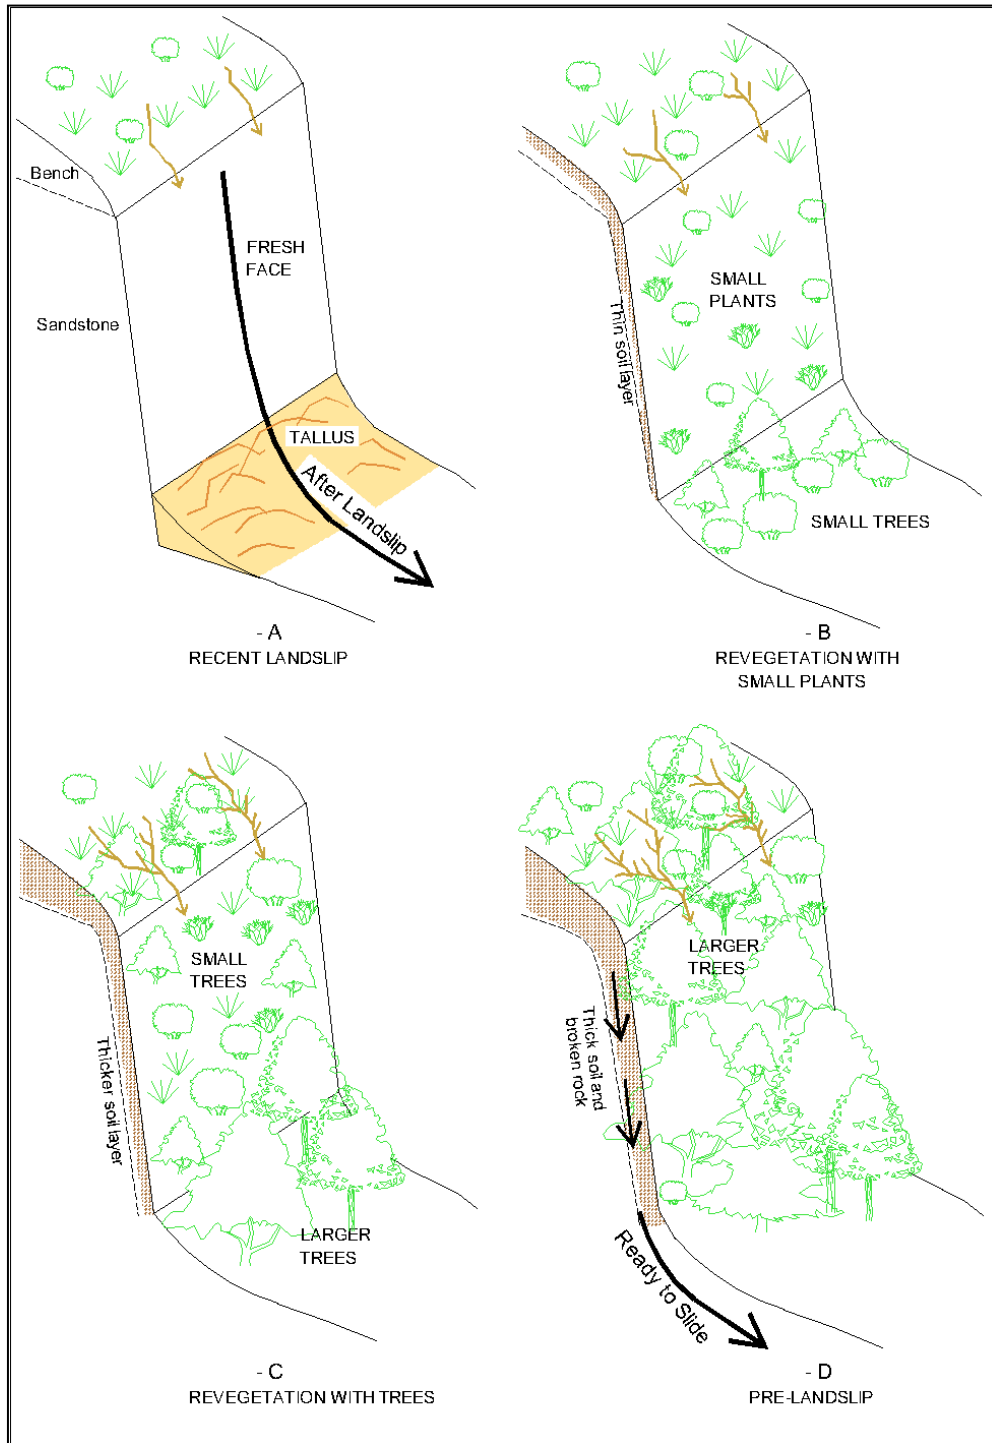
Figure 9.14: Illustration from T&T (2005) showing the natural cycle of vegetation establishment, growth and landslide on steep sections of the escarpment.

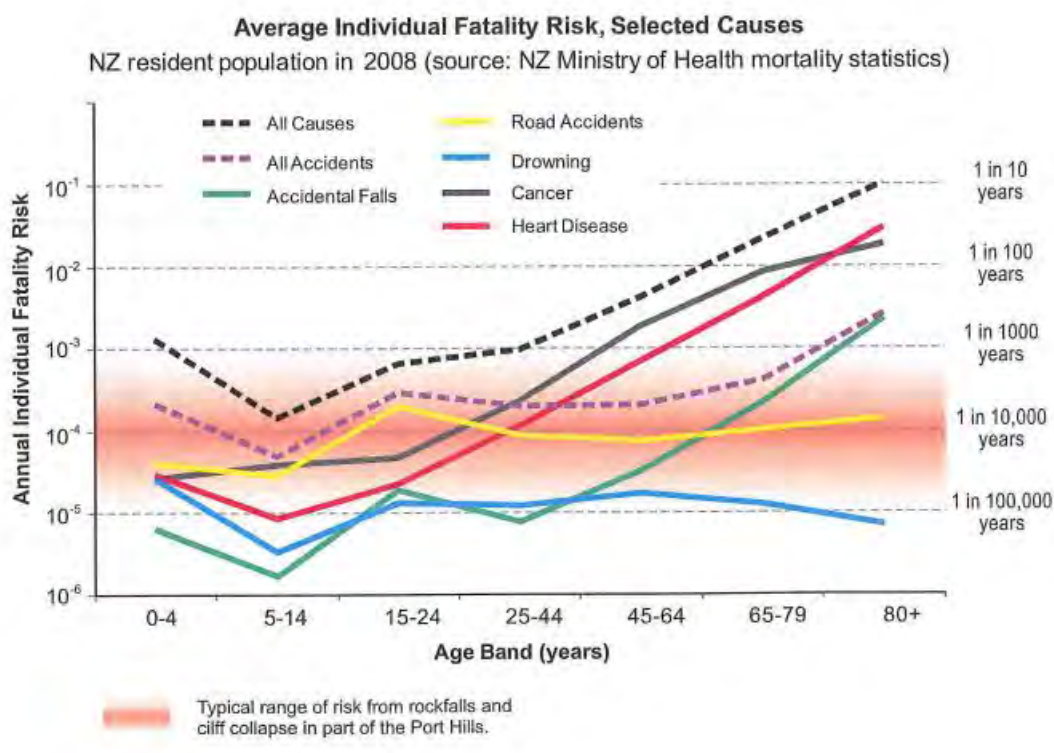
Figure 15.1: Comparison of Individual Fatality Risk for Different Hazards in New Zealand (Source: GNS, 2012)

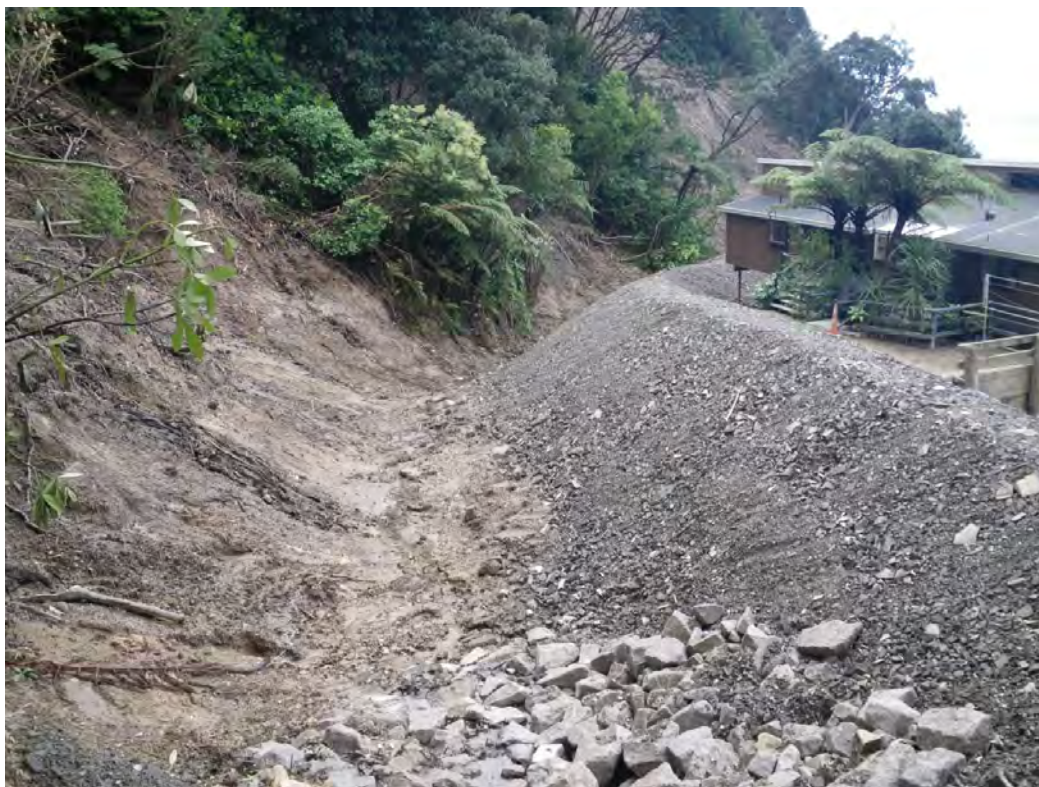
Figure 16.1: Earth bund constructed behind 71/71a West End Road

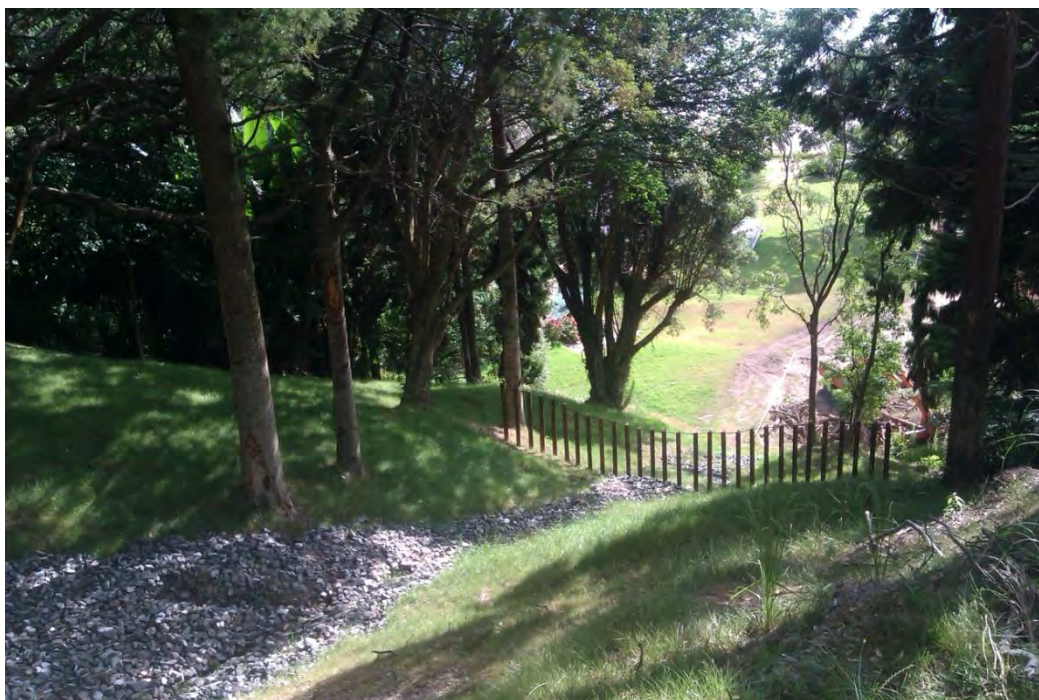
Figure 16.2: Line of steel posts providing protection across a potential landslide path

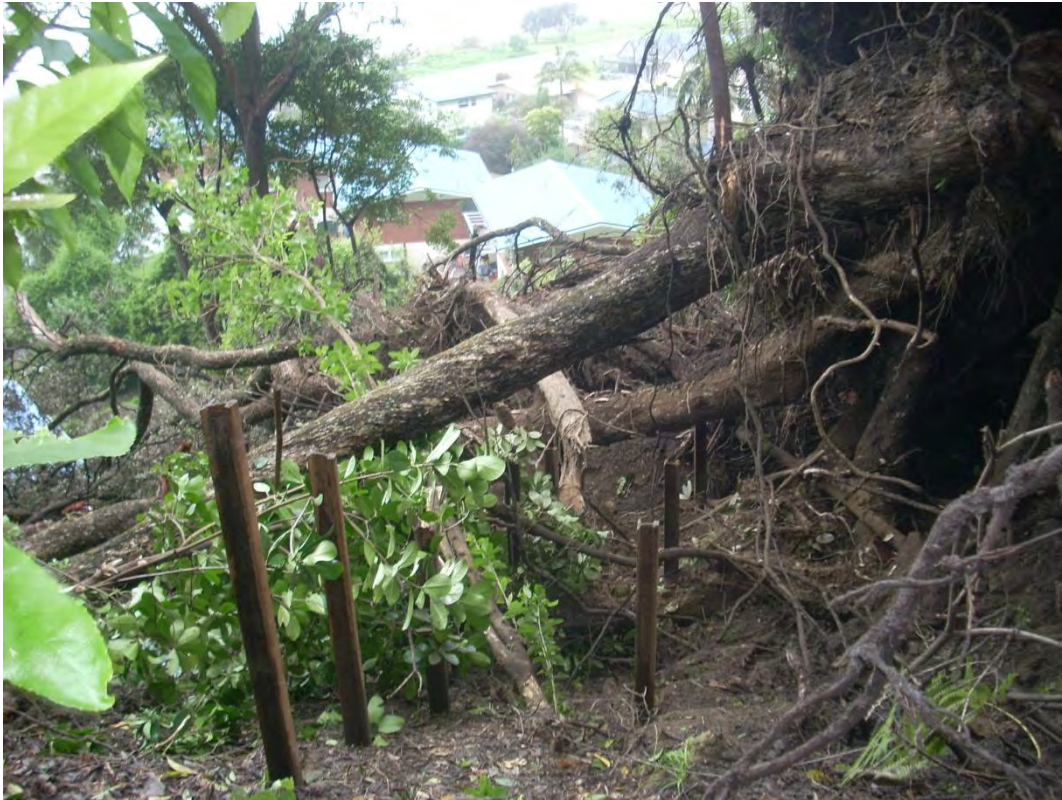
Figure 16.3: Informal line of iron posts which successfully prevented several large trees from impacting a rear dwelling on West End Road

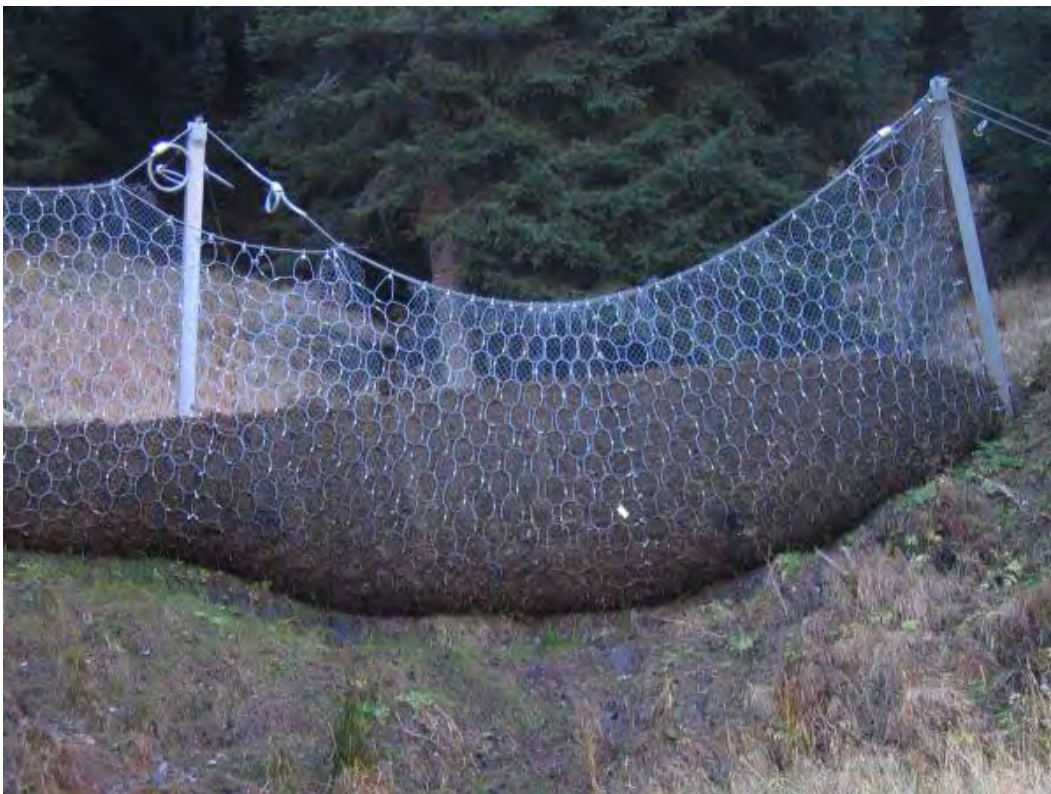
Figure 16.4: Example of flexible ring-net barrier

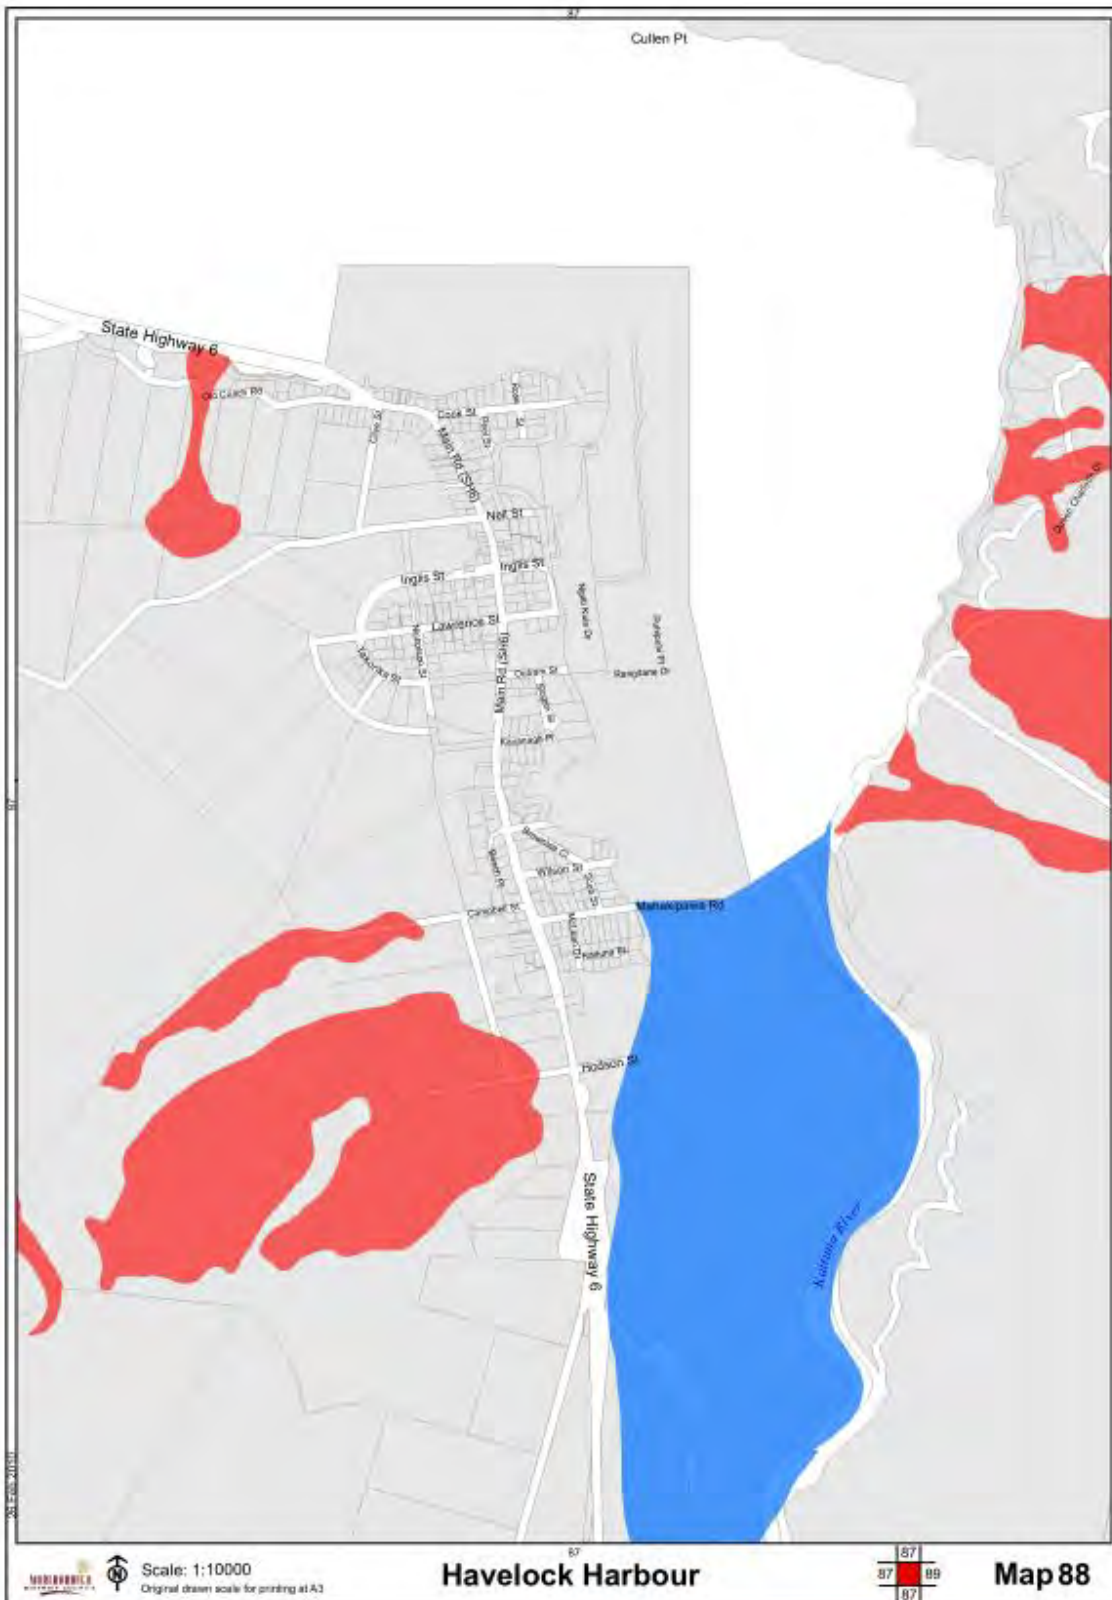
Figure 17.1: Example of a planning map showing natural hazards at property level. Areas in red are subject to land instability (Source: Marlborough Sounds Resource Management Plan).
