WDC 14-056 - Whakatane Central Business District Geotechnical Investigation

Data Delivery Report

Site investigation relating to the ground investigation of the Whakatane central business district as defined by the Geotechnical Investigation Form

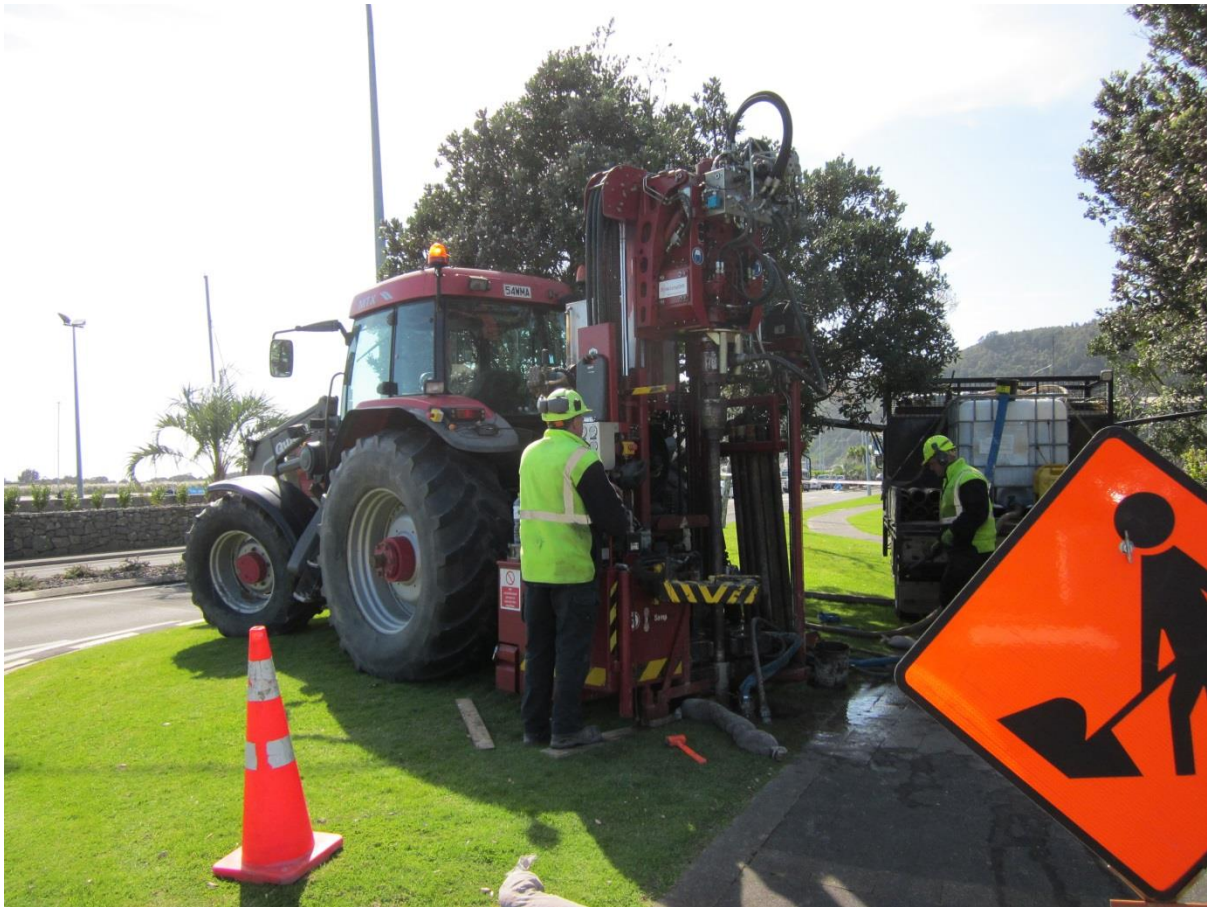
GEOTECH supplied a tractor mounted SONIC rig for continuous core recovery (Figure 1), with a retractable SPT boom to facilitate SPT recordings at 1.5m intervals.

Figure 1. GEOTECH sonic rig, BH 4

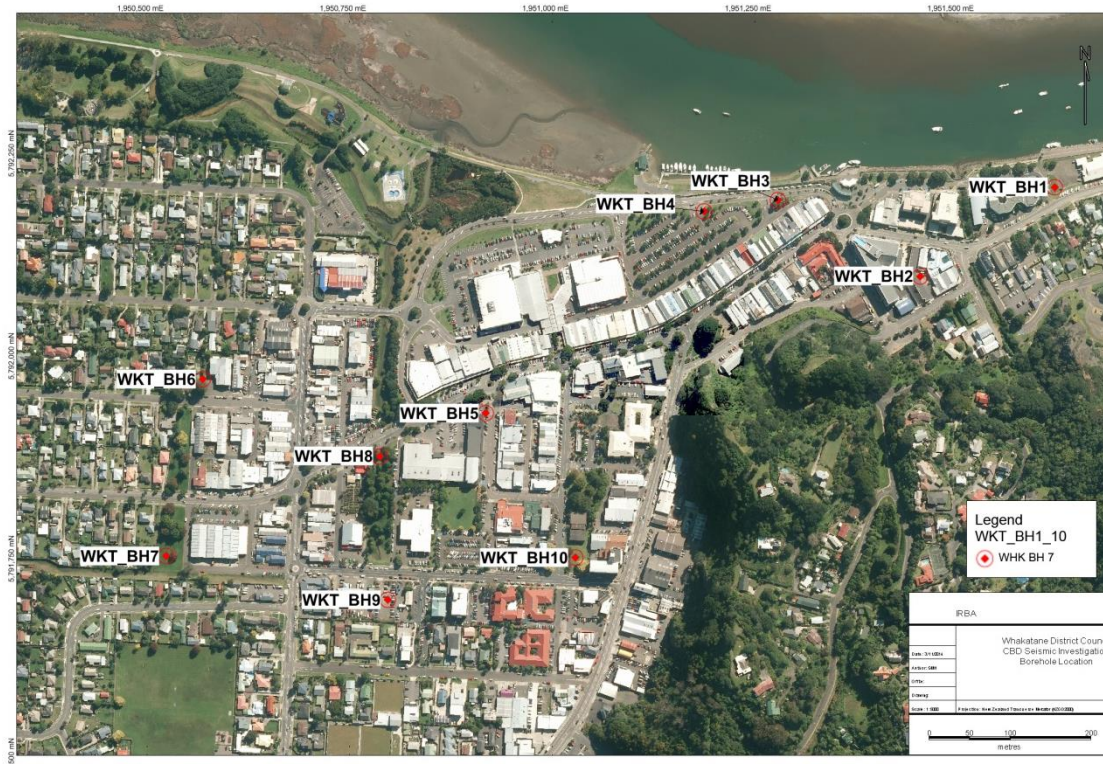
10 drillholes were completed (WHK_BH 1-10) in positions designated by WDC site representatives, accommodating minor geographic shifts to avoid underground services or significant above ground facilities.

Sites are illustrated in Figure 2, overlying CBD photography.

Figure 2. CBD bore hole locations

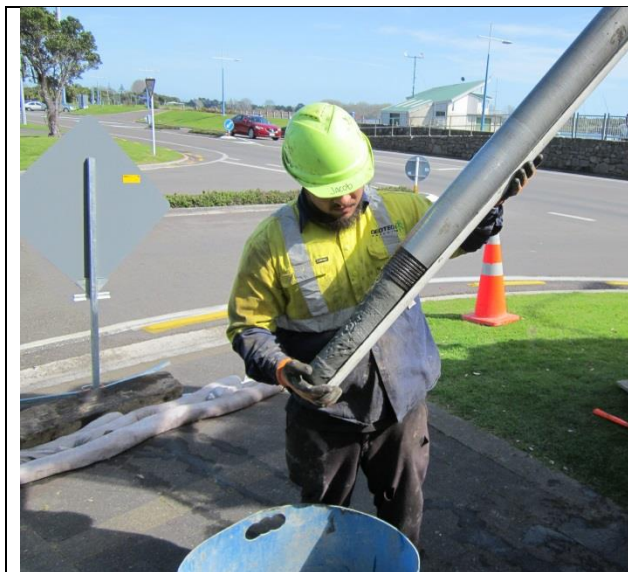
Drillhole diameter was 95mm, whole core was extruded into a plastic split tube, then placed in numbered intervals in plastic corrugated core boxes (Figures 4 & 5). The core boxes are stored at the WDC site Keepa Road, Whakatane.

Figure 4. Sonic split sample extrusion

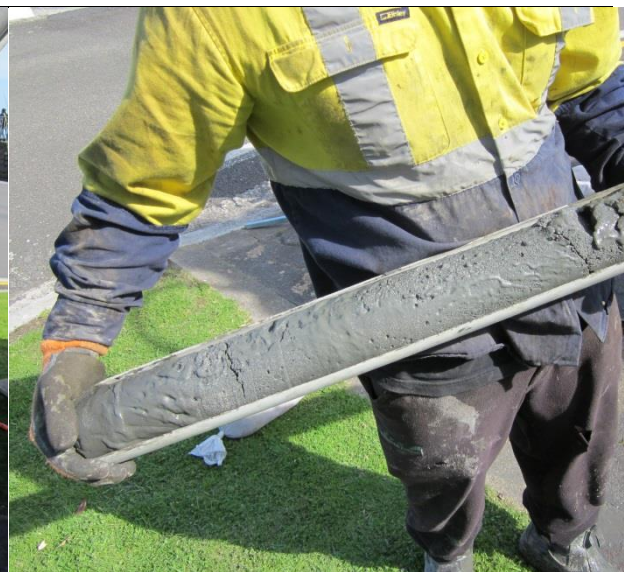
Figure 5. Sonic split tube sample complete

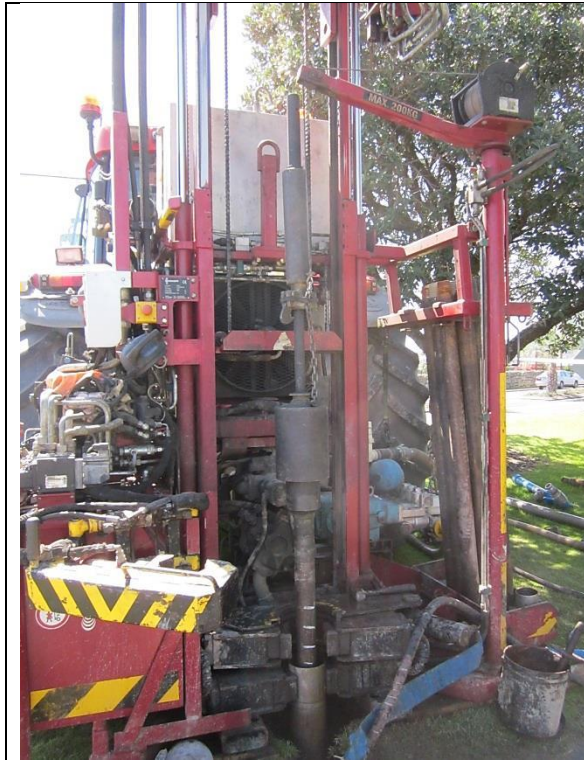
SPT samples were collected, bagged, and inserted in their appropriate locations at 1.5m intervals in the bore hole core boxes (Figures 6 & 7 SPT in operation). Samples were double bagged, with the above sample card inserted between the two encasing sample bags. As noted photographs of the sample in the SPT split were also collected and filed as per “photography”.

Figure 6. SPT hammer in progress

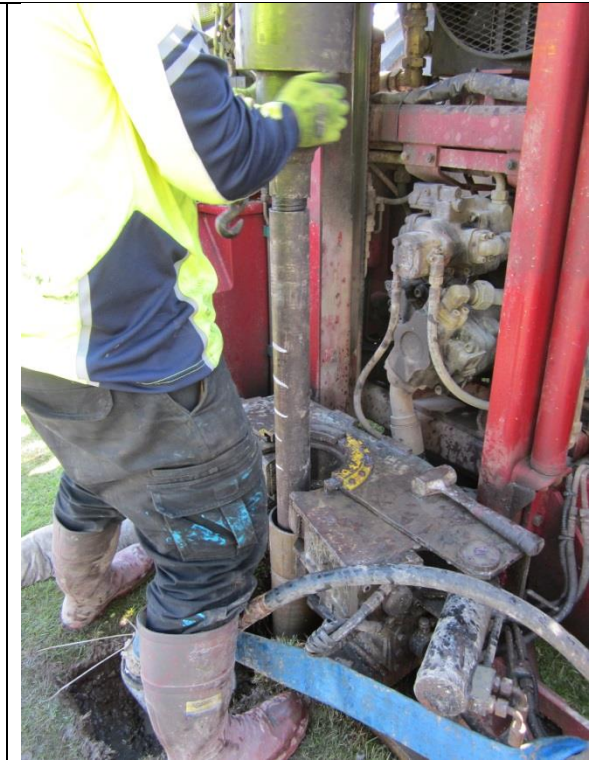
Figure 7. SPT setting up and marking 75mm intervals

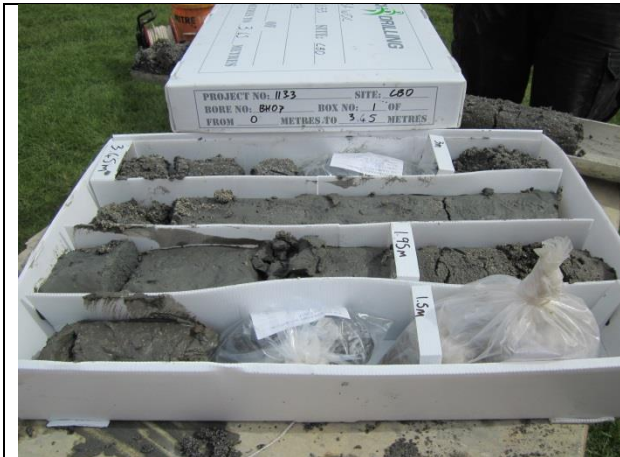
Full core box photos from commencement to bottom of hole, identified by Box No and interval (Figure 8).

Figure 8 Core box WKT BH7 Box 1, 0-3.45m.

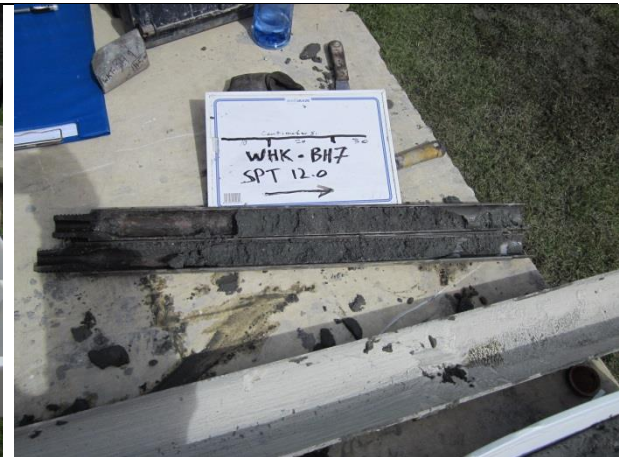
Individual photographs of each SPT split interval is recorded (Figure 9).

Figure 9 SPT record: WKT BH7 SPT 12m.

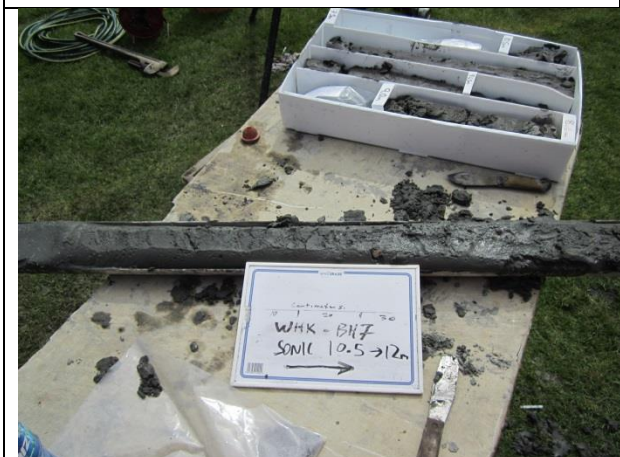
Several photos are taken to provide closer examination of “in situ” core, these are labelled as split core samples, or close-up photos of particular geological features (Figures 10 & 11).

Figure 10. In situ split tube core: WKT BH7 SPT 12m.

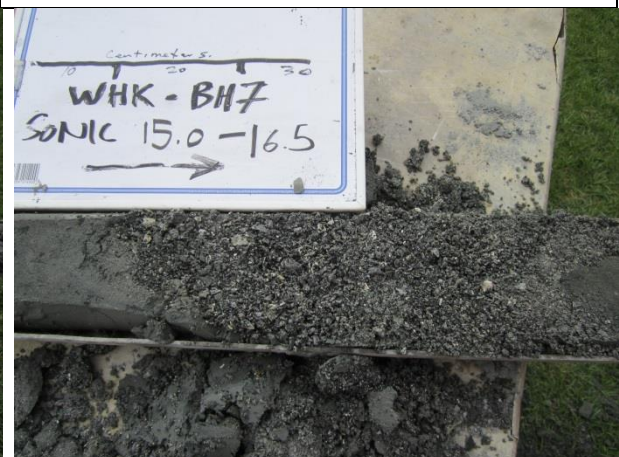
Figure 11. Close-up photo: WKT BH7 splits 15.8m shell beds

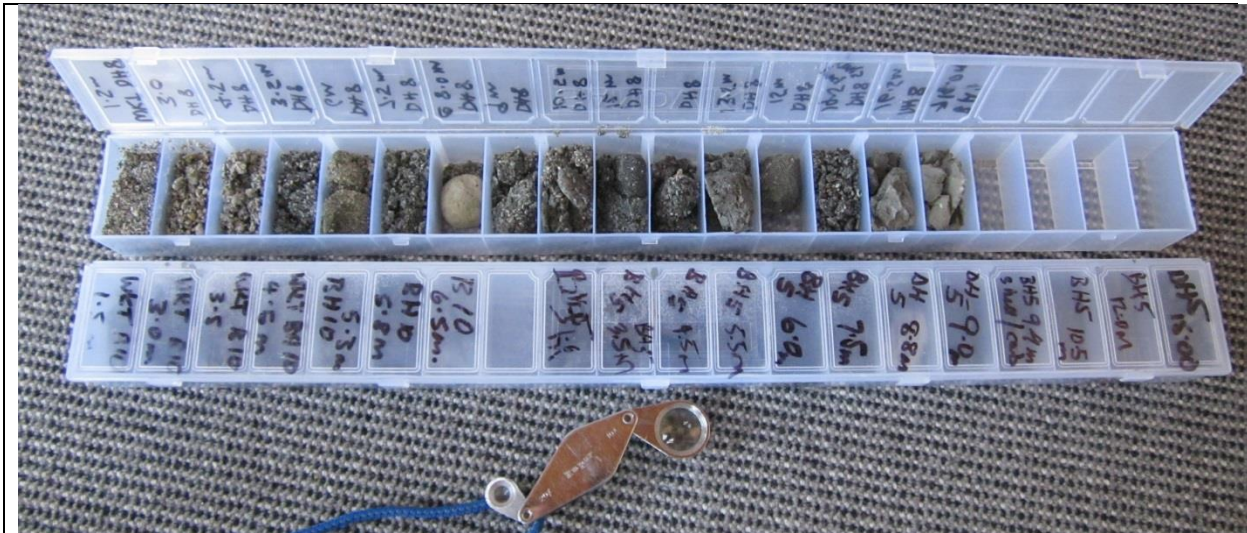
Chip trays have been retained for each hole for diagnostic and convenience purposes. These are “teaspoon” sized samples collected at 1.5m intervals representative of the interval drilled, along with individual units of interest for examination. This short-cuts the process of requiring return to the original core boxes to examine individual features. Currently these chip trays reside at IRBA offices in Belmont, Lower Hutt (Figures 12 & 13).

Figure 12. Chip tray BH 5

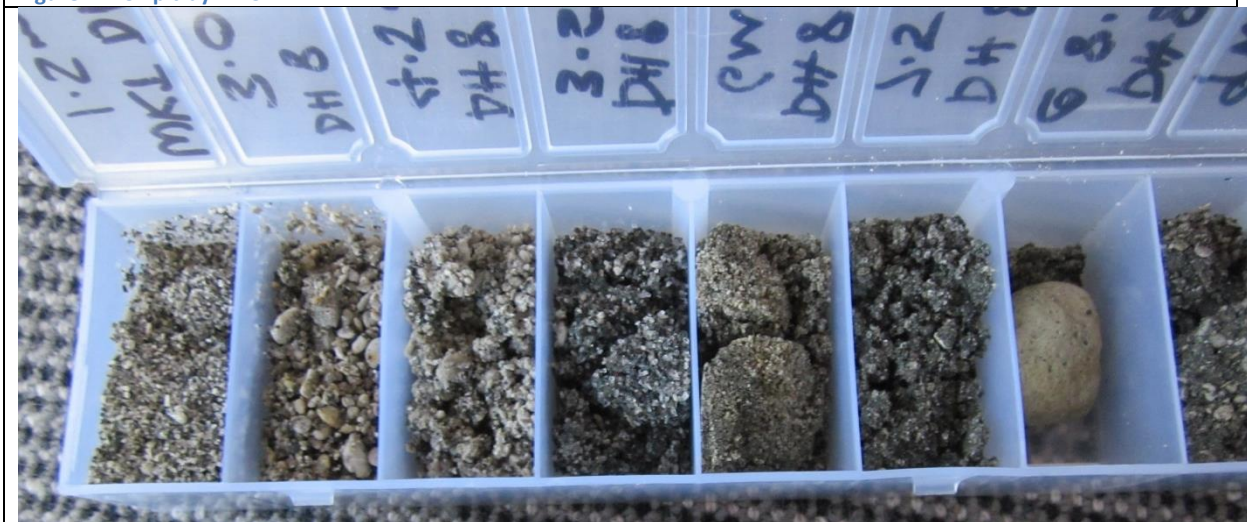
Figure 13. Chip tray close up BH 8

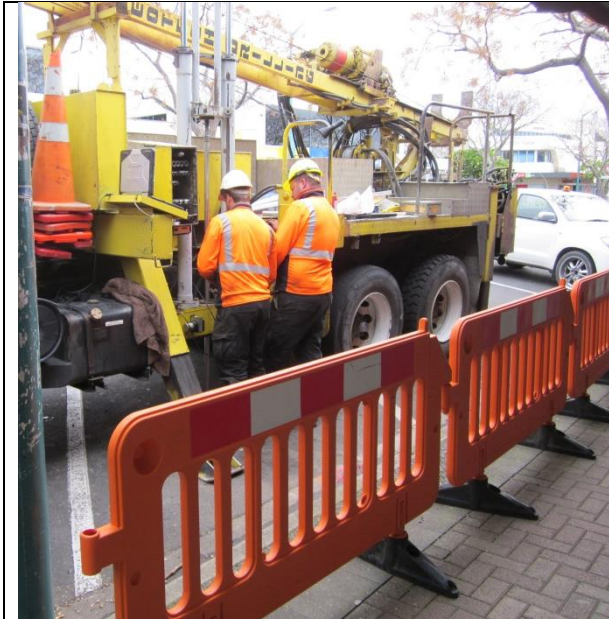
GEOTECH supplied a 2006 Isuzu FVZ1400 4x6 rig with both drilling and CPT capabilities as shown in (Figures 17-20).

Figure 17. GEOTECH CPT rig on Strand, note pedestrian management

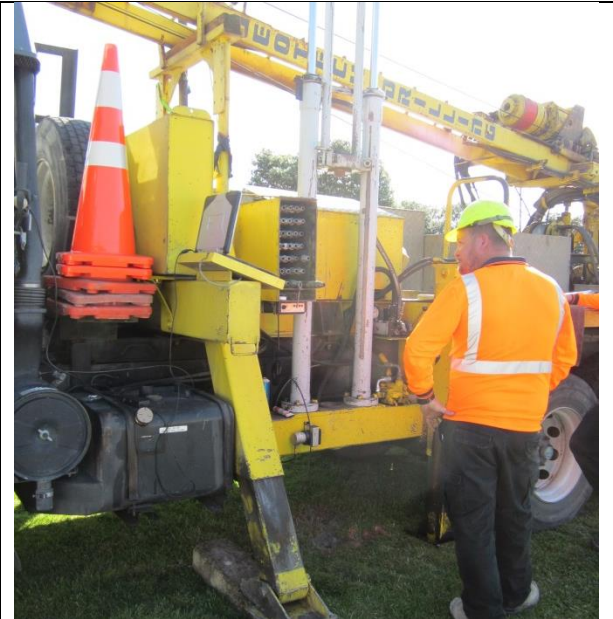
Figure 18. GEOTECH CPT rig, zero'ing electrics

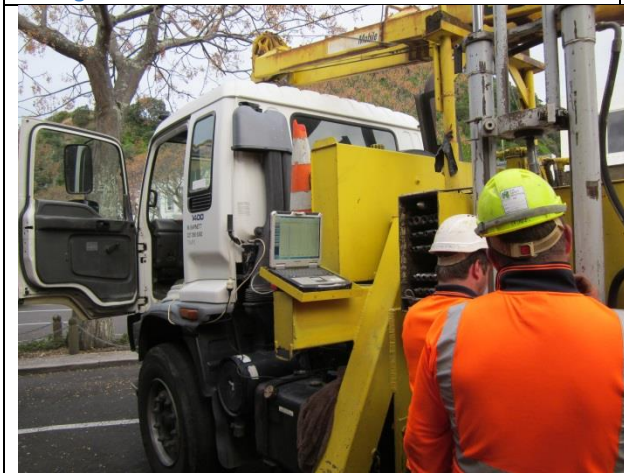
Figure 19. GEOTECH CPT rig, computer real time recording

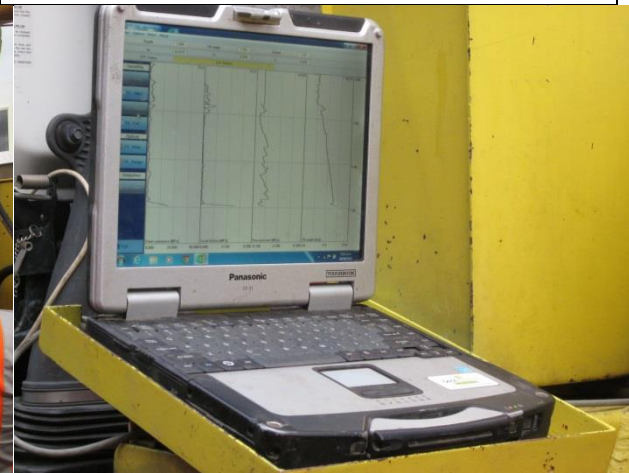
Figure 20. CPT Real time record CPT 17

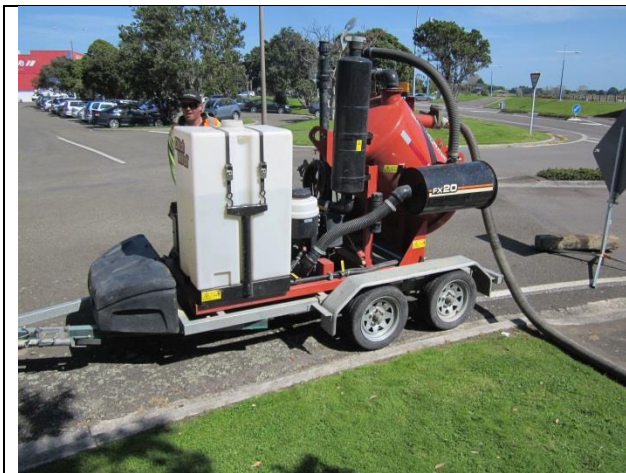
GEOTECH used a Ditchwitch Vacuum dredge to excavate starter pits to 1.2m on all CPT holes, using hand and crowbar methods where required (Figures 21-24). The materials were logged, and samples collected at 0.5, and 1.0m to represent the intervals excavated. These samples are labelled and stored in the WDC Keepa Street yard.

Figure 21. GEOTECH Vacuum trailer

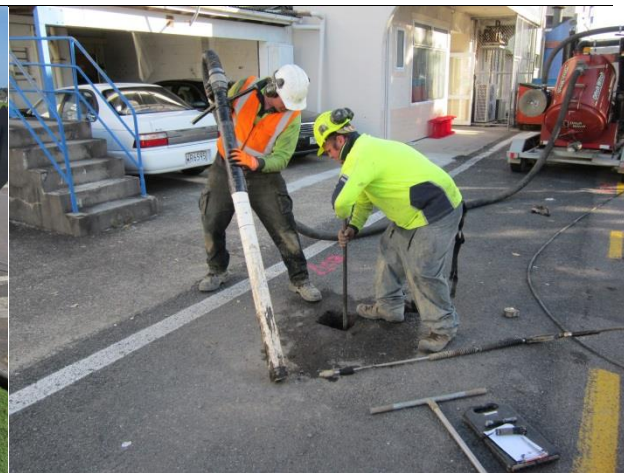
Figure 22. Vacuum wand and crowbar in action

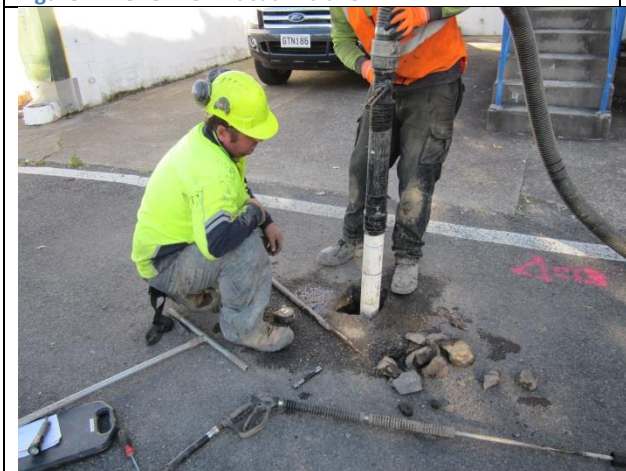
Figure 23. Vacuum wand recovering material

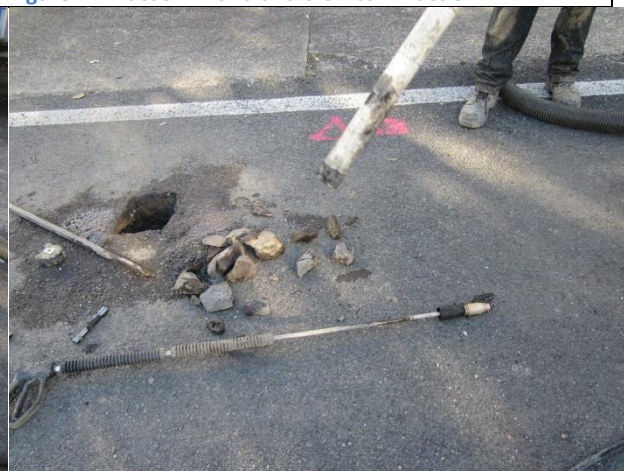
Figure 24. Vacuum debris and fill recovered

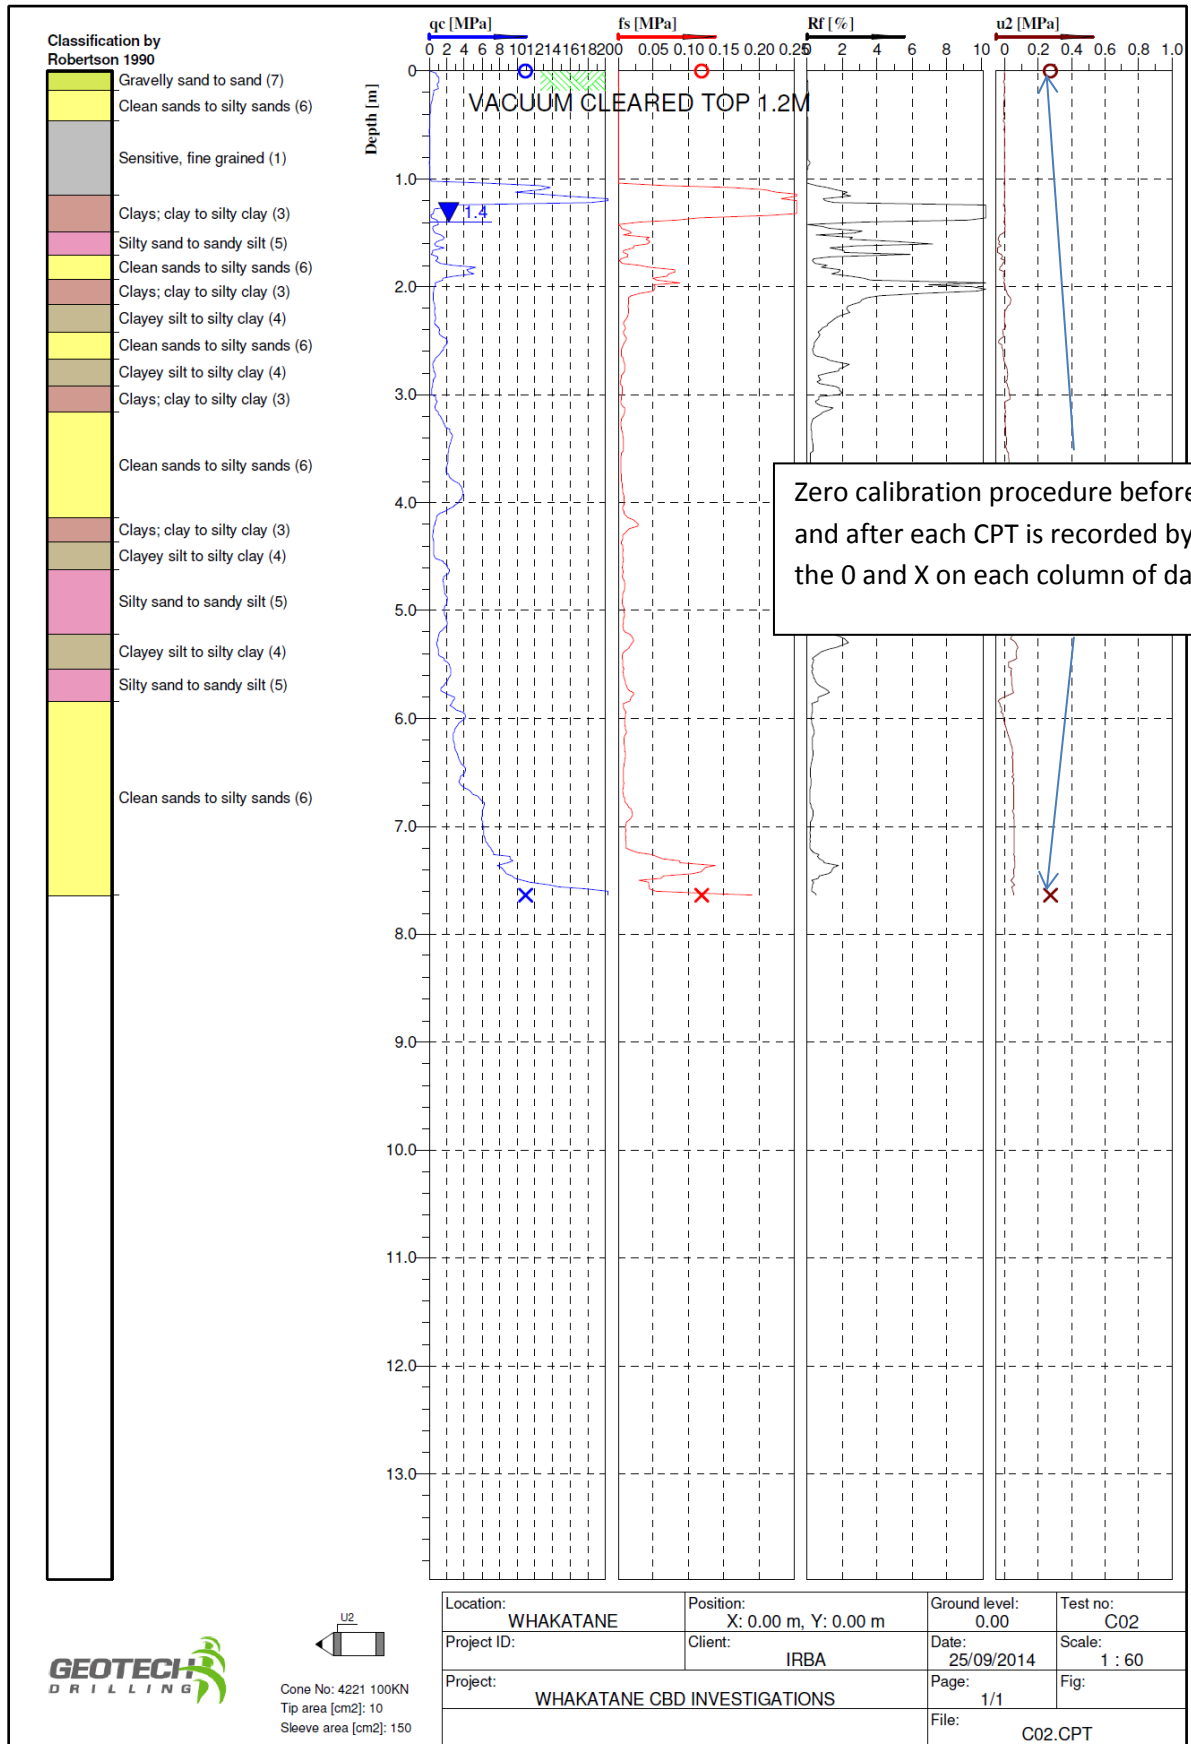
These data are then transposed onto clean copy sheets showing CPT records as a graphic log, showing cone resistance qc, sleeve friction fs, friction ratio Rf, and pore water pressure u2 and includes their interpreted soil classification by (Robertson 1990). (Figure 26). Water depth, cone number, tip and sleeve area and cone pressure are unique to each record, along with zero calibration as discussed in 3.4.

Figure 26. GEOTECH CPT Graph log C02

The cone is zero'd before and after each test and shown on the CPT pdf graph log as 0 and X at the start and end of each test (Figure 26). These are also recorded manually on the record sheet (Figure 25).
