**Appendix D: Seismic - Initial Evaluation Procedure**

**Initial Evaluation Procedure (IEP) Assessment - Completed for WDC**

Street Number & Name:	.....	Job No.:	851847
AKA:	.....	By:	DRV
Name of building:	Whakatane Commercial Wharf - 1919 section	Date:	12/12/2014
City:	Whakatane	Revision No.:	1

Street Number & Name:	.....	Job No.:	851847
AKA:	.....	By:	DRV
Name of building:	Whakatane Commercial Wharf - 1936 & 1940 sections	Date:	12/12/2014
City:	Whakatane	Revision No.:	1

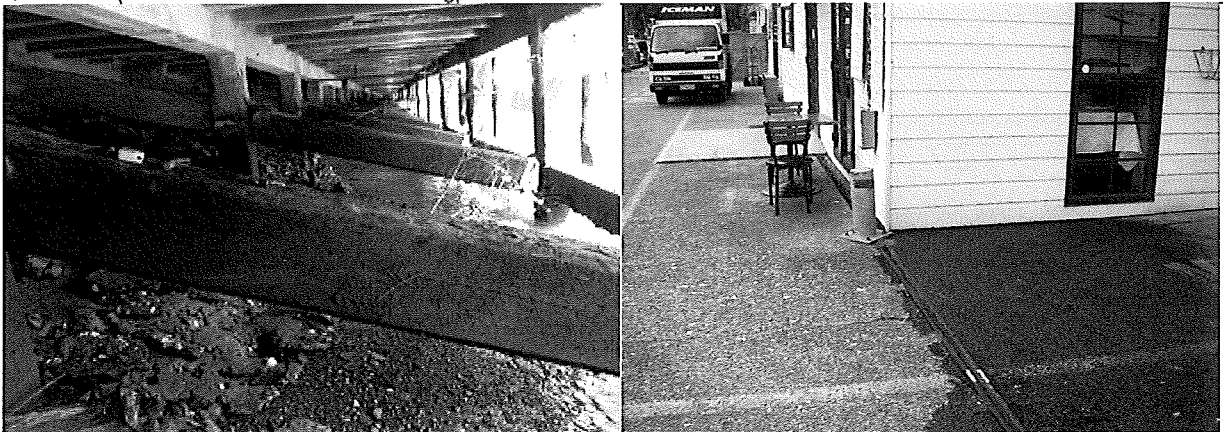
**1.1 Photos (attach sufficient to describe building)**

Reinforced concrete wharf constructed in 1919. The wharf deck between gridlines 3 and 4 is currently supporting a 1-2 storey building.  
 NOTE: This assessment assumes that the wharf has been repaired to reinstate spalled / cracked concrete and replace corroded reinforcing bars.

1. The wharf is currently in a poor state of repair. This assessment assumes that the wharf has been repaired to reinstate spalled / cracked concrete and replace corroded reinforcing bars.
2. It has been assumed that the wharf was designed as a 'public building'. This increases the IEP score by a factor of 1.25 (factor 'G') as public buildings were designed to higher loadings than other buildings.
3. Soil site class C has been assumed, based on T&T's experience of sites in the vicinity of the wharf. However, no site investigation at the wharf site has been undertaken. This may be required if a detailed assessment is undertaken.

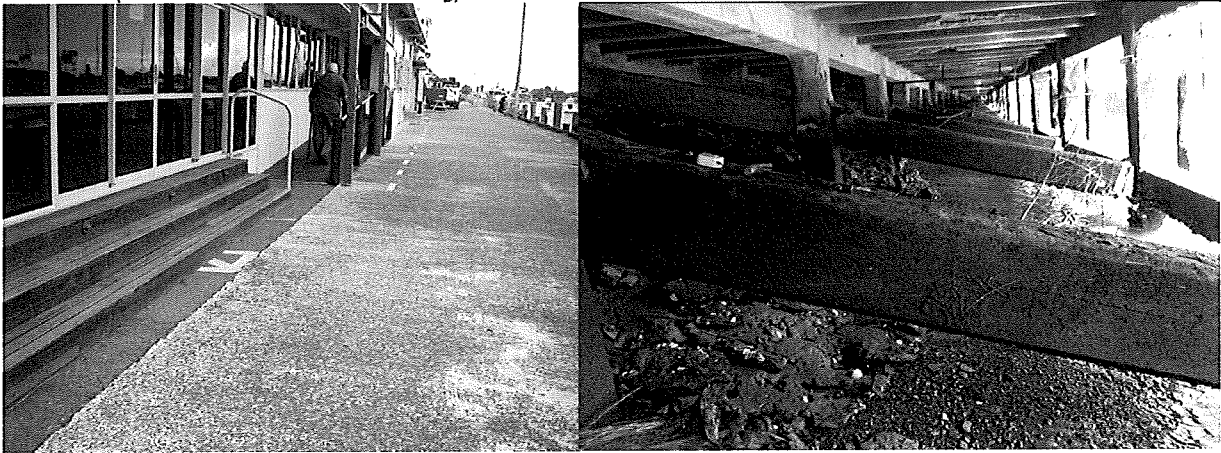
**1.1 Photos (attach sufficient to describe building)**

Reinforced concrete wharf constructed in 1936 (section A) and 1940 (section B). 1-2 storey buildings are located on grade, immediately behind the 1940 section of the wharf.

NOTE: This assessment assumes that the wharf has been repaired to reinstate spalled / cracked concrete and replace corroded reinforcing bars

- The wharf is currently in a poor state of repair. This assessment assumes that the wharf has been repaired to reinstate spalled / cracked concrete and replace corroded reinforcing bars.
- It has been assumed that the wharf was designed as a 'public building'. This increases the IEP score by a factor of 1.25 (factor 'G') as public buildings were designed to higher loadings than other buildings.
- Soil site class C has been assumed, based on T&T's experience of sites in the vicinity of the wharf. However, no site investigation at the
