**BEFORE THE ENVIRONMENT COURT
AT AUCKLAND**

ENV-2020-AKL-000064

**STATEMENT OF EVIDENCE OF CHRIS PHILLIPS ON BEHALF OF
WHAKATĀNE DISTRICT COUNCIL**

CATCHMENT MANAGEMENT

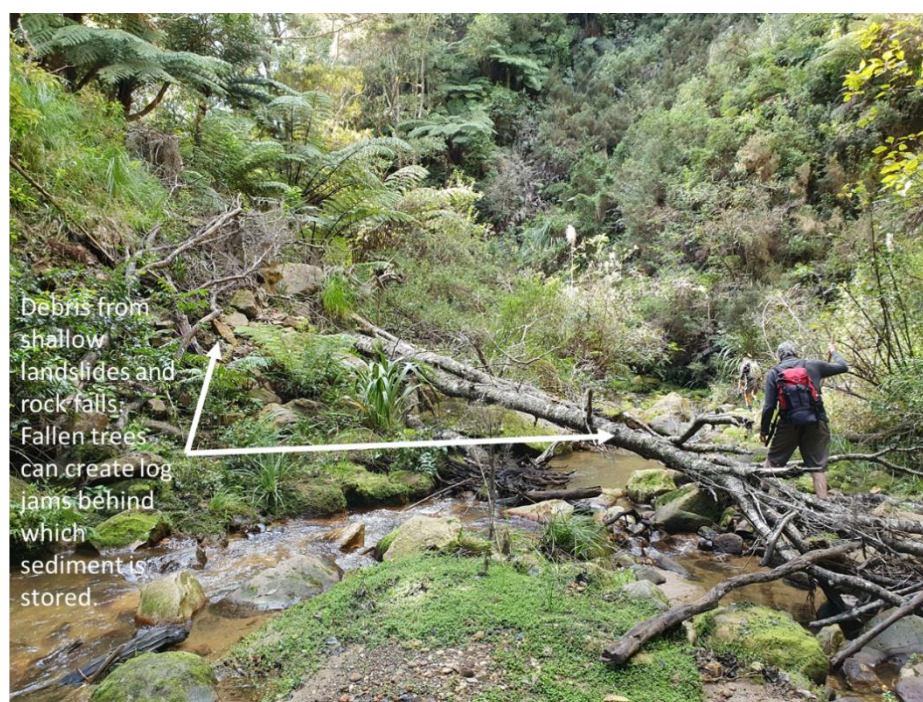
Figure 3 Photograph illustrating how fallen trees and woody debris delivered from cliff failures and/or toppling have the potential to form log jams in the Awatarariki Stream, July 2020.

- 7.18. Over time, debris and sediment is delivered to the stream channel via erosion of the side slopes from landslides, rock falls, tree toppling, and surface erosion, all of which cause the stream bed to aggrade (Figures 2 and 3). This is a natural process.

- 7.20. Logs and vegetation delivered to the streams from cliff tops and by landslides may also create barriers or log jams behind which sediment and debris can accumulate (Figure 3). This also is a natural process. These log jams are removed only in the largest erosion events such as in 2005 when debris flows evacuate all (or nearly all) stored material within the channel (usually down to bedrock – see Figure 4) delivering it downstream onto the fanhead where it is deposited as the debris flow loses energy as the slope gradient lessens, the flow depth reduces, and the debris flow loses water.

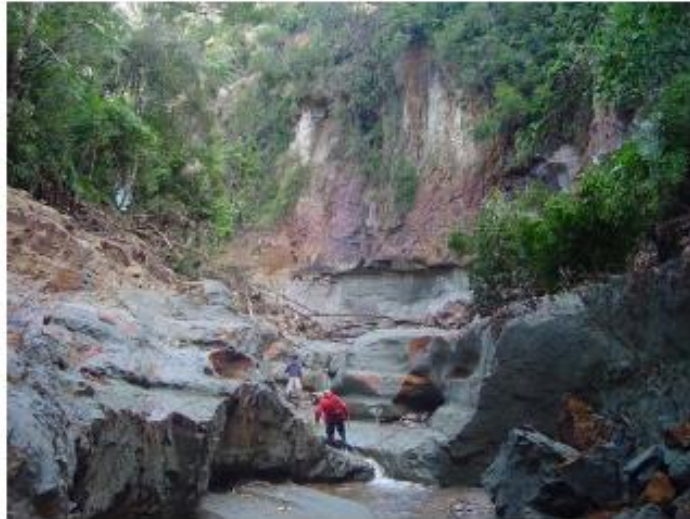
Figure 4 Cleaned out channel following 2005 debris flow. Photo M. McSaveney (McSaveney et al. 2005).
