**Finding the concealed section of the Whakatane  
Fault in the Whakatane Township with a shear wave  
land streamer system: A seismic surveying report**

**GNS Science Report 2016/41  
August 2016**

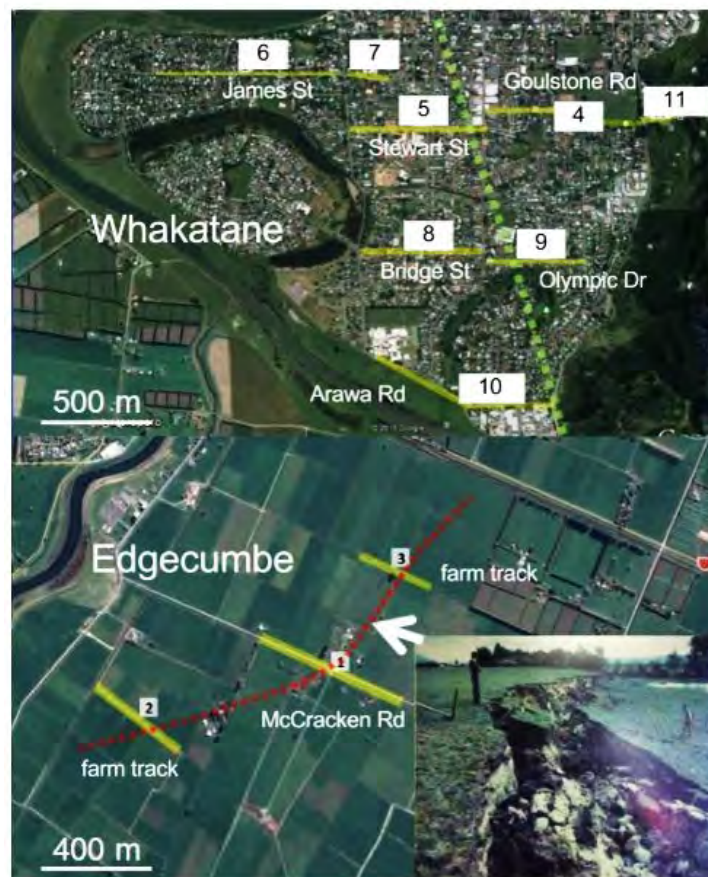
**Figure 4.1** Overview of the survey area and seismic profiling map (yellow lines) at Edgcumbe (lower) and Whakatane (upper) survey sites. At Edgcumbe, the red dotted line marks the fault scarp of the 1987 rupture, the green dotted line marks the linear extrapolated Whakatane Fault trace from its known location south of the city. Street names: 1 - McCracken Rd, 2,3 - farm tracks, 4 - Goulstone Rd, 5 - Stewart St, 6,7 - James St, 8 - Bridge St, 9 - Olympic Dr, 10 - Arawa Rd, 11 - Gorge Rd.

The aim in Whakatane was to locate the Whakatane Fault within the town where its precise location was unknown prior to this study. In Whakatane, E-W profiles across the strike of the fault were designed to include the likely location of the fault. The profiles cover most of the Whakatane residential area (Figure 4.1). An overview of the survey area is shown in Figure 4.1. The figure caption gives a reference to the names of the streets these profiles followed.

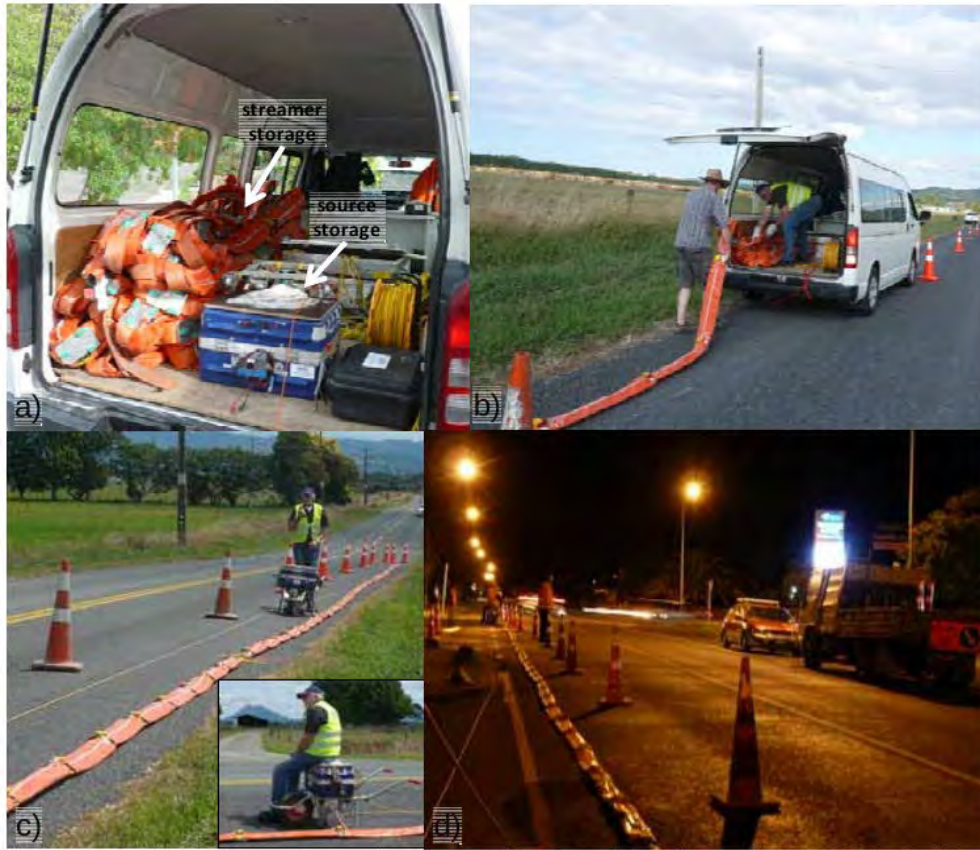
**Figure 4.3** Seismic land streamer receiver system (developed by LIAG and GEOSYM): a) during transportation including the dismantled source system; b) during release on site; c) during recording operation on Edgcumbe Fault slope site; d) during night operation in Whakatane. The geophone system was permanently connected to a GEODE seismic recording unit of 96 channels within the recording car at the front of the streamer, from where the recording operation was managed.

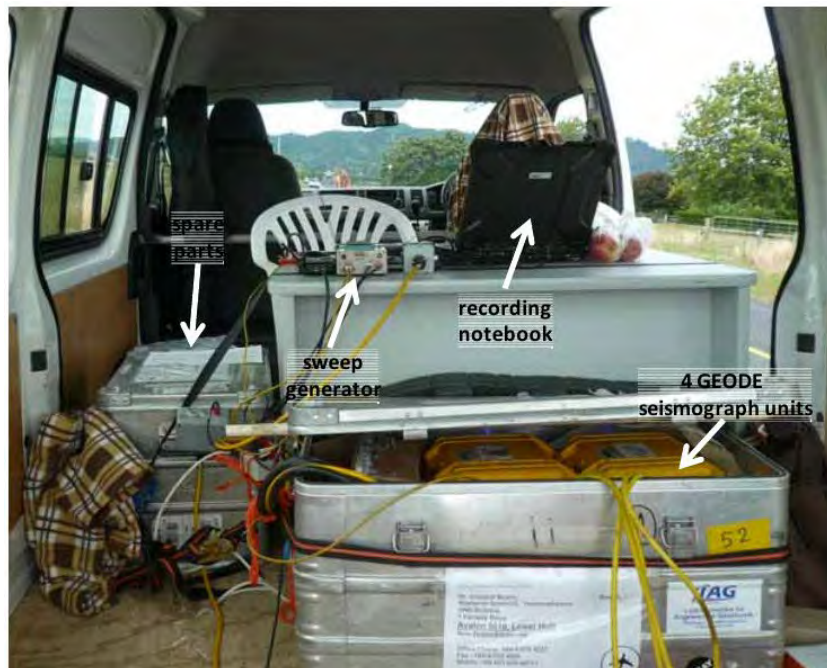
**Figure 4.4** Recording equipment installation in the recording car and operators place. The yellow boxes within the aluminium box contain four GEODE seismograph digitizers connected to the recording notebook by an ethernet line. A pack of four 12 V batteries of 160 Ah in total are stored hidden below the table to enable sufficient power supply for several days. The sweep generator on top of the table creates the desired frequency modulated chirp signal (sweep) real time from a digital storage EPROM and initialises precisely the start of the data recording. The signal is sent parallel to the source and the recording system.

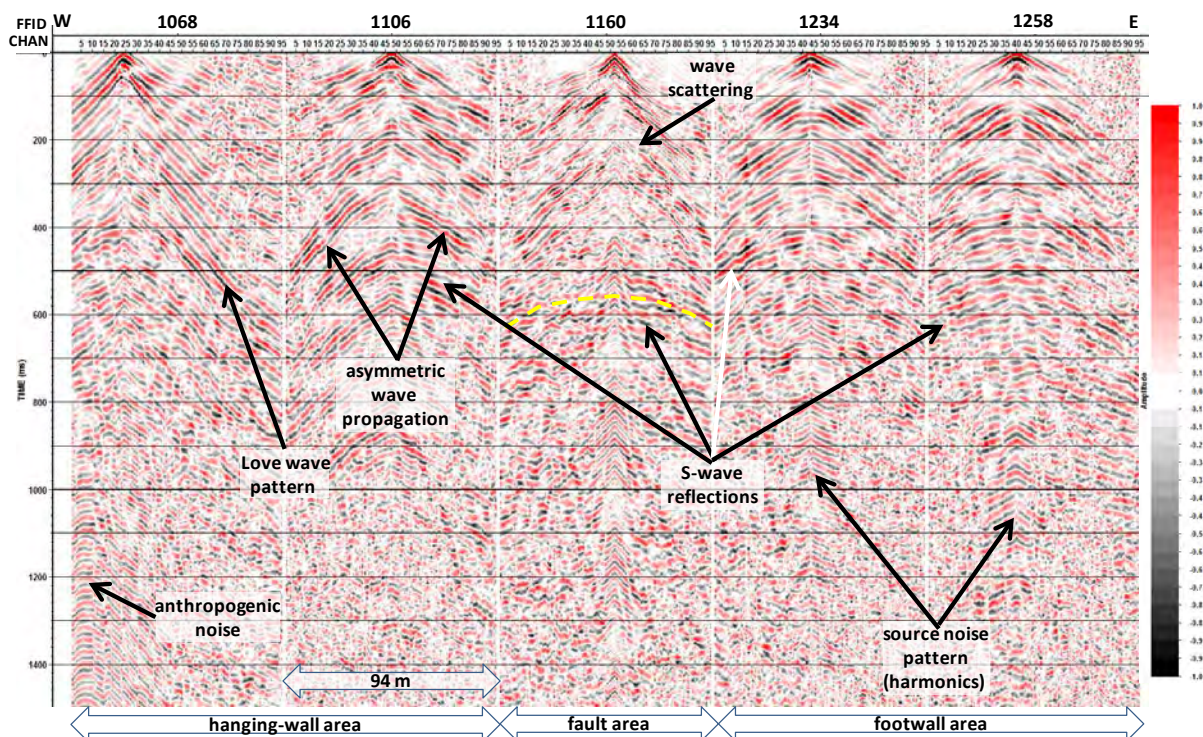
**Figure 5.1** Examples of raw records from profile 1 across the Edgecumbe Fault (AGC 250 ms, Bandpass Filter 18-22-65-75 Hz) showing three zones of different wave propagation behaviour along the profile. In the western part (FFID 1068 and 1106) some Love waves of low velocity and an asymmetric propagation behaviour are dominant in the records, mostly covering the reflection signals. In the zone above the fault (FFID 1160), wave scattering is dominant in the upper part of the records, whereas clear reflections are visible below. In the eastern part of the profile the records consistently show a series of good quality reflections without disturbing wave parts. See Figure 4.1 for profile location.

Figure 5.1 shows a single example record from profile 1, which crosses the Edgecumbe Fault nearly perpendicular to McCracken Road southwest of the village of Edgecumbe (see Figure 4.1 for profile location). Here, the surface trace of the Edgecumbe Fault is clearly visible in the terrain and expressed as a c. 4 m topographic step adjacent to the road. The trace was thoroughly documented after the earthquake in 1987 (Beanland et al., 1989).

The wave propagation behaviour is almost asymmetric with respect to the source position, which indicates an anisotropic subsurface structure. Furthermore, even though a uniform asphalt pavement of good quality is present at the surface, Love wave propagation is partly visible in the western part of the profile, indicating low velocity layers in the shallow subsurface. Tests to eliminate the Love wave portion in the raw records by applying a FK-filter led to unsatisfactory results, especially with respect to structural imaging near the fault area. The best result for the whole profile was achieved using a processing sequence without any suppression of undesirable parts of the wave field. The analysis of the velocity field required careful tests in a narrow velocity window required by the overall low velocity range of 50-250 m/s. The analysis was carried out using an interactive velocity analysis, combining several data imaging versions for a parallel analysis. An example from profile 1 is shown in Figure 5.2.

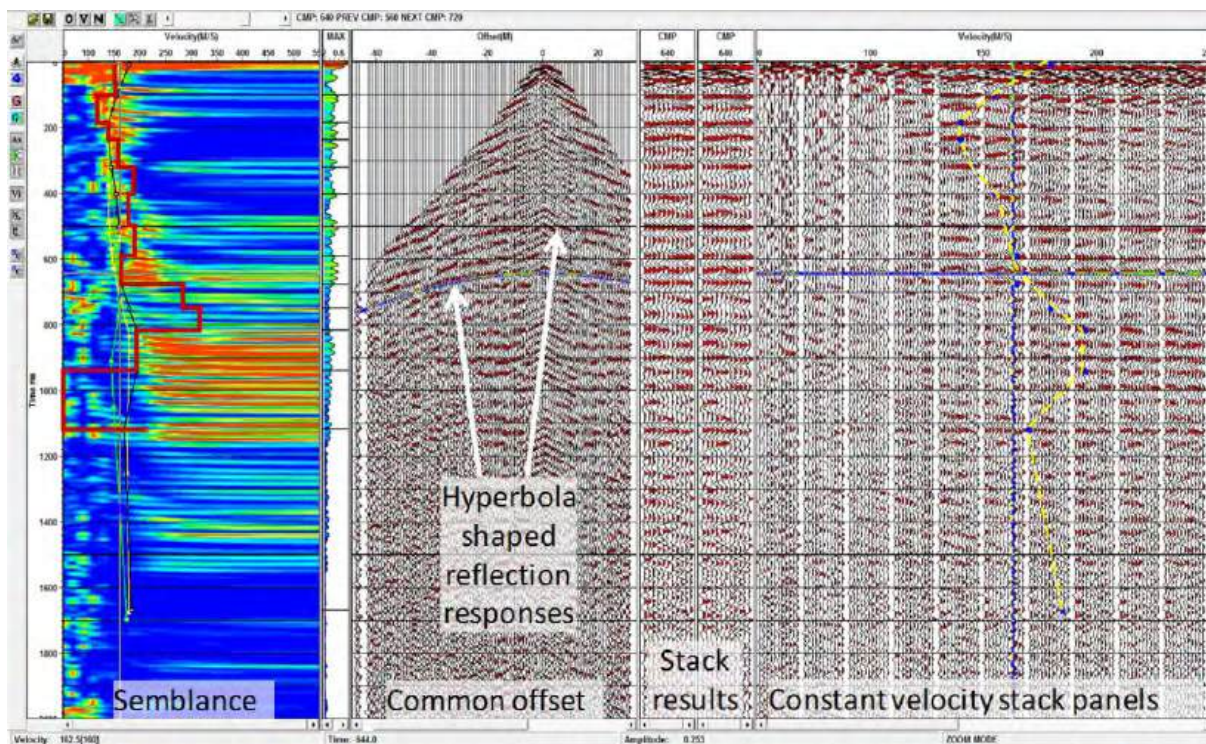
**Figure 5.2** Screenshot example from Interactive Velocity Analysis at CMP 640 of profile 1 (Edgcombe Fault) during the Brute processing. It mainly consists of a combination of three data imaging windows called Semblance, Common Offset Trace Gather (COG), and Constant Velocity Stack (CVS) panels. This analysis supports the verification of reflection responses indicated by the hyperbola curvature characteristics in the COG and the calculation of a best fitting NMO velocity-time-function (shown as yellow line in the CVS panel). Lines shown in the Semblance window image changes from previous CMP analysis location (green) to current CMP analysis location (black) and to next CMP analysis location (yellow). The red line shows the resulting interval velocity in time derived from the NMO velocity (black). Semblance window colours mark the resulting stacking energy (blue: low, red: high) depending on the velocity used. See Figure 4.1 for profile location.

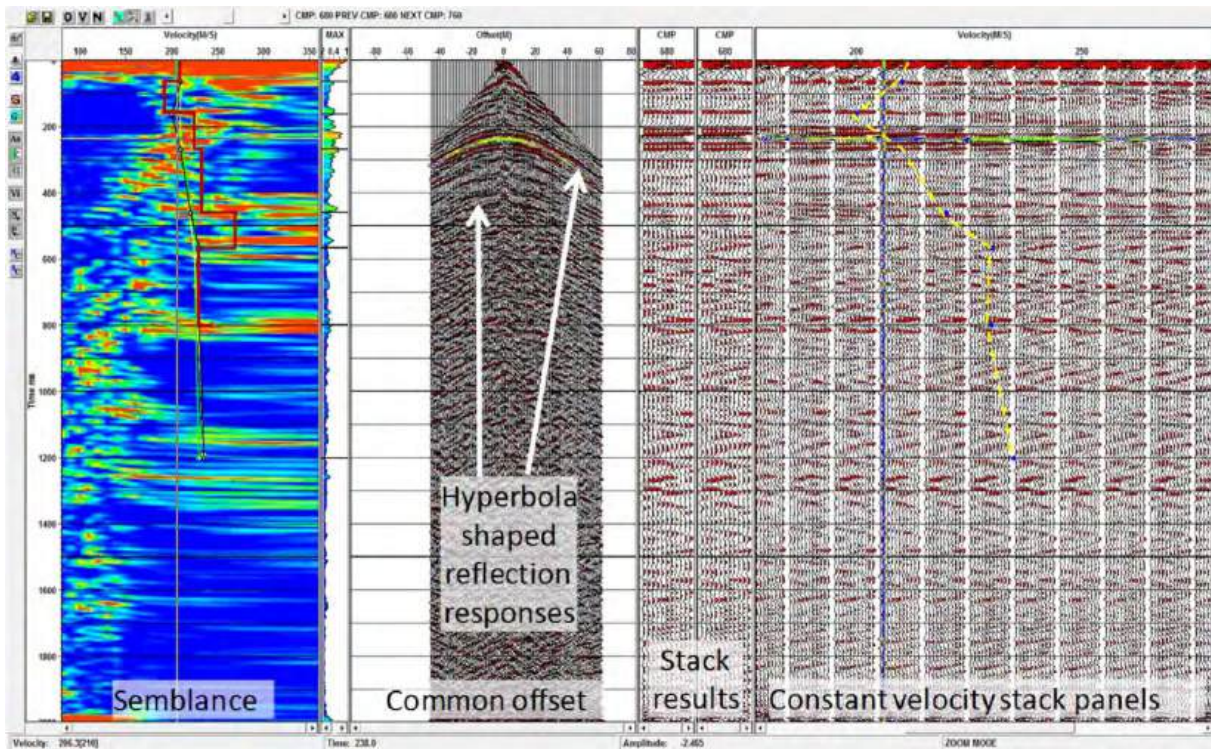
**Figure 5.8** Screen shot example from Interactive Velocity Analysis at CMP 680 of profile 5 in Whakatane township. For the marker reflector a mean velocity of nearly 200 m/s can be determined with good precision, providing an estimated depth of nearly 20 m. surrounding wavelet signatures indicate a vertical resolution of less than one metre. Below 20 m the precision of the velocity determination and the resolution decreases due to lower reflection strengths and, below 600 ms, due to the restricted offset range of the survey setup. See Figure 4.1 for profile location.

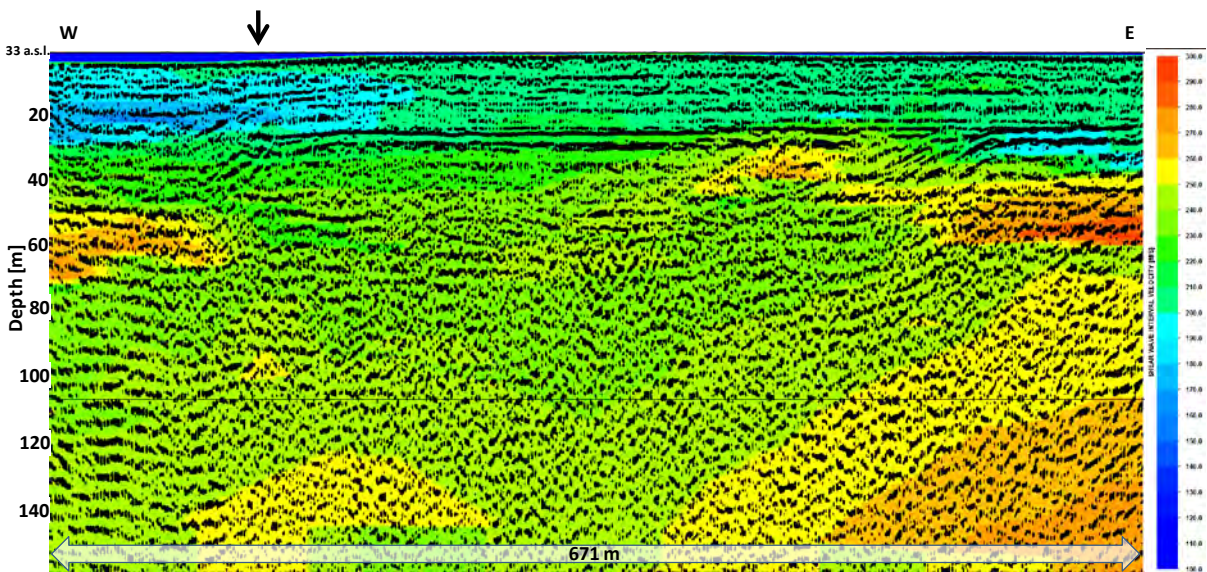
**Figure 5.12** Depth section of profile 5 in Whakatane township colour coded by shear wave interval velocities in depth derived from the seismic data (horizontal-to-vertical scale of 1:2). Due to the limited offset range of the survey setup, velocities below 80 m may be erroneous. The blue zone on top left is caused by topographic corrections applied (reference datum 33 m a.s.l.). See Figure 4.1 for profile location.

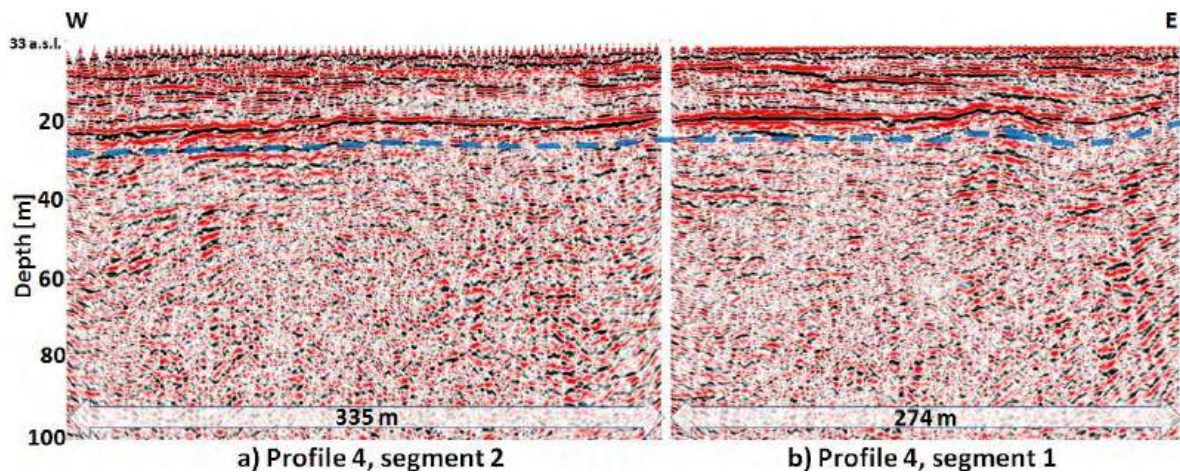
**Figure 6.2** Depth sections of profile 4 with a horizontal-to-vertical scale of 1:2 (each). The profile was acquired in two segments (2, west, 1 east) along Goulstone Rd. The profile clearly exhibits a marker horizon (blue dashed line traces the horizon slightly deeper to avoid concealing it), which correlates well with findings in Begg et al. (2015) (see Figure 6.3). Figure 4.1 provides profile location.

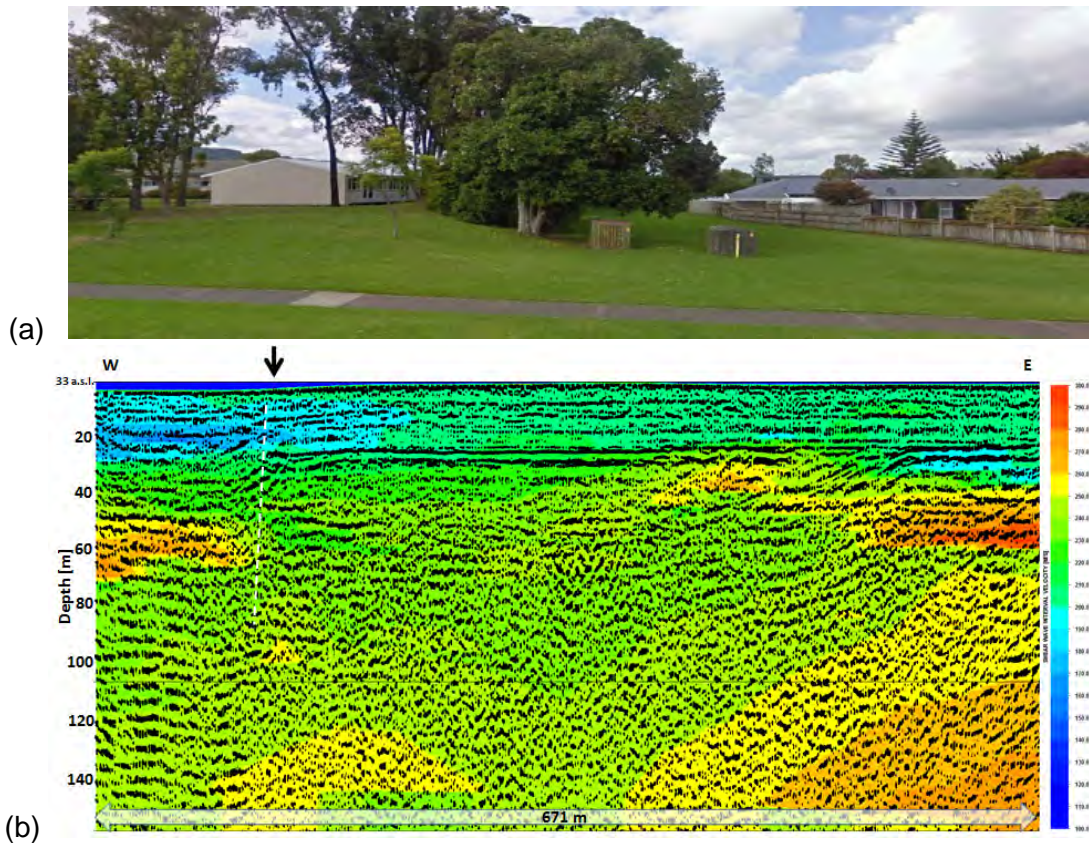
**Figure 6.4** a) View to the south on Stewart Street at profile metre 550, Profile 5. The step in the terrain is obvious and is also observed further north on James Street (Profile 7) and Victoria Avenue – for further discussion see text. b) Same as Figure 5.12 but with an interpretation of the location of the fault (white dashed line) based on changes in reflectivity patterns, seismic velocity structure and discontinuation of the marker horizon.

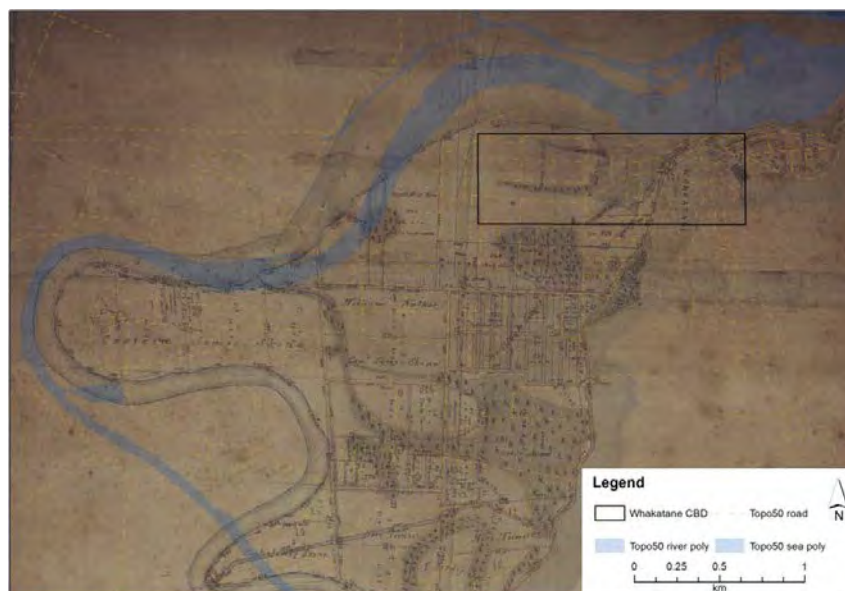
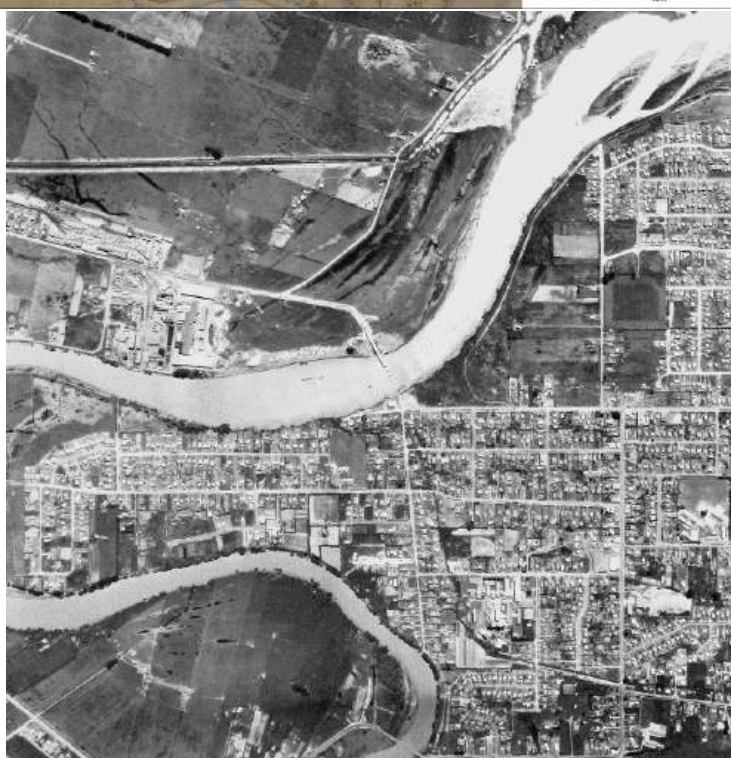
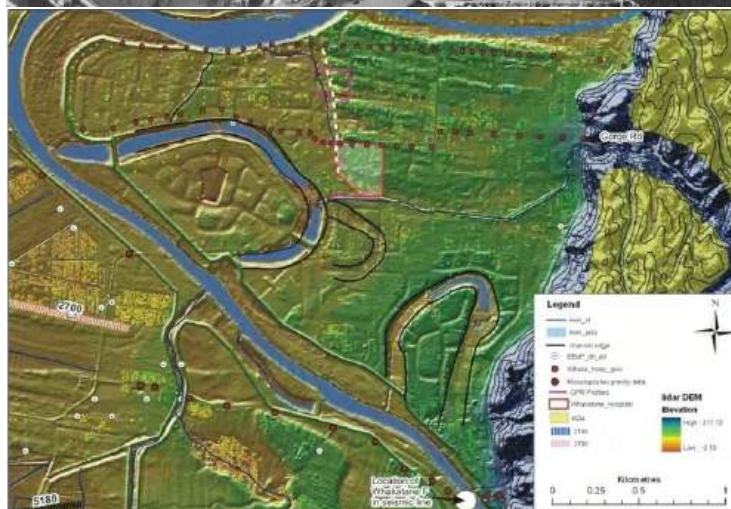
**Figure 6.6** a) Whakatane District Council archival map dated 1867 (Begg et al., 2015) showing a swamp and stream system following the surface features discussed here. b) Aerial photograph from 1988 (Lands and Survey Department, Wellington, New Zealand, photo number 3331/47). c) The LIDAR image of the area also shows this feature (white dashed line).

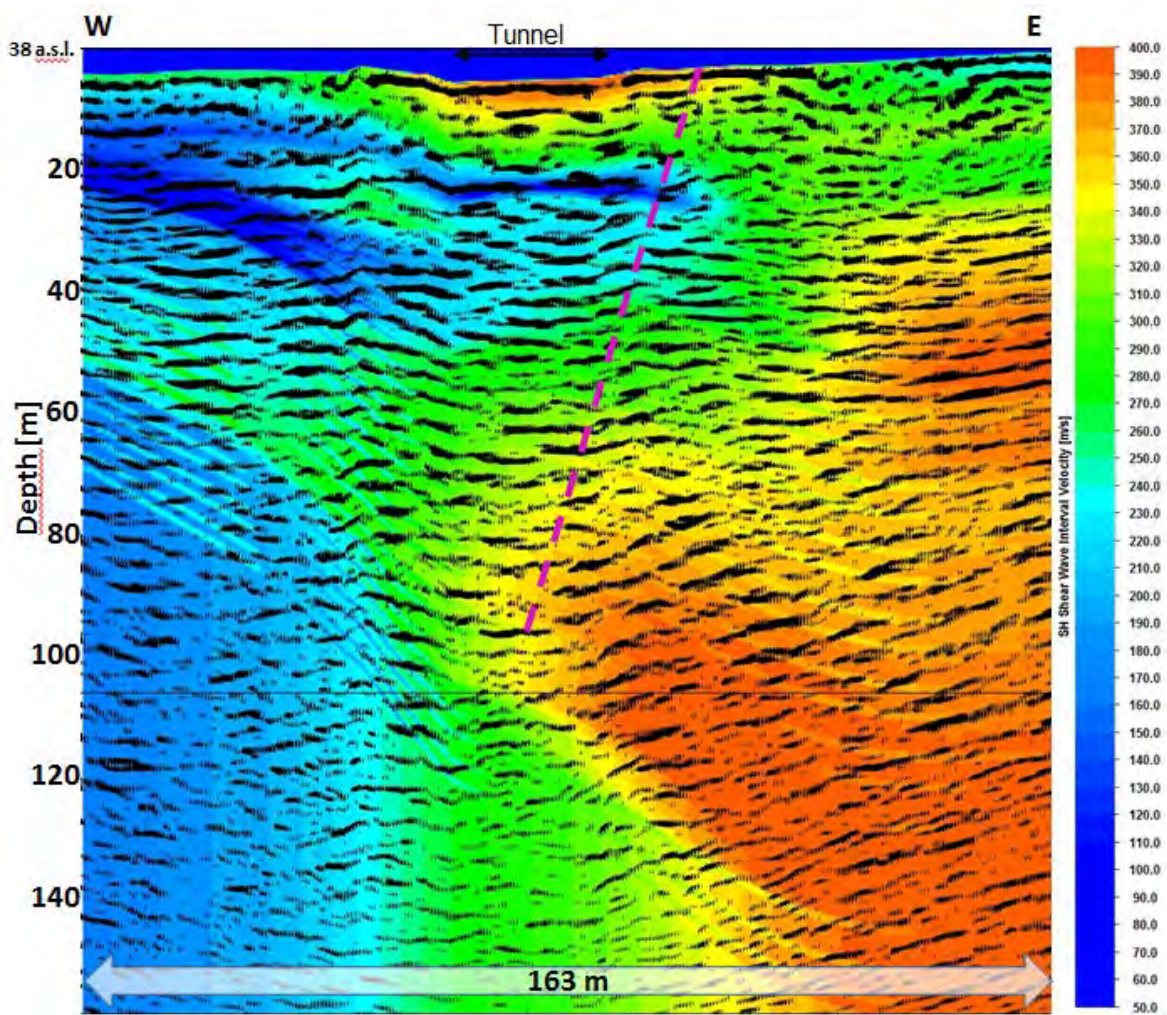
**Figure 6.11** Shear wave interval velocity structure for profile 11 (compare with Figure 6.10). The dashed magenta line gives a tentative interpretation of a potential fault location which was expected due to the geological structure. This profile was acquired through the pedestrian tunnel made of concrete connecting Goulstone Rd and Gorge road. The location of the tunnel is indicated and also visible due to the high velocities close to the surface. See Figure 4.1 for profile location.
