Whakatane Commercial Wharf

Condition Assessment and Repair Options Report

**Prepared for:
Whakatane District Council**

February 2015
Job No: 851847

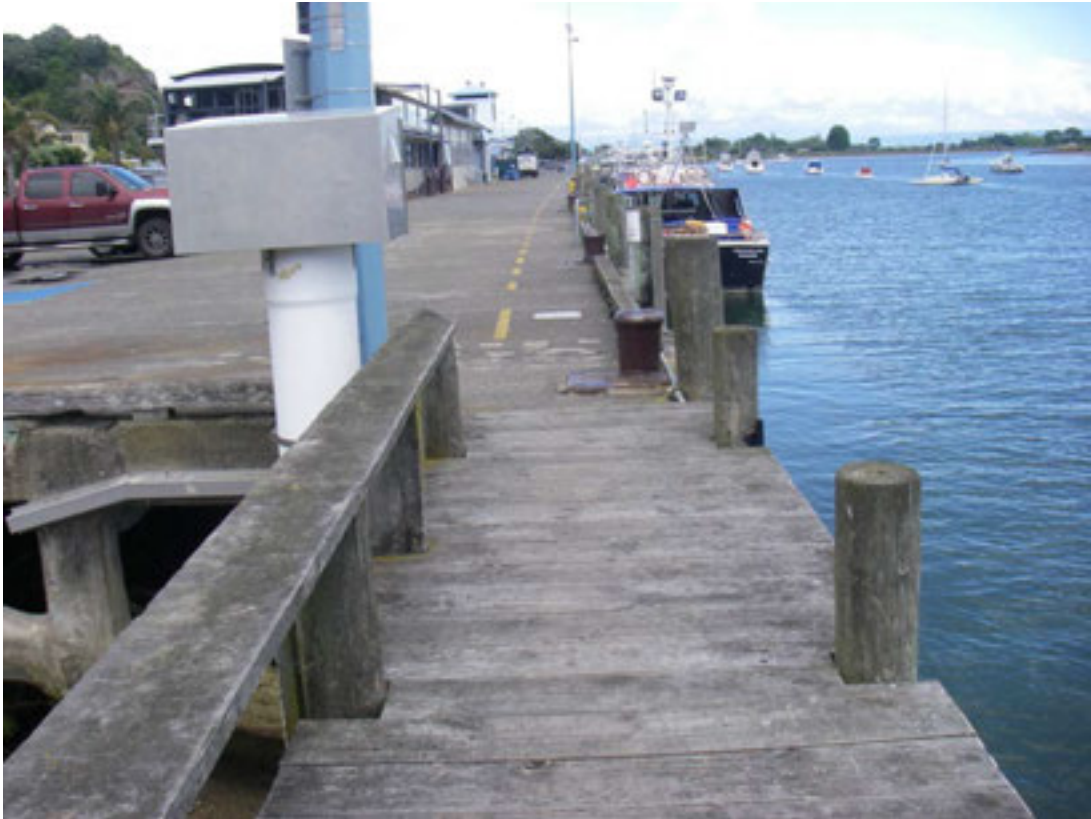
Photo T01 - view from east end of wharf

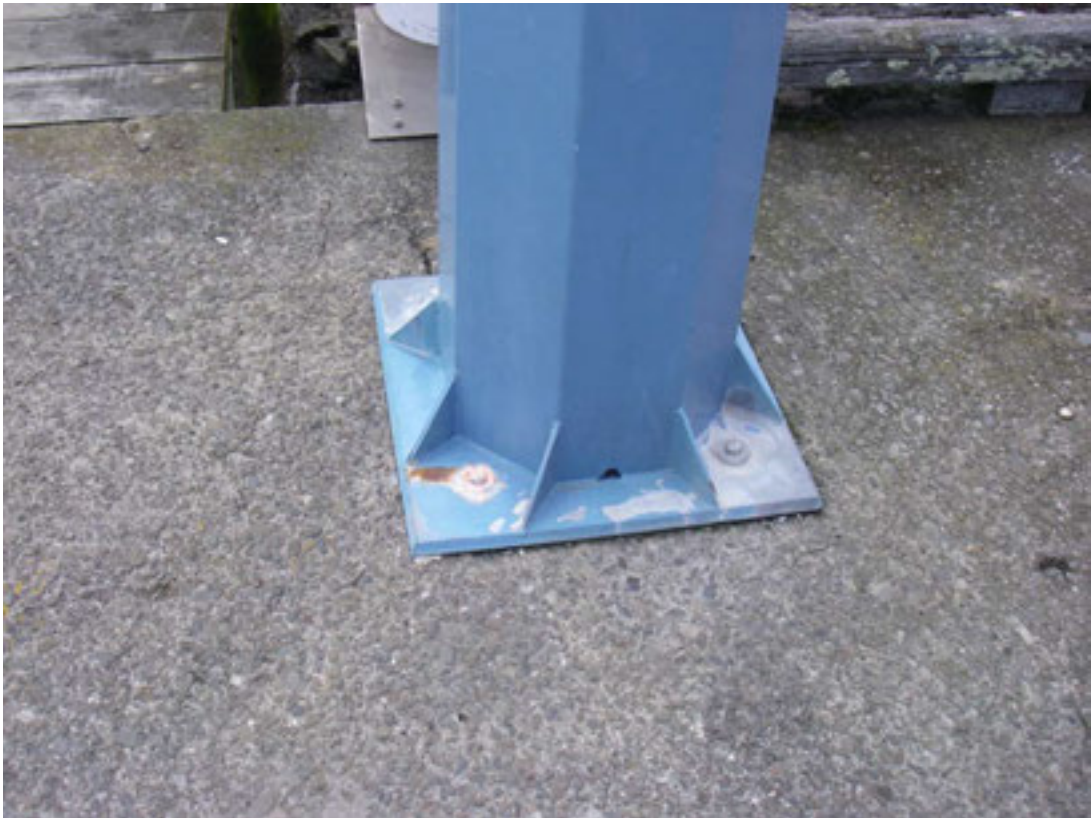
Photo T02 - pole at east end of wharf

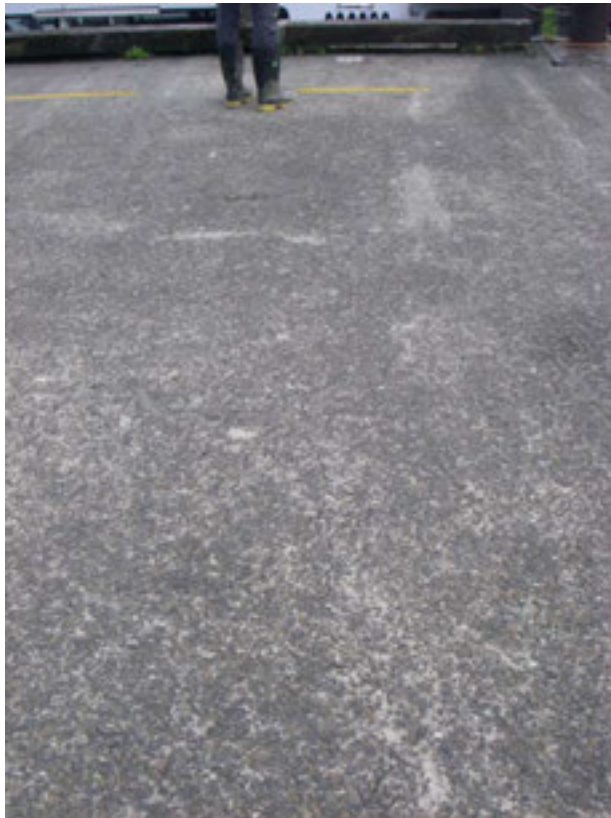
Photo T06 - cracking in slab (1940 section)

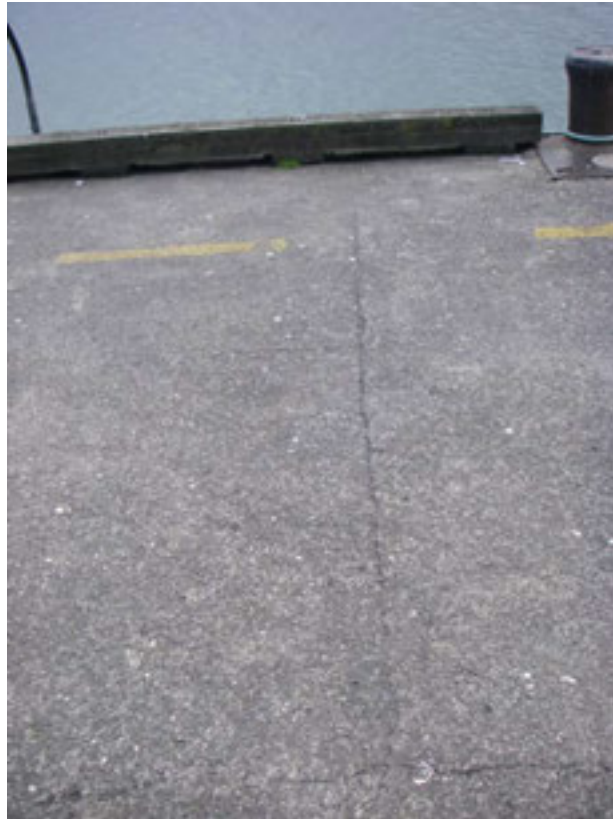
Photo T09 - cracking in slab (1919 section)

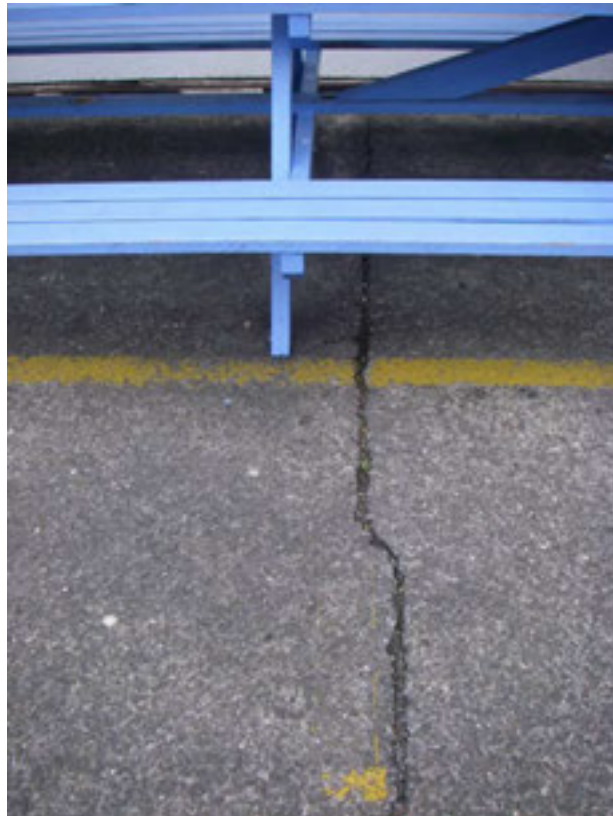
Photo T10 - cracking in slab (1919 section)

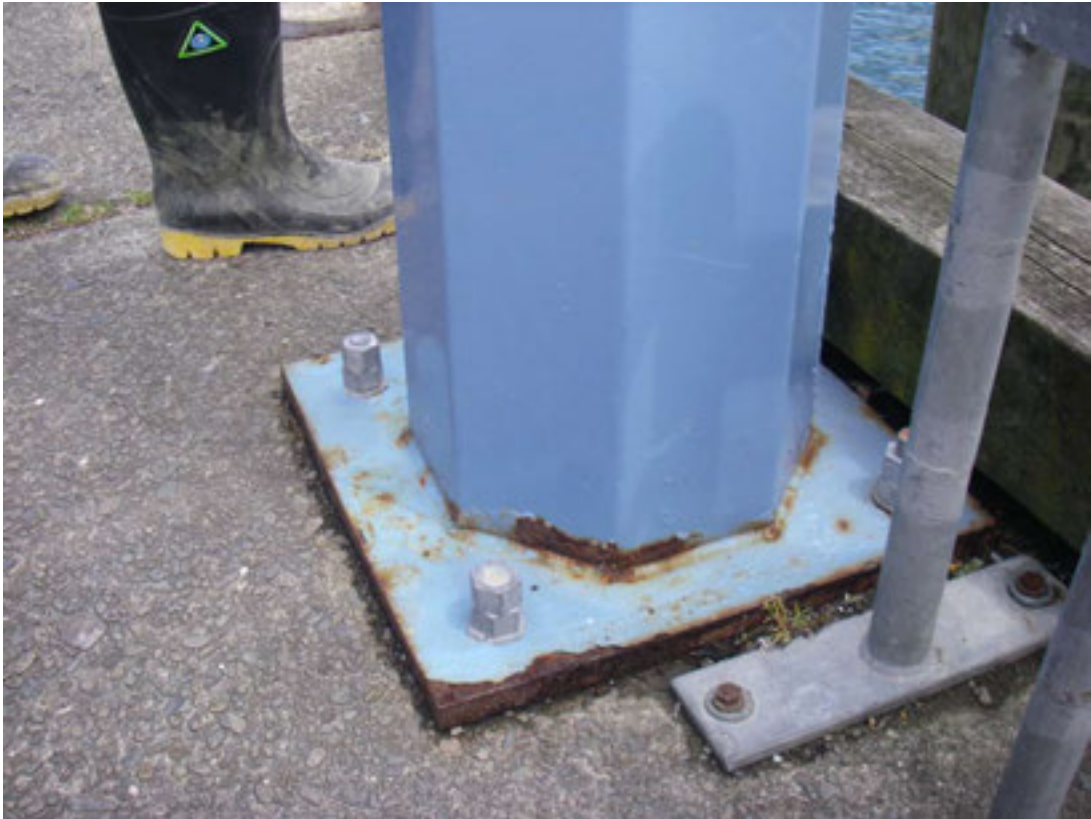
Photo T13 - pole on wharf (1940 section)

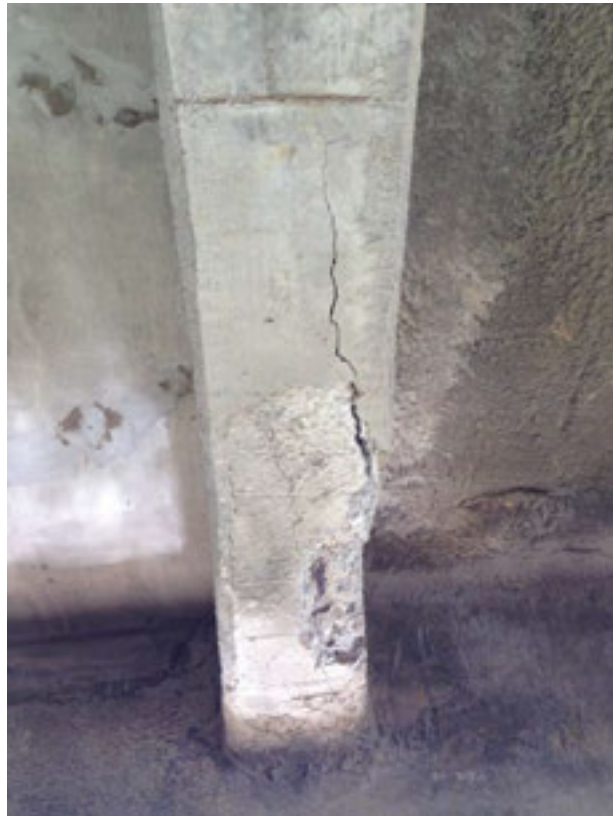
Photo A07 - beam cracking / spalling between A1 and A2

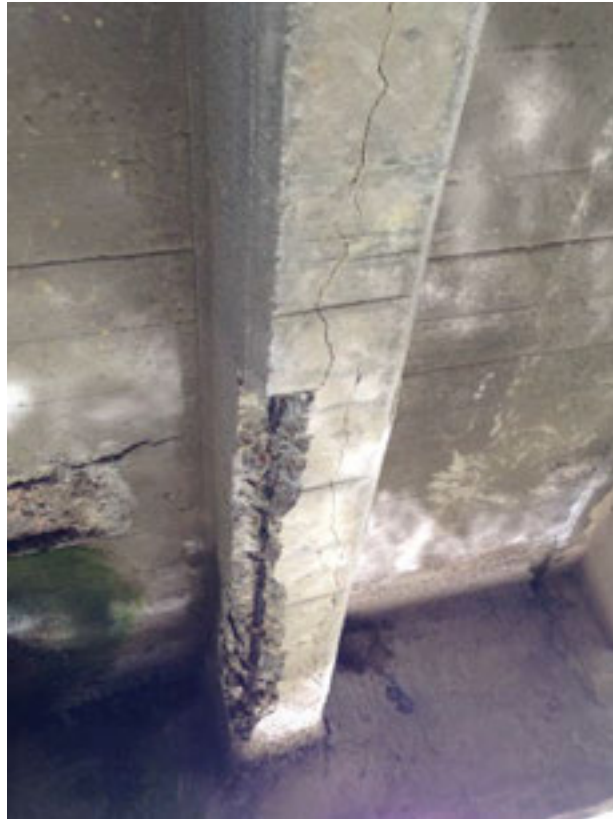
Photo A08 - beam cracking / spalling between A1 and A2

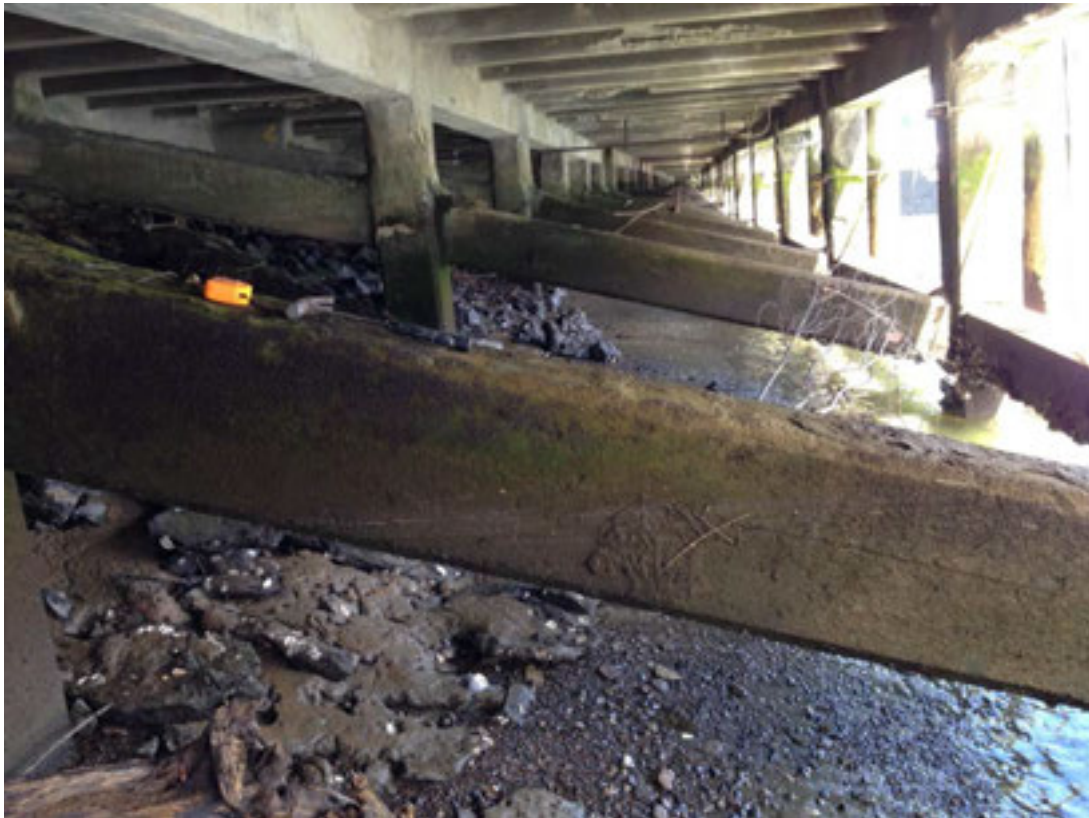
Photo A09 - View along wharf from gridline A2

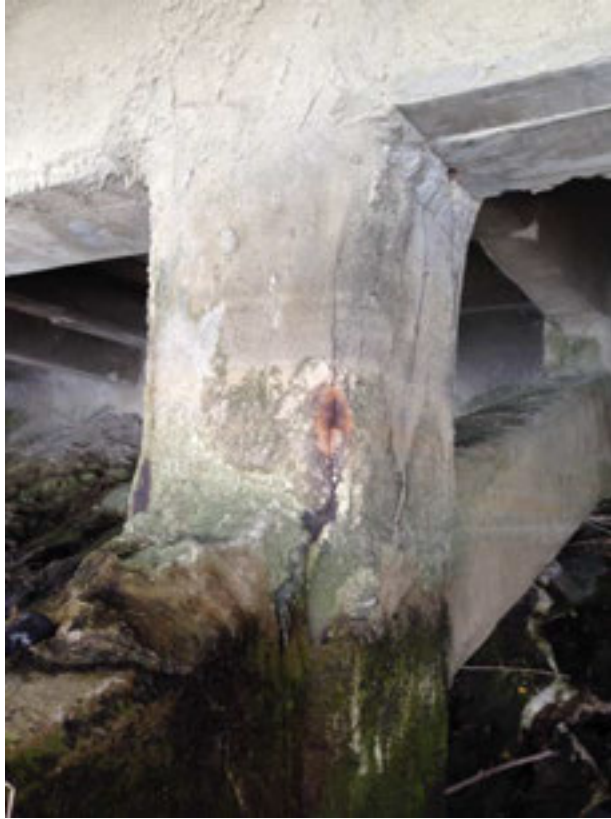
Photo A18 - Pile cracking at A3

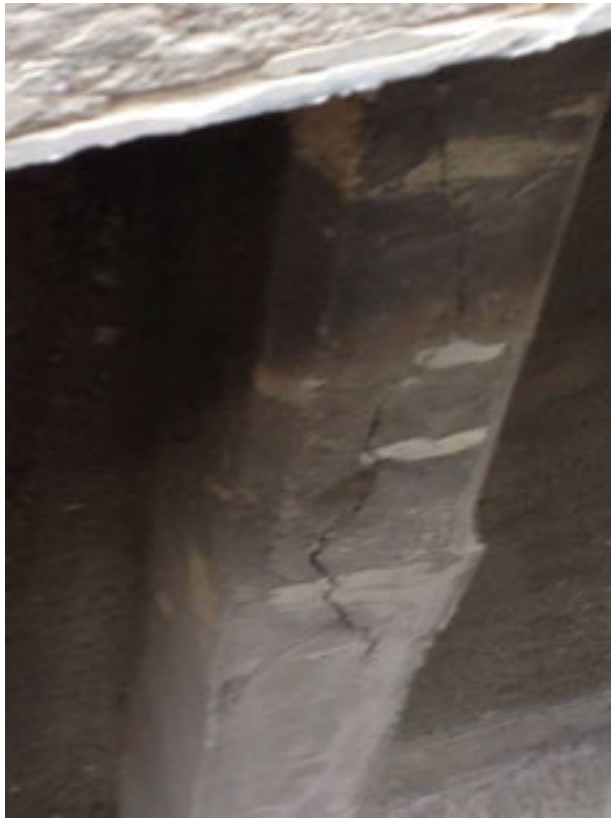
Photo A19 - Cracking of beam between A3 and A4

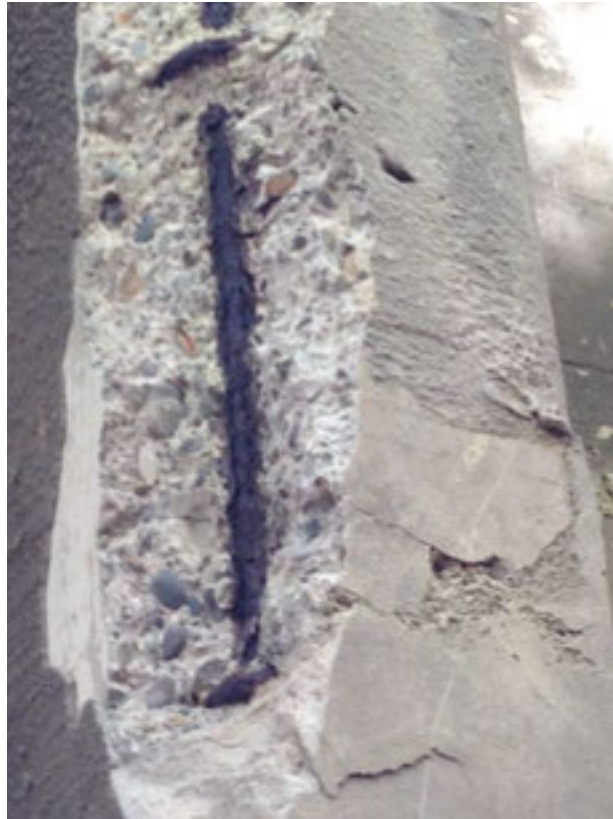
Photo A20 - spalling of beam between A3 and A4

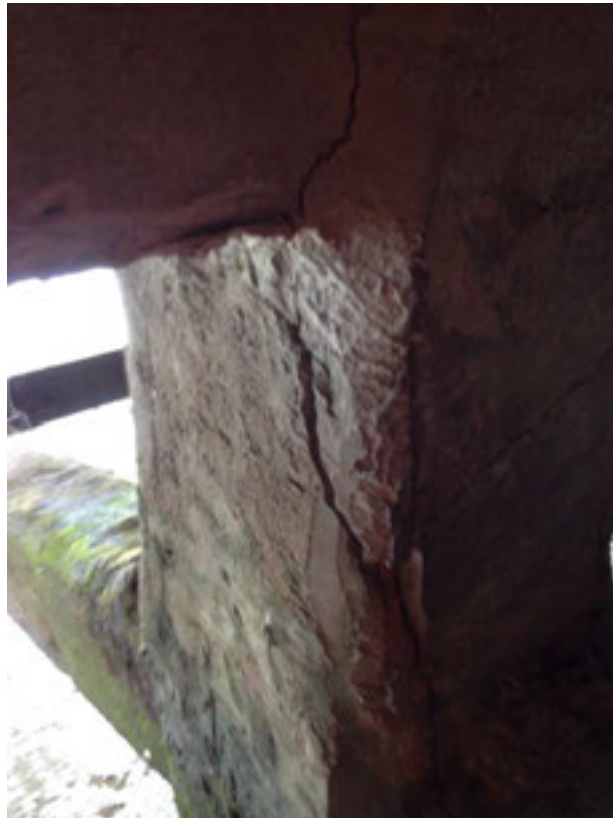
Photo A27 - Cracking of pile at A4

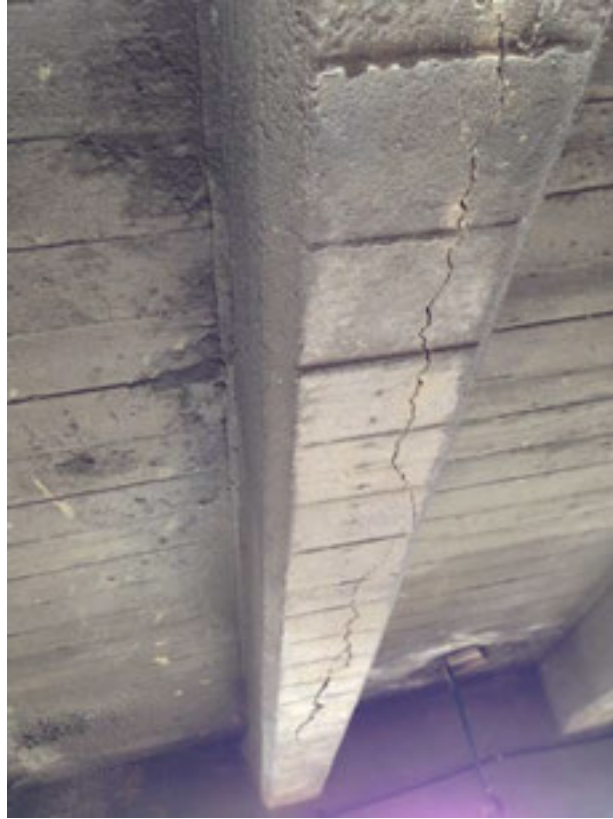
Photo A30 - cracking of beam between A5 and A6

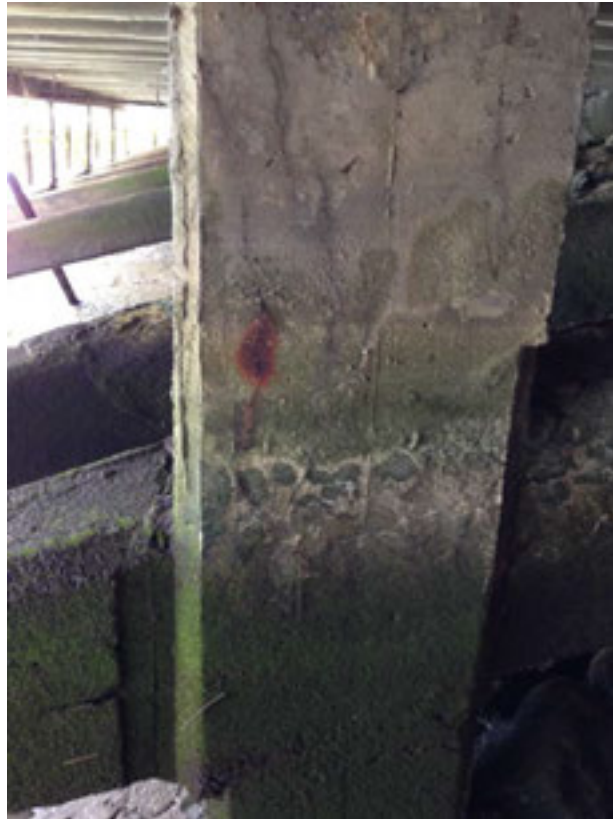
Photo B02 - Staining at B1

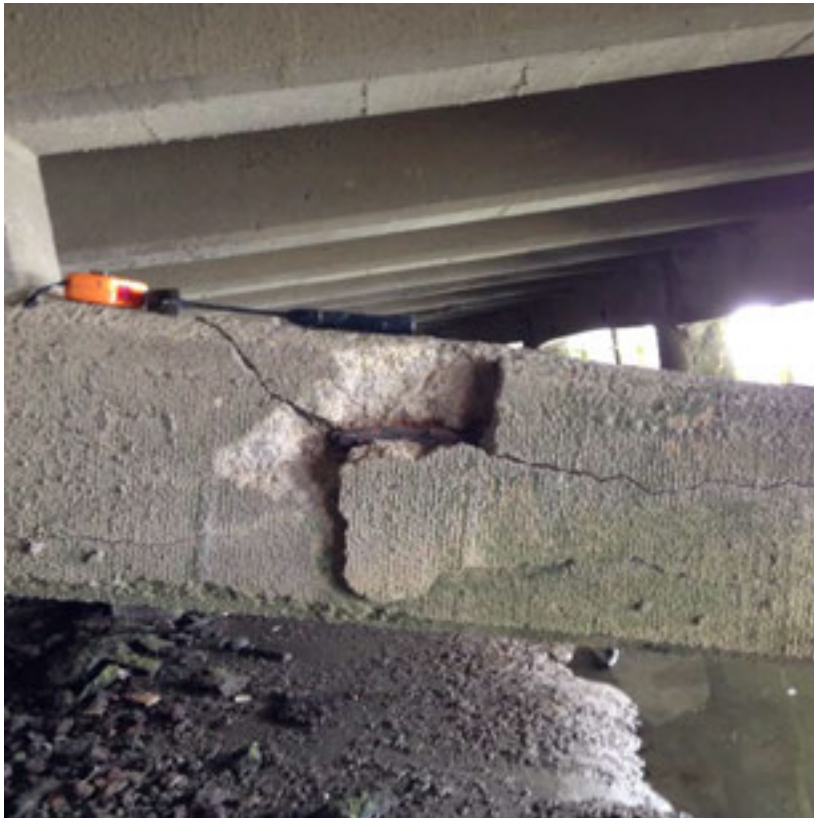
Photo C01 - cracking in beam at C2

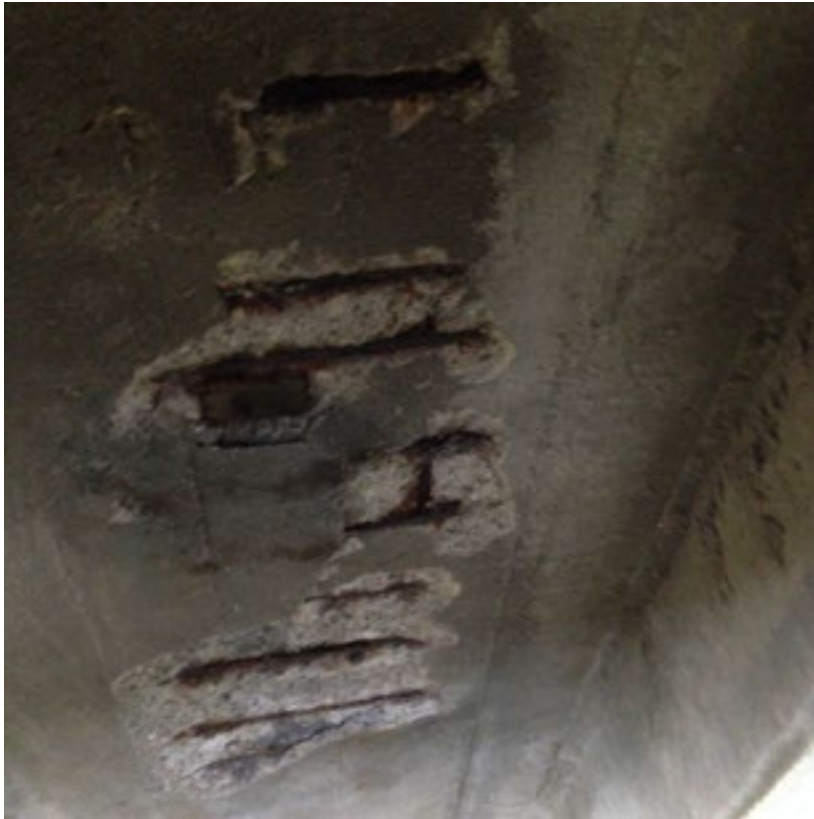
Photo C02 - slab spalling between C2 and C3
