Otumahi Public Water Supply – Water Safety Plan

Whakatāne District Council

Pattle Delamore Partners Ltd

- Version 2.00, August 2019

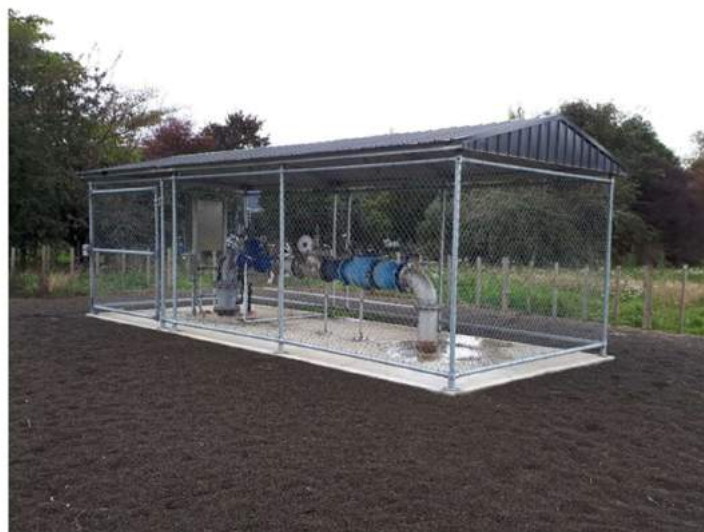
Figure 3: Paul Road Borehead and security enclosure

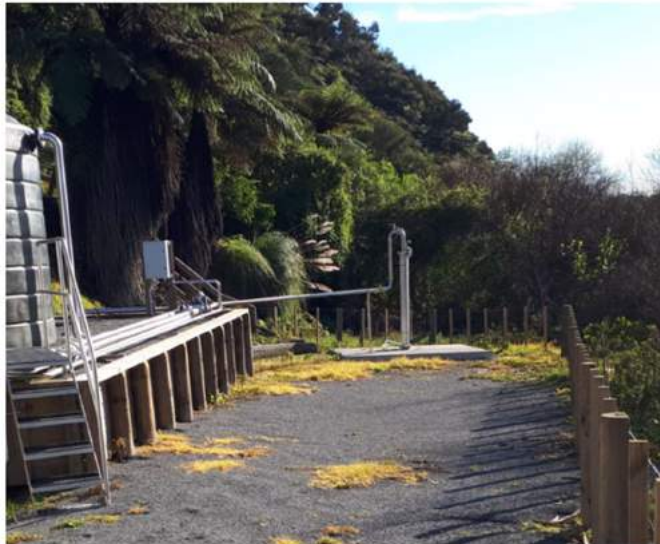
Figure 4: Tahuna Road Water Treatment Plant borehead

Cartridge filtration treatment at Tahuna Road consists of a 5 µm cartridge and a 1 µm cartridge connected in series. The cartridges are replaced periodically depending on run-times and gauge pressure, which are recorded in a Log book. Disinfection of cartridge housing is carried out after each cartridge replacement and testing is carried out to check successful changeover by passing water at maximum flow rate through the cartridges and recording residual pressure. Cartridges are sourced from recommended suppliers and the filtration units are operated according to manufacturer's instructions. WTP operators are trained in operating and maintaining the cartridge system according to manufacturer's specifications and best practice.

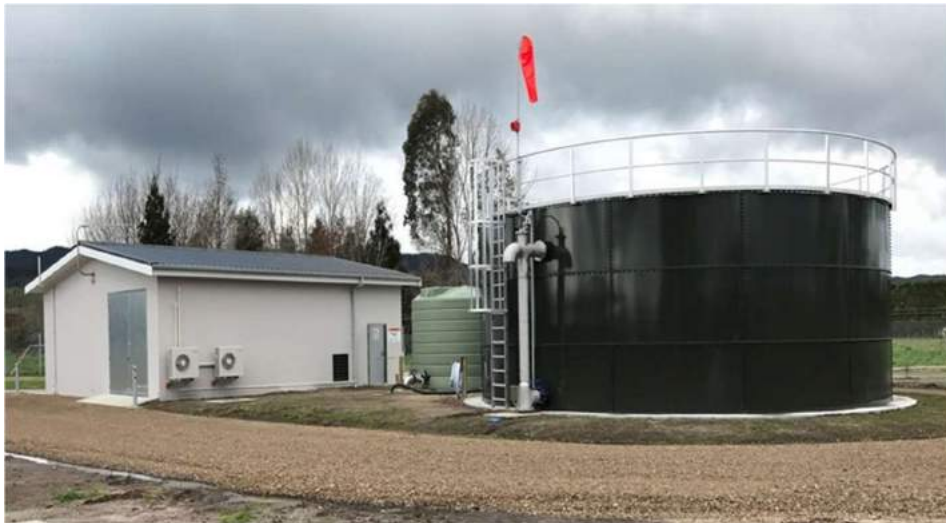
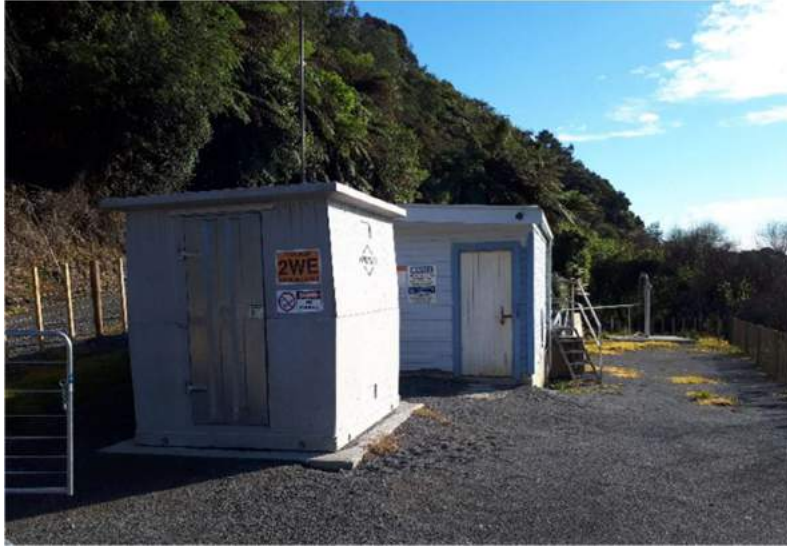
Figure 5: Paul Road Pump Station/ Treatment Plant Site (Above) and Tahuna Road Pump Station/ Treatment Plant Site (Below)

FAC, pH, flow and turbidity (NTU) are monitored continuously at the water treatment plant and the plant is designed to alarm when these parameters exceed set limits. If turbidity exceeds critical limits, both the Paul Road and Tahuna Road treatment plants are set up so that the plant stops operating. In instances where automatic shut-down occurs as a result of high turbidity, either plant can be manually overridden by WDC to provide water to the scheme accompanied by relevant procedures such as boil water notices and appropriate notification to the DWA. This process is especially true for the Tahuna Road site which has persistent issues with turbidity during periods of high rainfall. The process is currently being reviewed to allow some chlorine disinfection to occur when auto shut-off has been over-ridden.

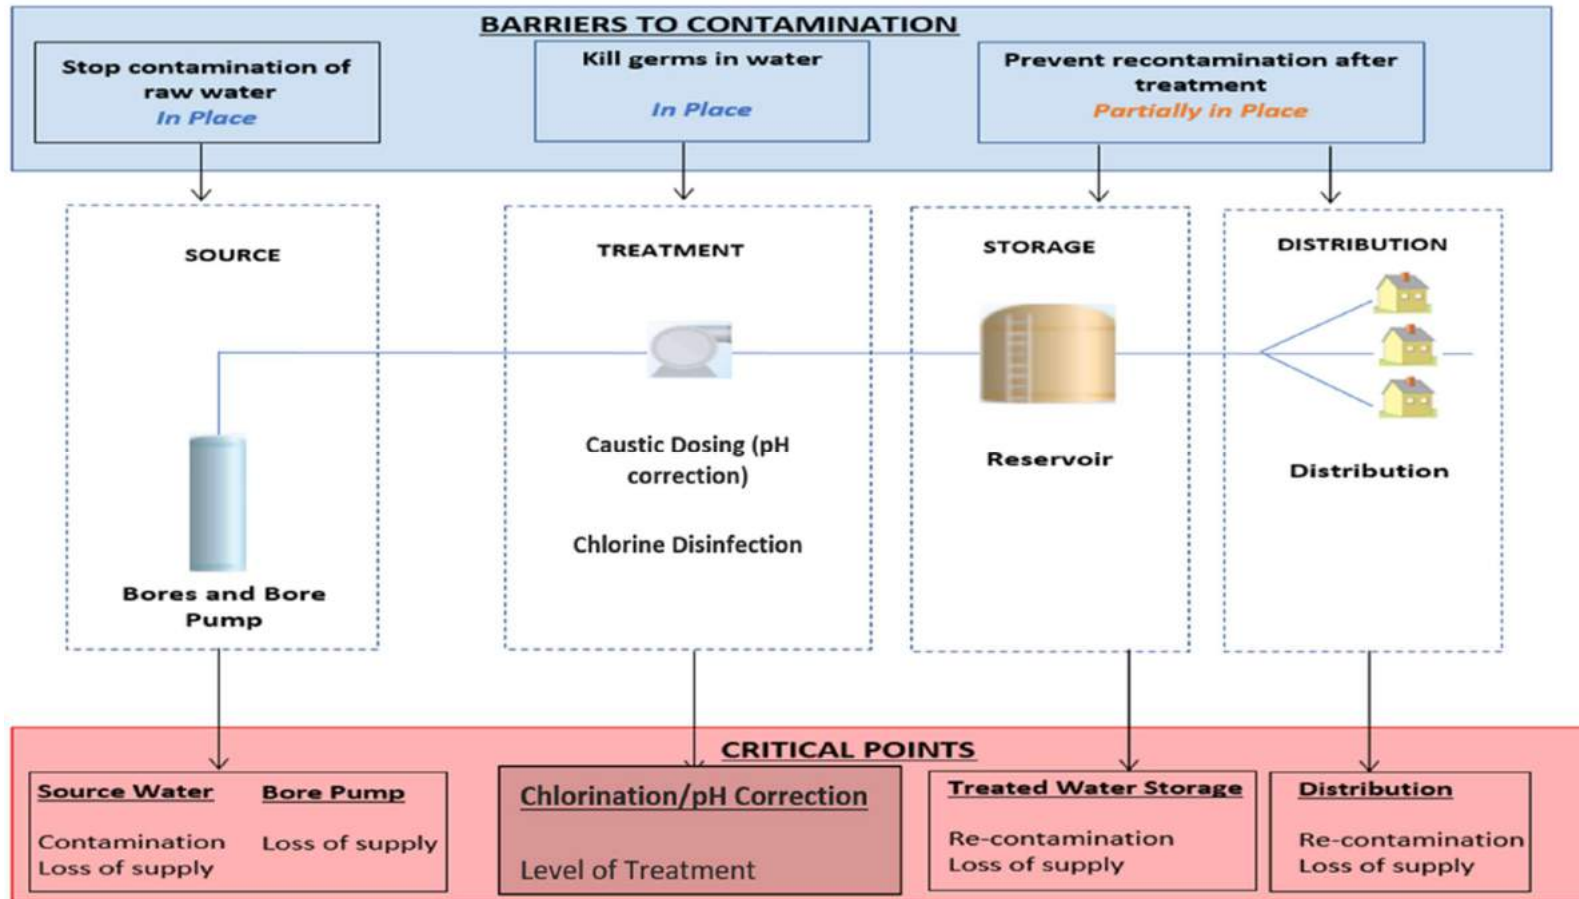
Figure 6: Barriers to Contamination and Critical Points of Paul Road Source and Treatment

Critical Points are areas in the scheme where there is potential for contamination or loss of supply of water. These were identified and presented in Table 4.

Figure 6 (Paul Road) and Figure 7 (Tahuna Road) show the Critical Control Points (CCPs) of the Otumahi Scheme and the Control Parameters that are to be monitored and measured at each CCP.

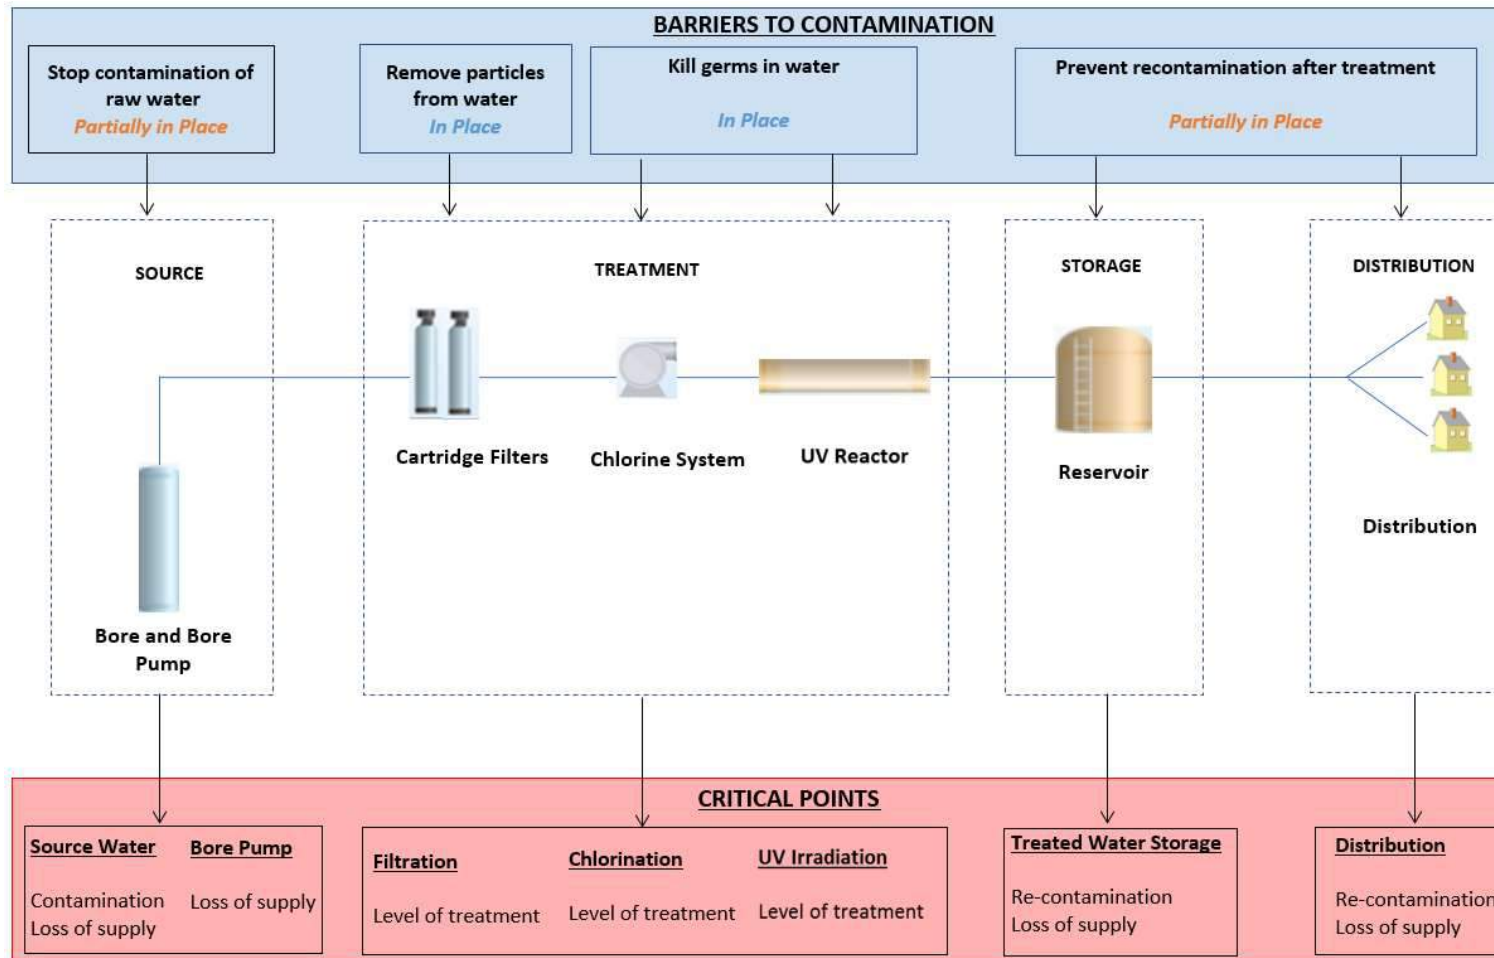
Figure 7: Barriers to Contamination and Critical Points of Tahuna Road Source and Treatment
