Te Mahoe Public Water Supply – Water Safety Plan

Whakatāne District Council

Pattle Delamore Partners Ltd

- Version 1.05, November 2018

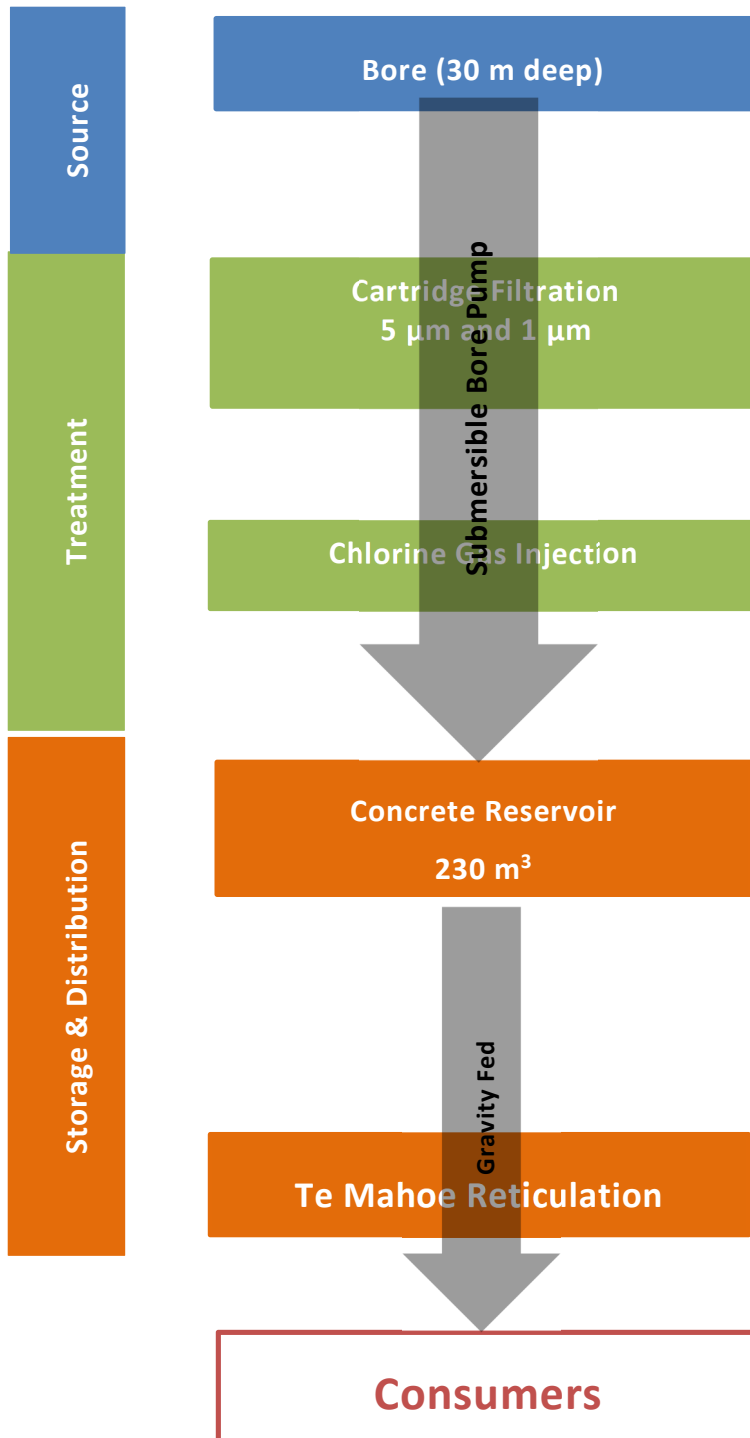
Figure 3: Schematic of Te Mahoe Water Supply Scheme

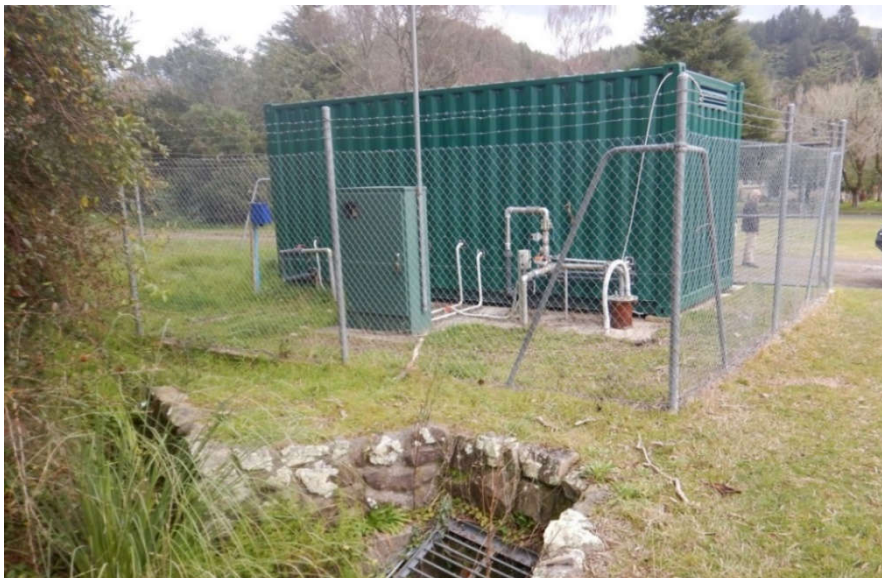
Figure 4: Bore Head and Container Housing for Treatment Equipment at Pump Station/Treatment Plant Site

A submersible pump pumps water from the bore through the water treatment plant to the storage reservoirs. There are no high lift or booster pumps in the system.

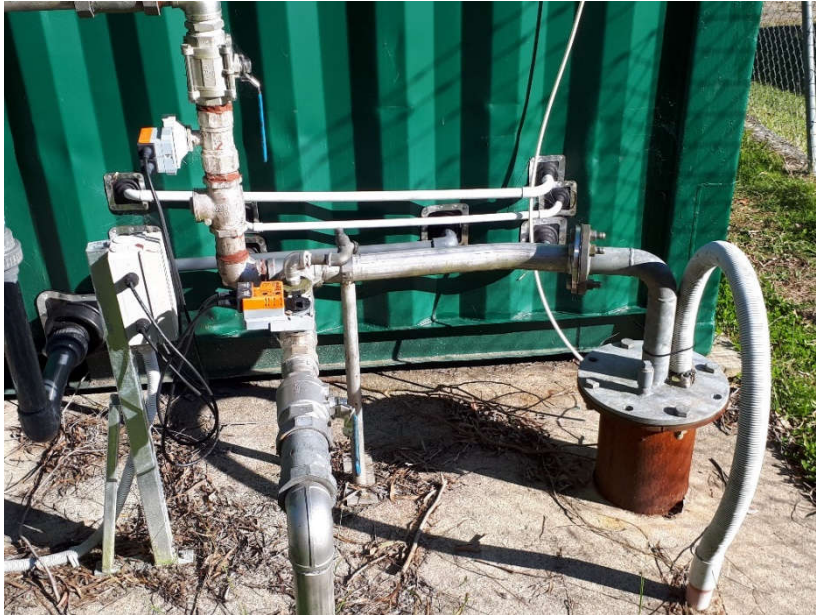
Figure 5: Bore Head Works at Pump Station/Treatment Plant Site

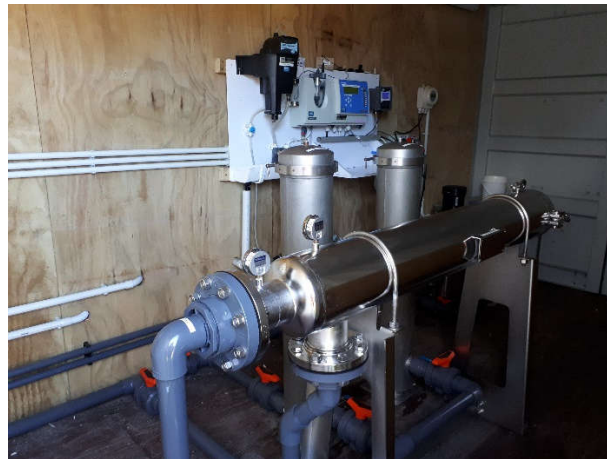
Figure 6: WTP Cartridge filtration and monitoring equipment within container housing

The cartridge filtration treatment consists of a 5 µm cartridge and a 1 µm cartridge connected in series. The cartridges are replaced periodically depending on run-time which is recorded in a Log book. Disinfection of cartridge housing is carried out after each cartridge replacement and testing is carried out to check successful changeover by passing water at maximum flow rate through the cartridges and recording residual pressure. Cartridges are sourced from recommended suppliers and operated filtration unit is operated according to manufacturer's instructions. WTP operators are trained in operating and maintaining the cartridge system according to manufacturer's specifications and best practice.

FAC, pH and Turbidity (NTU) are monitored continuously at the water treatment plant and the plant is designed to alarm when these parameters exceed set limits. Flow is measured continuously and differential pressures in the cartridges are measured twice a week. When certain parameters exceeded limits the plant automatically shuts down by cutting off power to the bore pumps. During some instances automatic shut -down of the plant is manually overridden by WDC to provide water to the scheme accompanied by relevant procedures such as boil water notices and appropriate notification to the DWA.

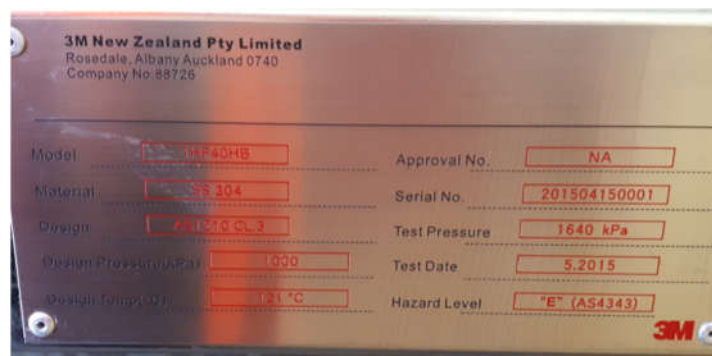
Figure 7: Te Mahoe filtration cartridge plate – model 1HF4OHB

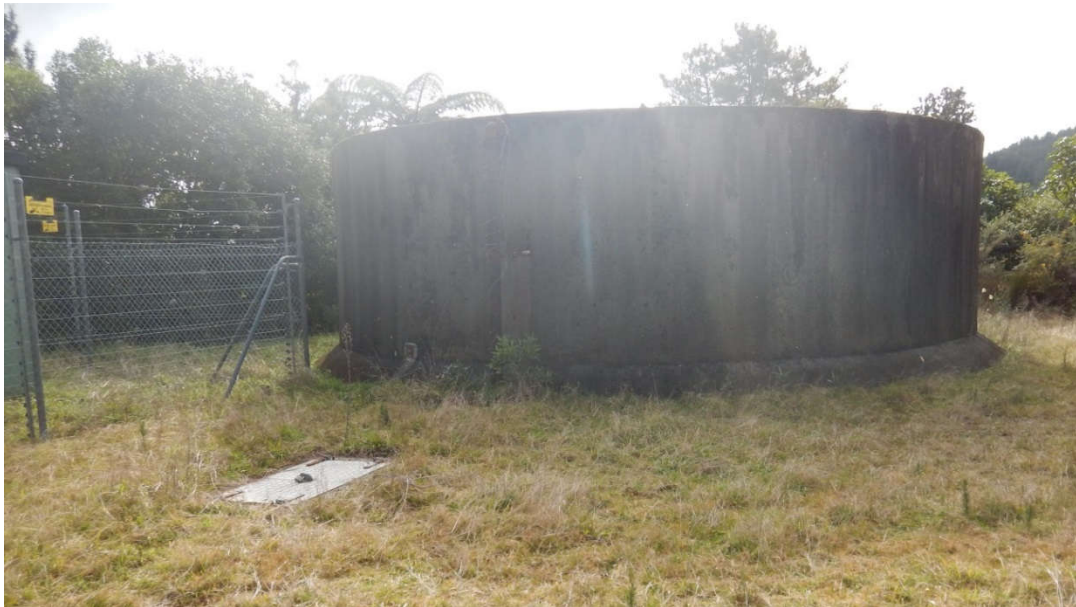
Treated water is pumped to a reservoir located nearby before being gravity fed to the Te Mahoe reticulation system. The reservoir is concrete with a capacity of 230 m³ and storage available is sufficient to meet average daily demand and fire-

fighting flows and provide 24-hour emergency storage. Condition of the structural integrity of the reservoir is to be monitored and upgraded if required as it is reaching the end of its average useful life.

Figure 8: Concrete Storage Reservoir

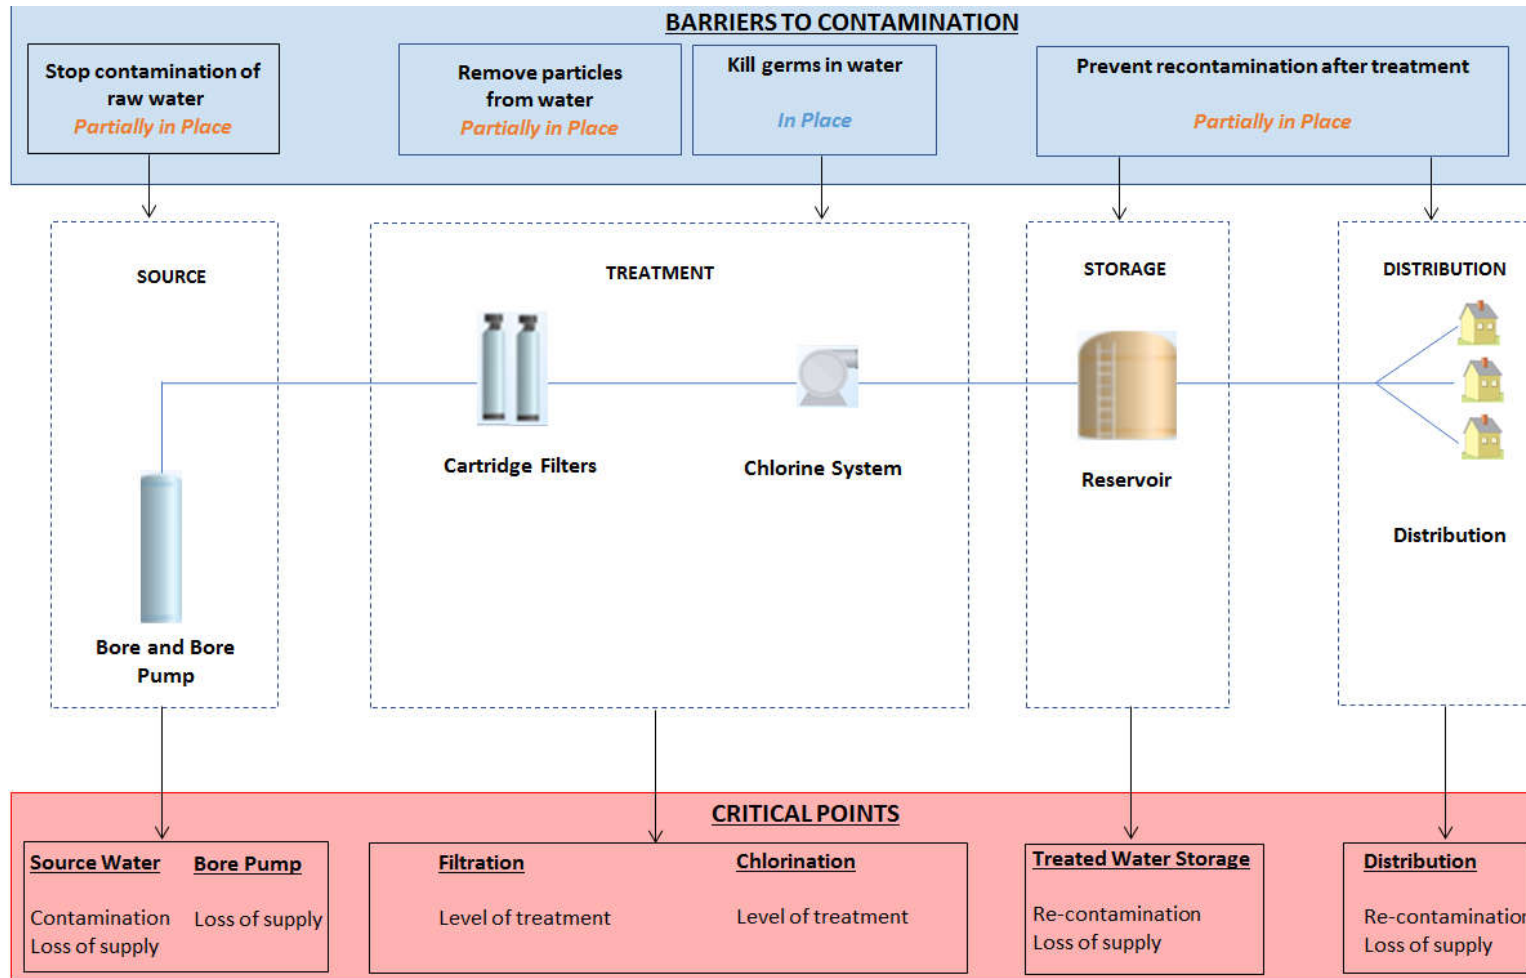
Figure 9: Barriers to Contamination and Critical Points of the Te Mahoe Scheme

Critical Points are areas in the scheme where there is potential for contamination or loss of supply of water. These were identified and presented in Table 6 and graphically in Figure 9.

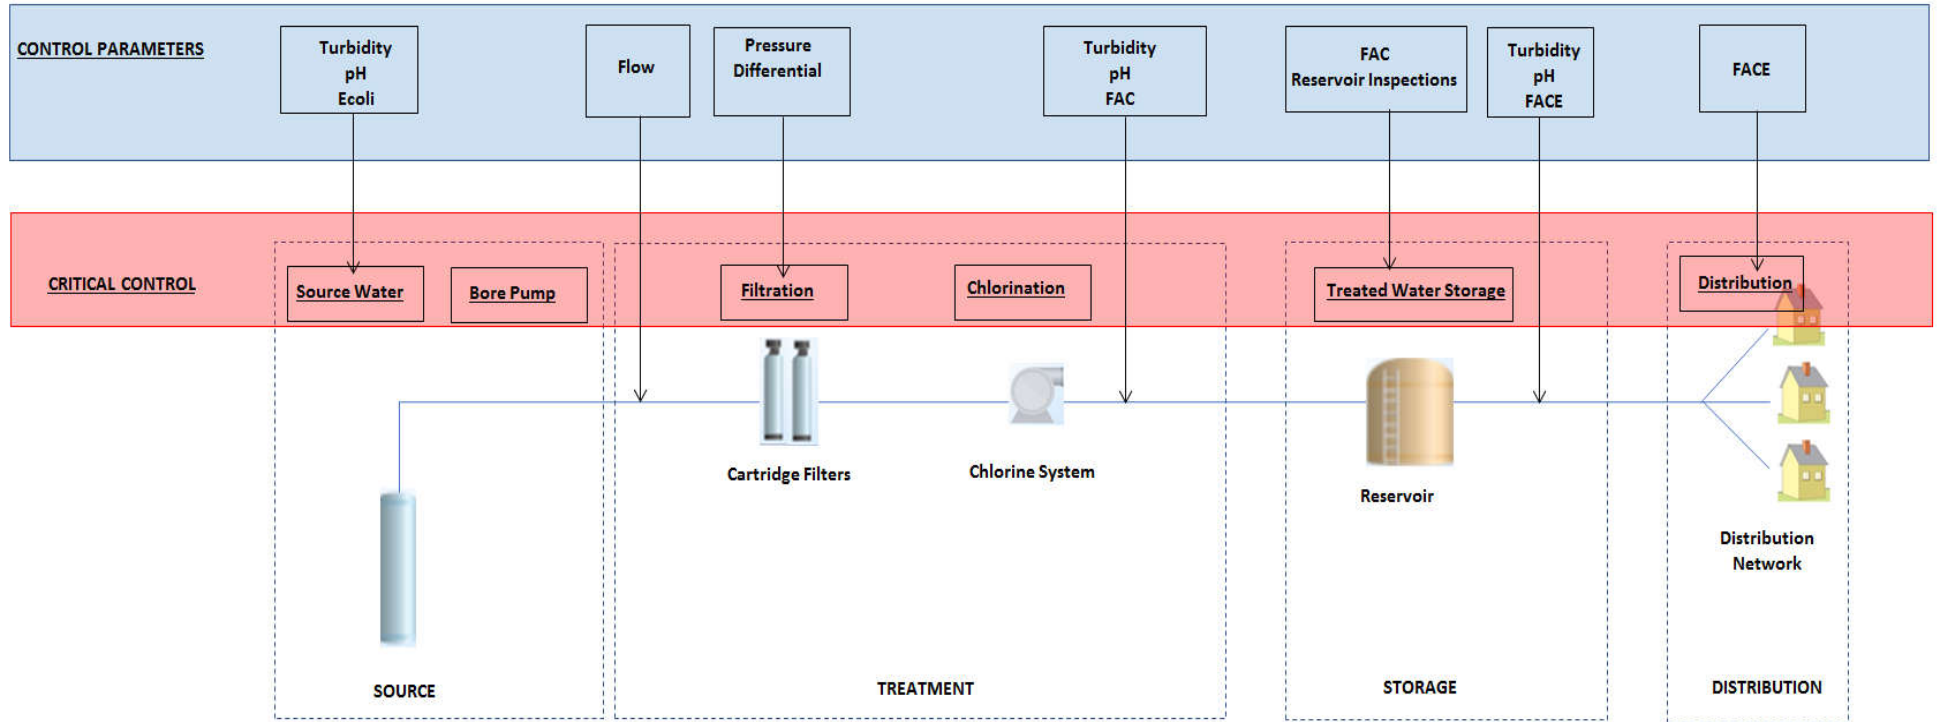
Figure 10: Critical Control Points and Corresponding Control Parameters for the Te Mahoe Scheme for Source, Treatment, Storage and Distribution

Figure 10 shows the Critical Control Points (CCPs) of the Te Mahoe Scheme and the Control Parameters that shall be monitored and measured at each CCP.

Process Control Summaries have been prepared for the Treatment CCPs of the Te Mahoe Scheme. Process control summaries have not been prepared for the Source, Storage and Distribution CCPs further to guidance from the DWA.

A description of each Treatment CCP can be found in Sections 9.1 (Filtration) and 9.2 (Chlorination) and Appendix B sets out Process Control Summaries for each of the Treatment CCPs.
