Whakatane Commercial Wharf

Condition Assessment and Repair Options Report

**Prepared for:
Whakatane District Council**

February 2015
Job No: 851847

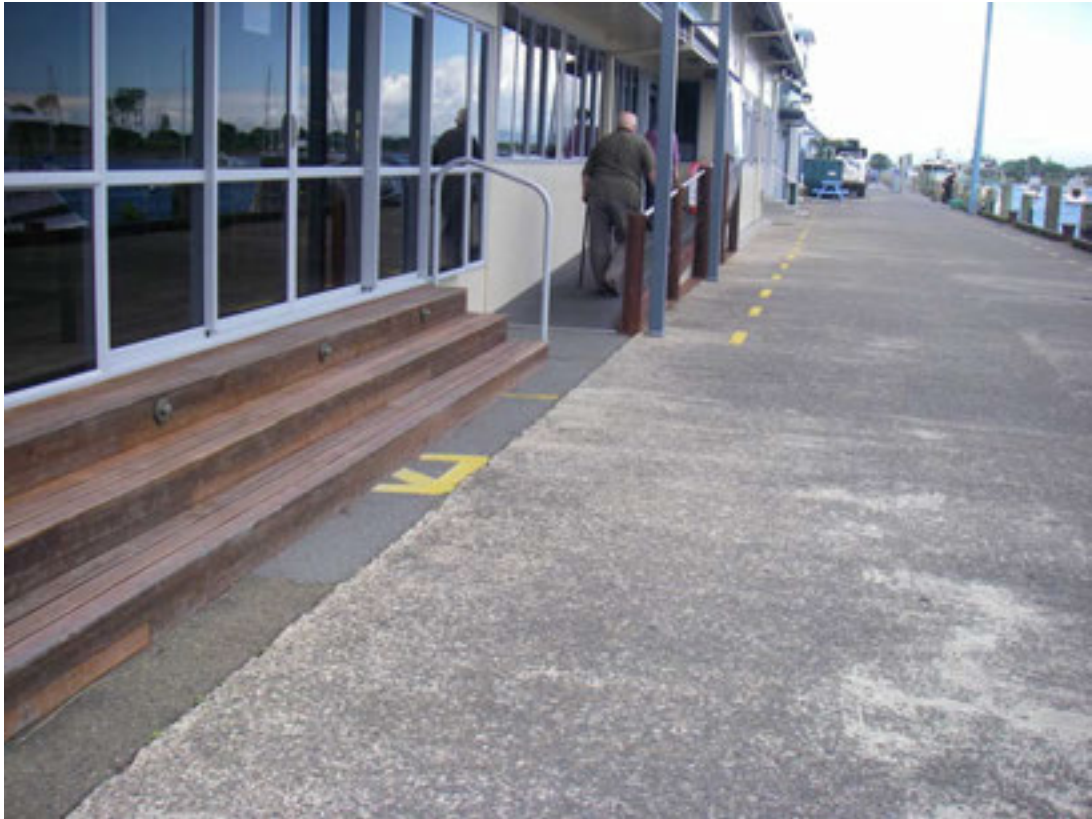
Photo T07 - view to east

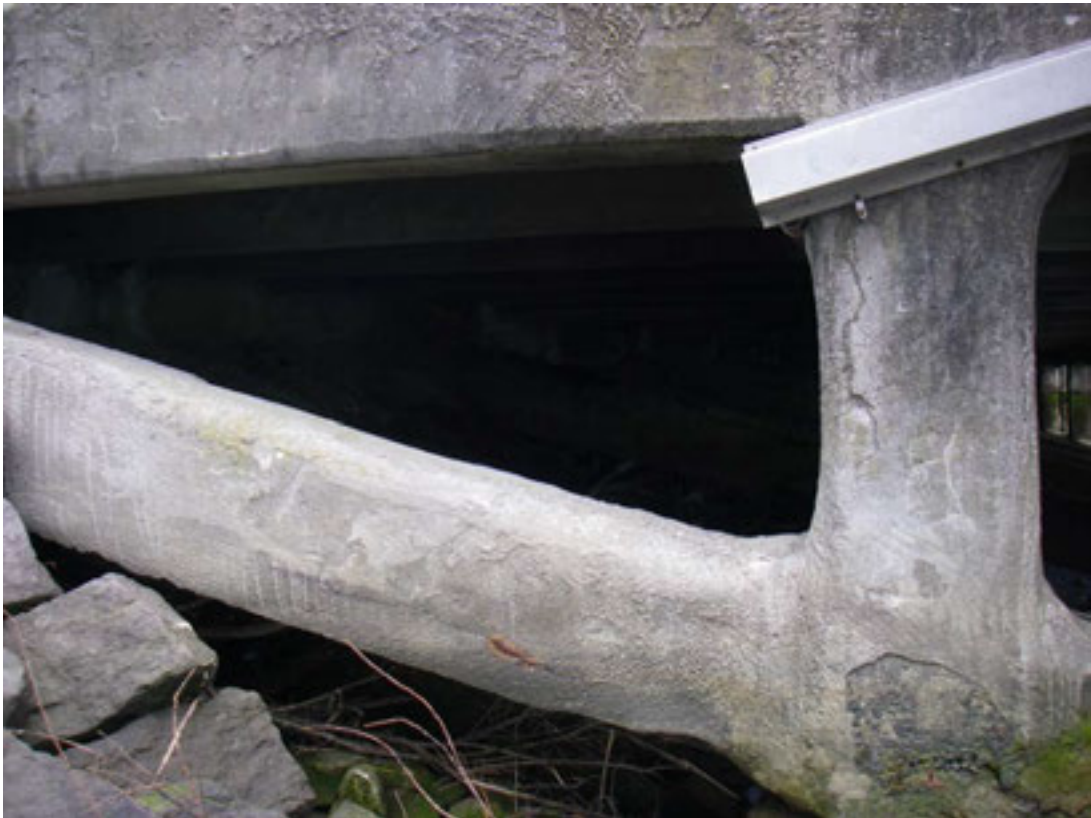
Photo A01 - gridline A1

Of immediate concern is the wharf slab at the south eastern corner of the 1936 wharf (between gridlines A1 and A2 and gridlines 2 and 3), where the reinforcement has completely corroded in places and daylight is visible through the slab. **This section of slab is considered dangerous and we recommend that this section of slab is fenced off immediately to prevent vehicle loading.**
